Problem: During the 2015 Christmas and New

Years flooding events two-36 in. diameter corrugated metal pipes failed causing immanent road failure.

Propsed Solution: Replace with two-36 in. diameter reinforced concrete pipes and headwalls.

Project: 155 Westbridge Circle – 2017 SPLOST

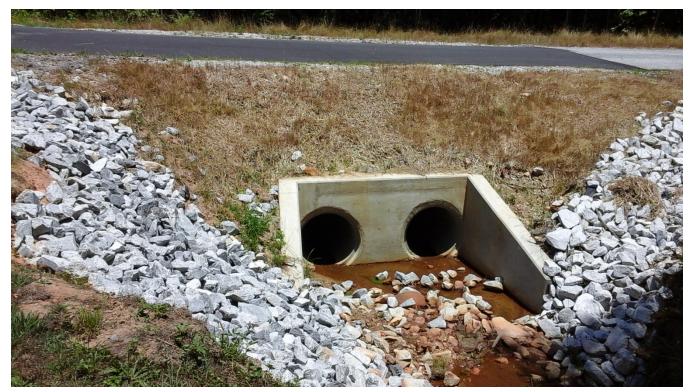
Photo 1: The two new 36" concrete pipes and headwalls have been installed. Rip rap was placed around the project area. (Work completed 01/14/2016)

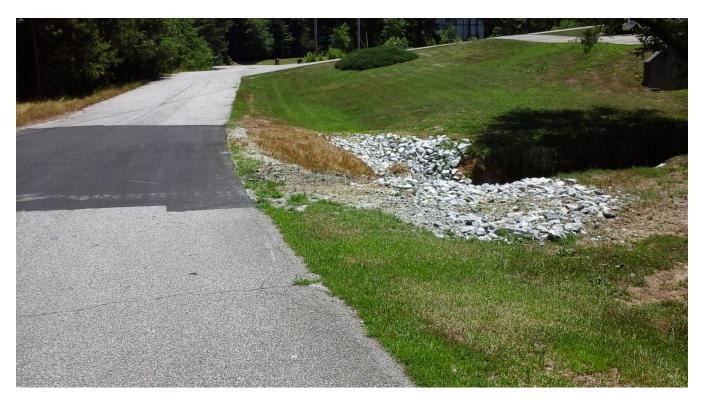
Photo 2: The roadway was repaired, repaved, and opened for traffic. (Work completed 01/14/2016)

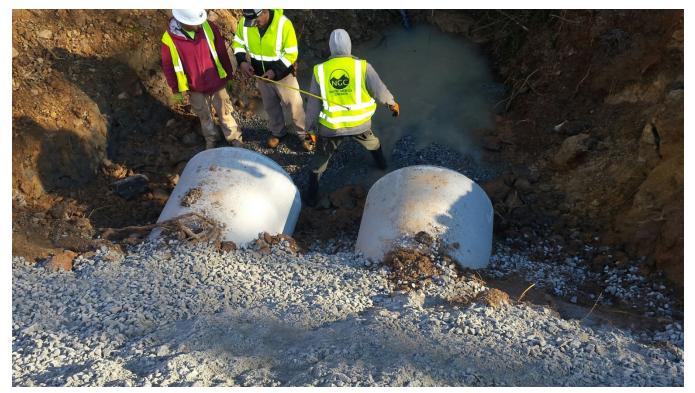
Photo 1: The contractor continues to install the new pipes.

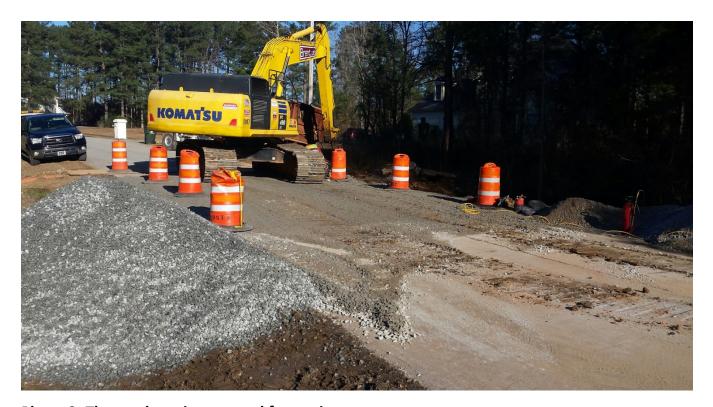
Photo 2: The roadway is prepared for paving.

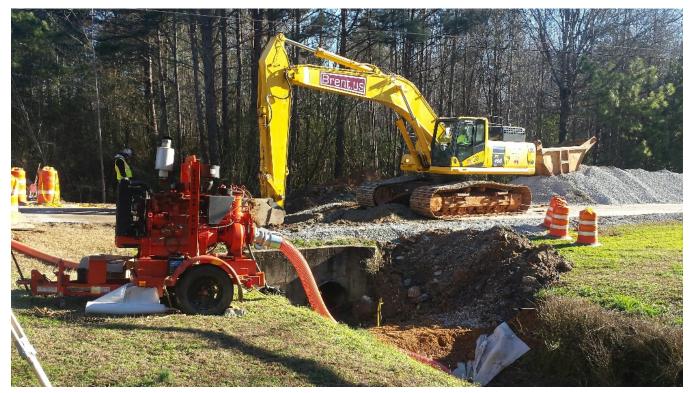
Photo 1: Excavation began at project location. The water was pumped around the location to provide dry site conditions.

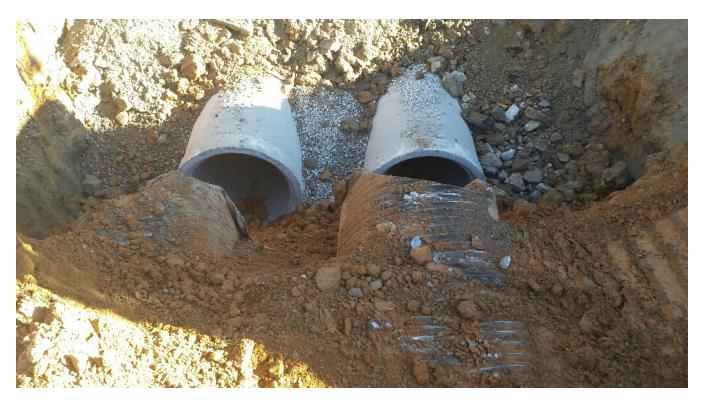
Photo 2: The existing pipes were removed and replaced by two 36" concrete pipes.

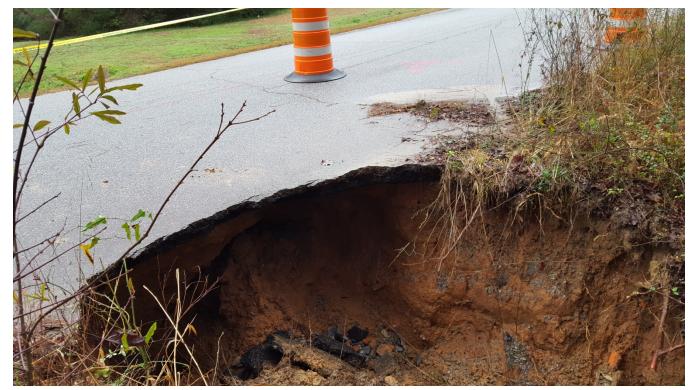
Photo 1: Pre-existing condition. During the December 2015 and New Year's (2016) rain events, two 36" metal pipes failed causing immanent road failure. This shows washout

underneath road on downstream side of pipe.

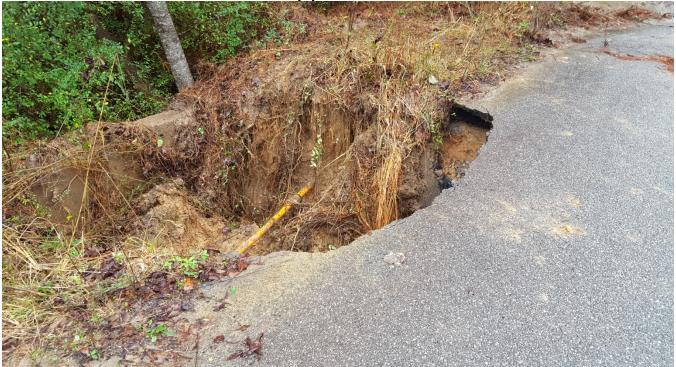
Photo 2: The shoulder of the road washed away exposing a gas line.
