# 228 Bernhard Rd

Project: 228 Bernhard Road – 2017 SPLOST

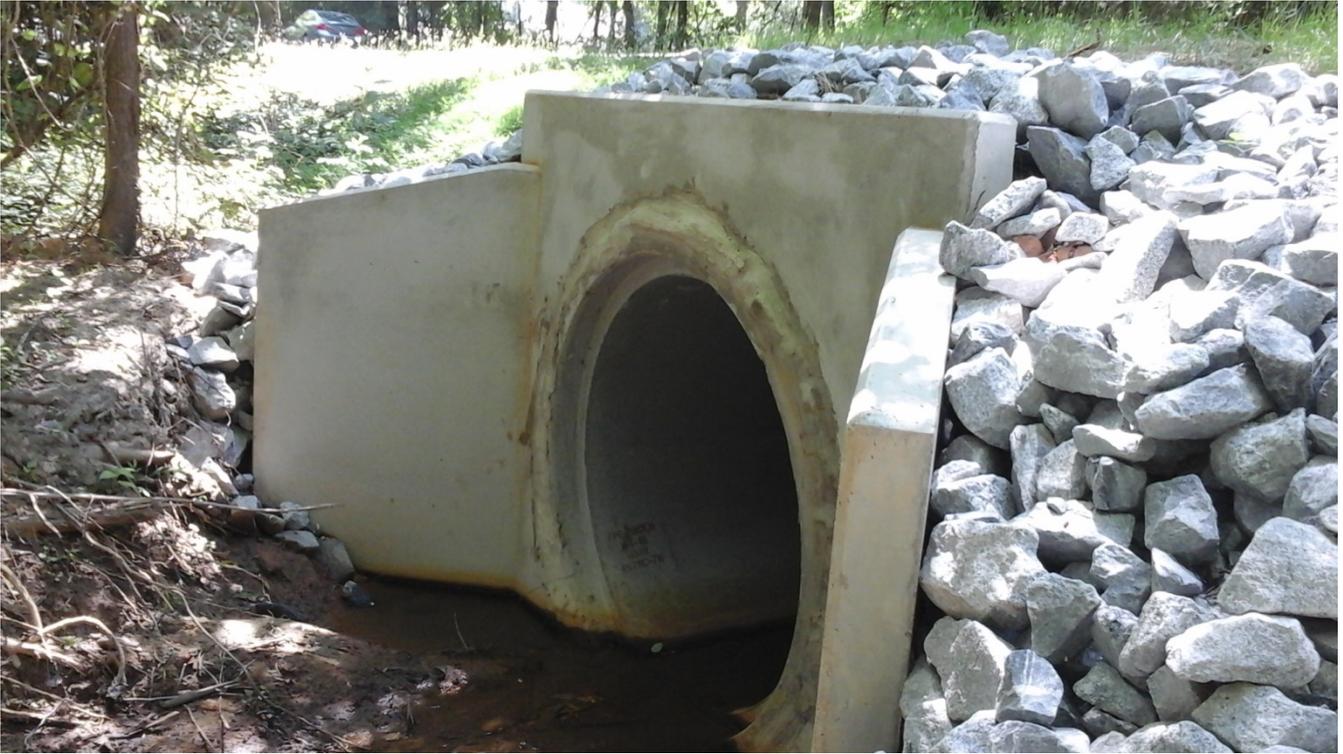
**Photo 1: Completed project. Photo captures new headwall that was installed.**

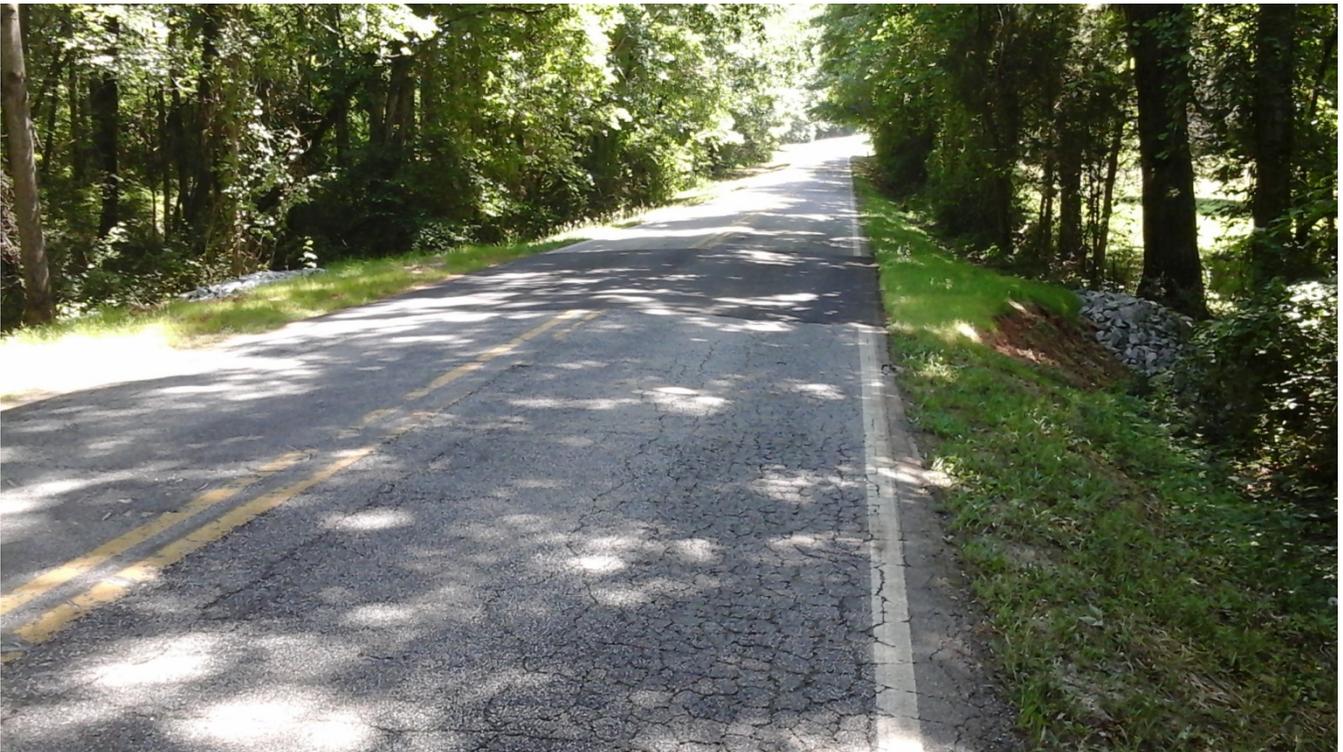
**Photo 2: Completed project. New headwalls and rock are visible on both sides of the road.**

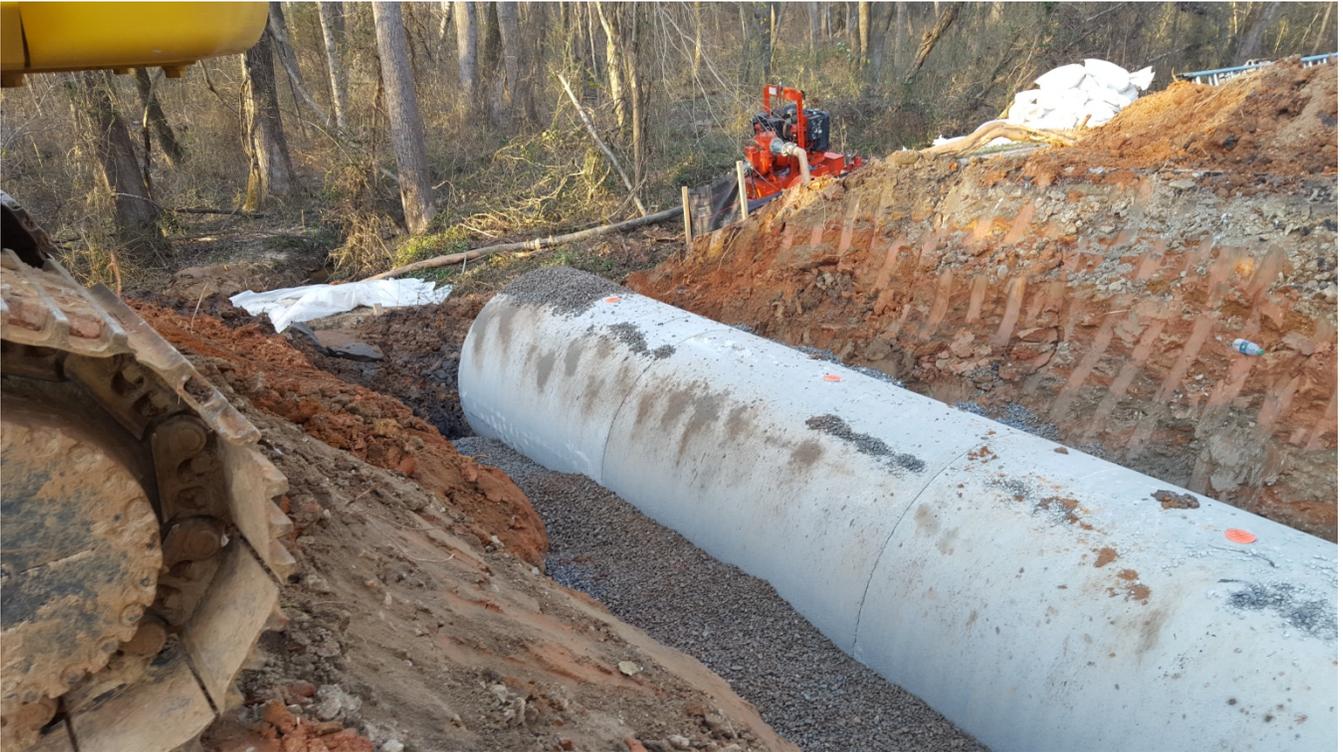
**Photo 1: Installation of 42" concrete pipe. (03/07/2016)**

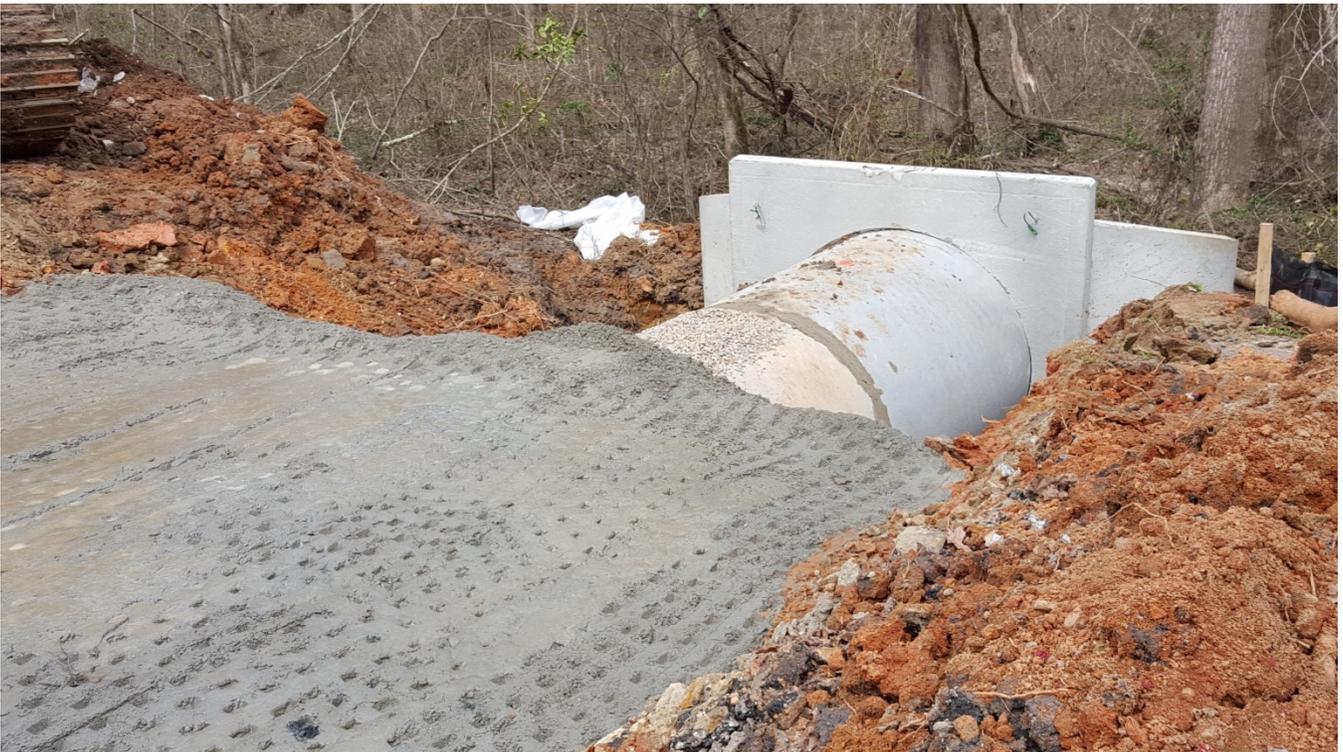
**Photo 2: Installation of headwall and location grading. (03/08/2016)**

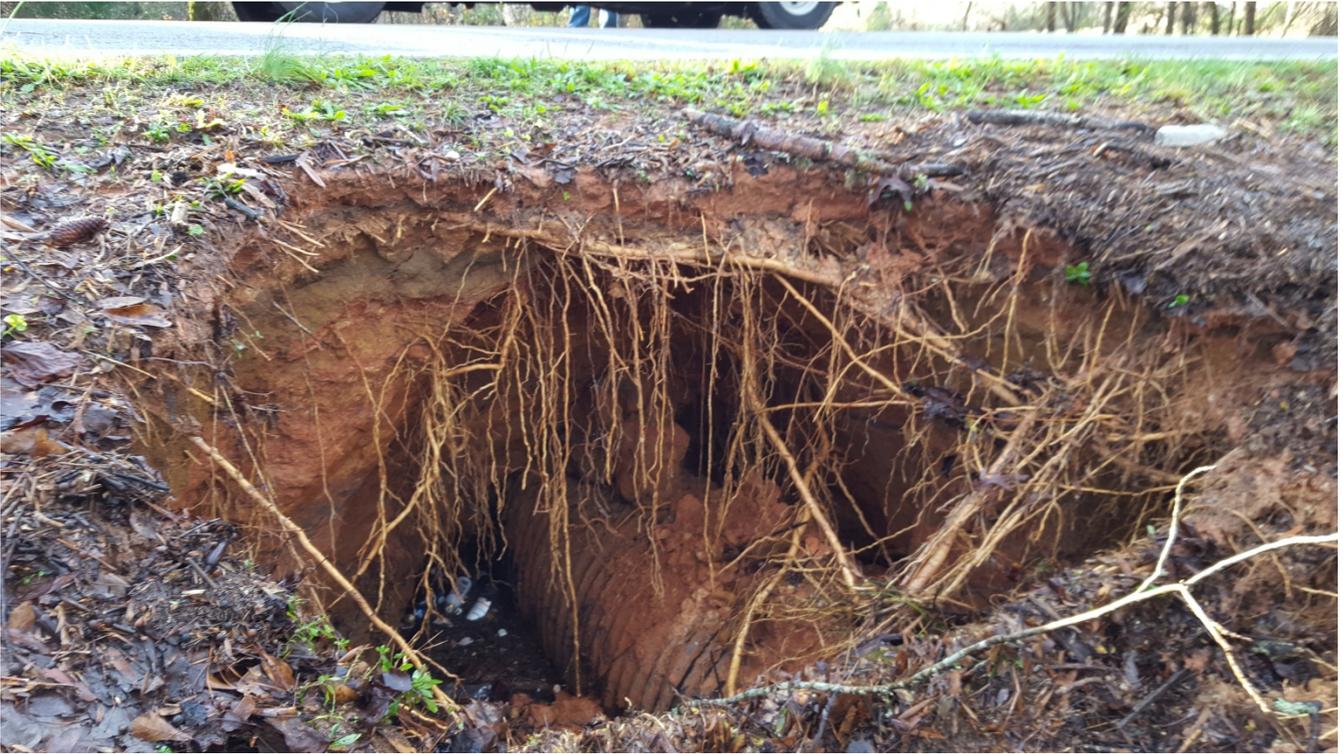
**Photo 1: Pre-existing conditions.**

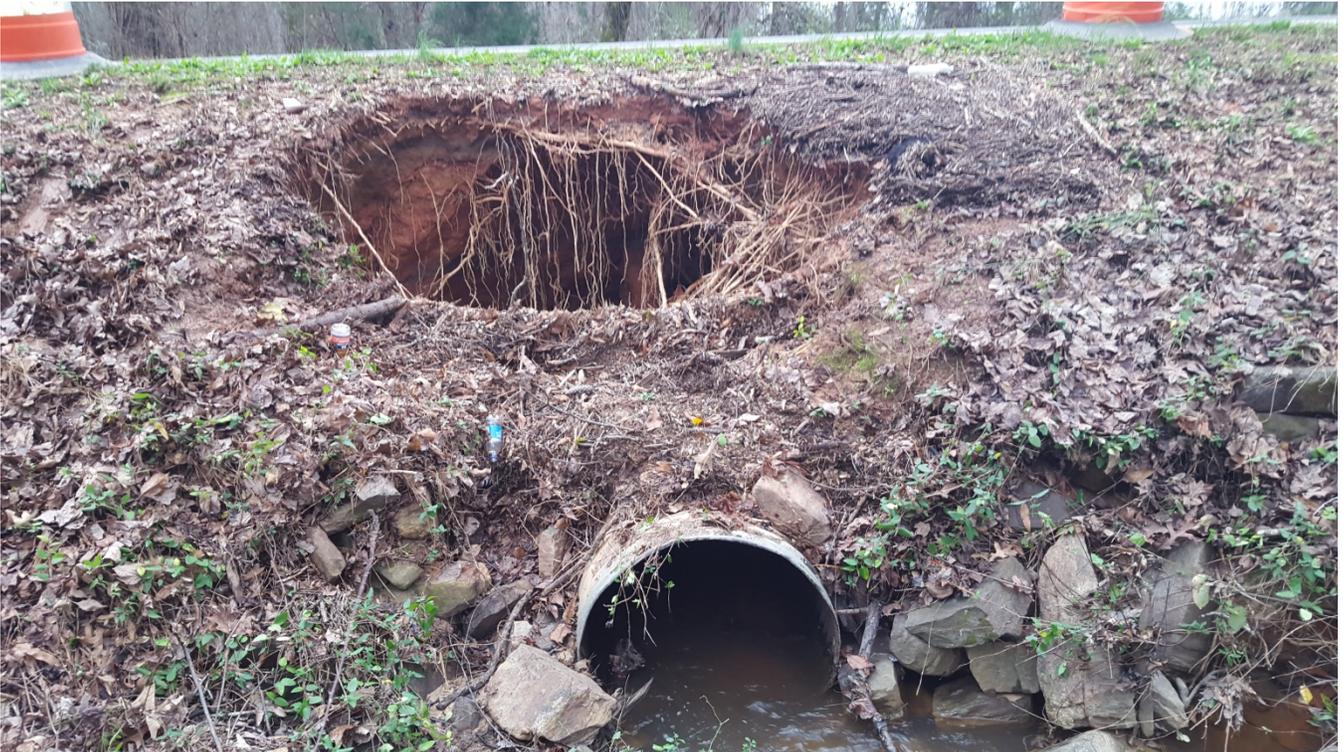
**Photo 2: Pre-existing conditions.**
