Pre-construction Photo

Problem: Washout around the 54 in. diameter

Propsed Solution: Install a 54 in. reinforced concrete pipe

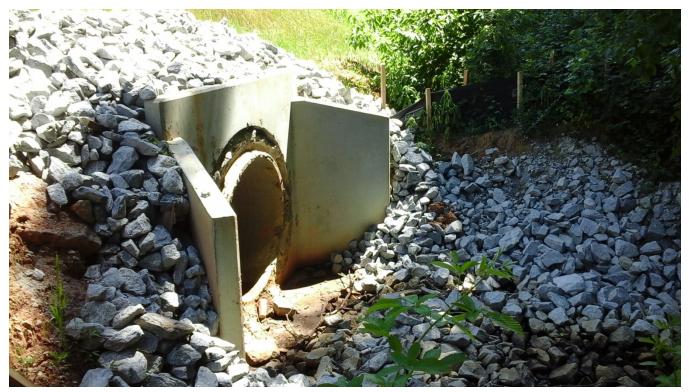
Photo 1: The new 54" concrete pipe and headwalls have been completely installed, along with rip rap along the shoulder and creek bed.

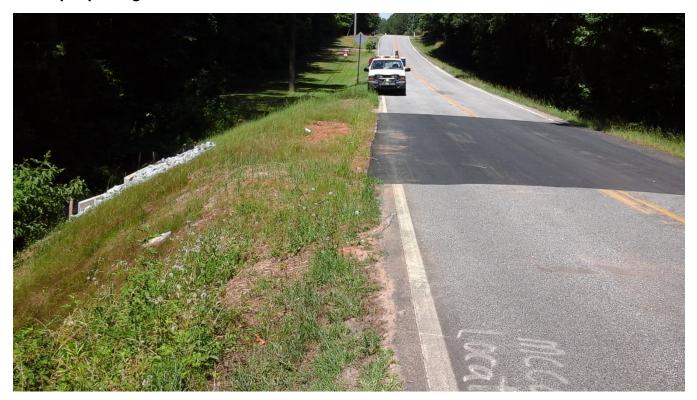
Photo 2: McBride Road was repaired, repaved, and opened for traffic.

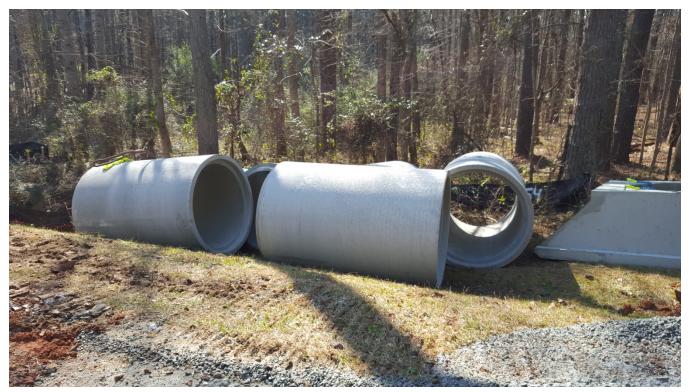
Photo 1: The new 54" concrete pipe and headwalls were delivered and staged until installation.

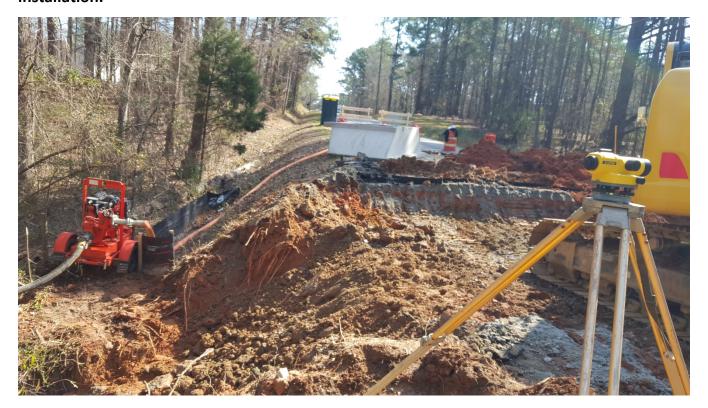
Photo 2: Water was pumped around the project site to allow for dry installation of new pipe.

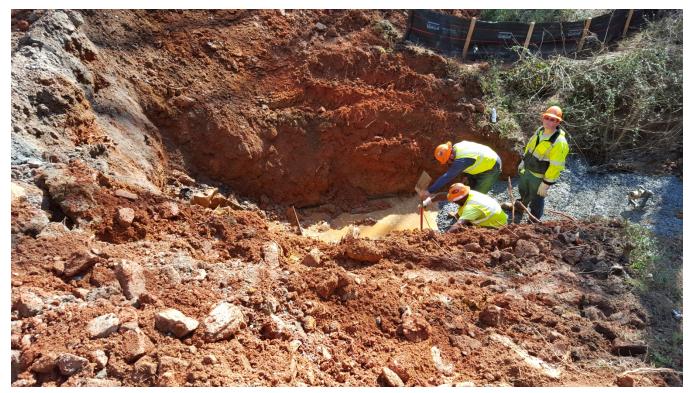
Photo 1: Crews work to prepare the site for new concrete pipe.

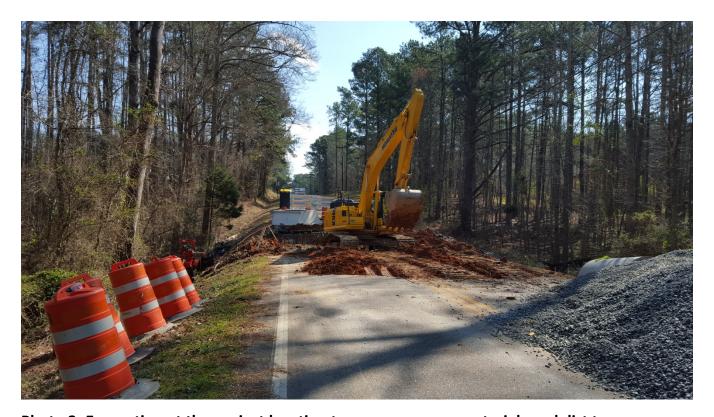
Photo 2: Excavation at the project location to remove excess materials and dirt to prepare for pipe installation.

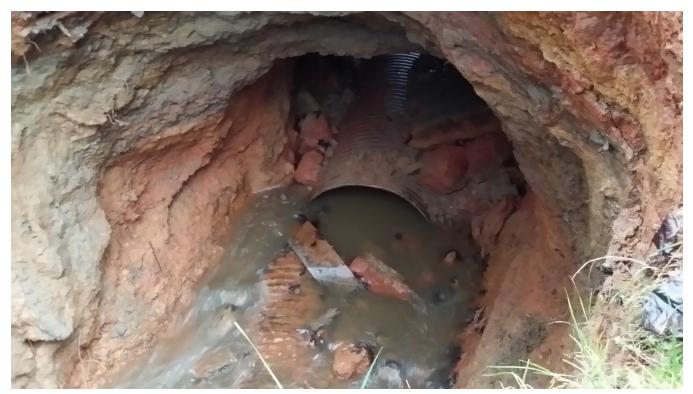
corrugated metal pipe caused complete

road failure.

Photo 1: Pre-existing condition of 54" metal pipe. Washout, during the December 2015 rain event, occurred around the pipe resulting in complete road failure.

and headwalls.

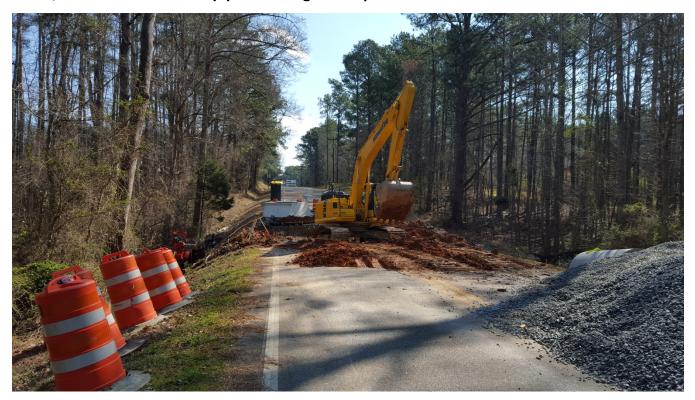
Photo 2: There was a large void between the washout pipe and the bottom of the road surface. The road was collapsed by the Road Department, to prevent vehicles from driving across the road resulting in catastrophic accidents until the pipe could be replaced.
