**Subject: Invitation to Bid 27043-B: Lake McIntosh Dam Structural Repairs**

**SCOPE AND SPECIFICATION**  
**ITB 27043-B: Lake McIntosh Dam Structural Repairs**

Fayette County Water System is seeking bids from qualified vendors for structural concrete repairs to the Lake McIntosh Dam spillway structure. The work is based on the Lake McIntosh and Lake Kedron Dam Spillway Walls Structural Assessment prepared by Arcadis U.S., Inc., dated October 27, 2023, and the associated Lake McIntosh Dam Spillway Structure Photograph Log. The work generally includes repair of non-structural and structural cracks, repair of leakage locations, patching of concrete surface deterioration and form-tie locations, and restoration of affected areas.

Structural Evaluation Report – Attachment A Photograph Log  
Lake McIntosh and Lake Kedron Dam Spillway Wall Structural Assessment  
Fayette County Water System (FCWS)

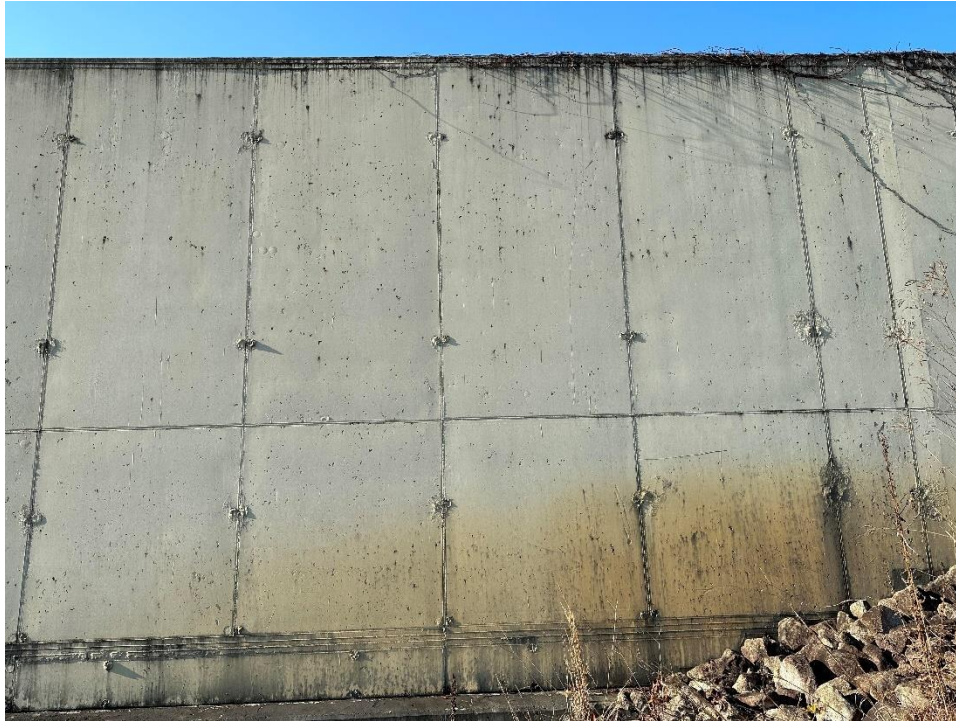
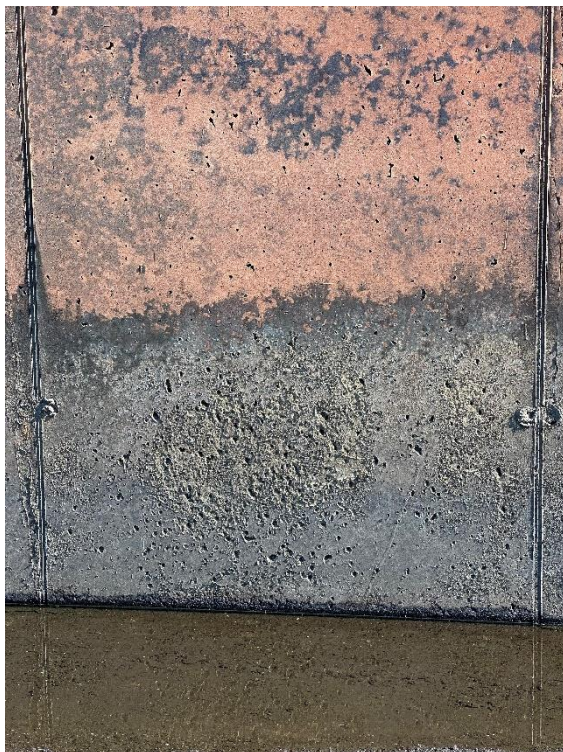
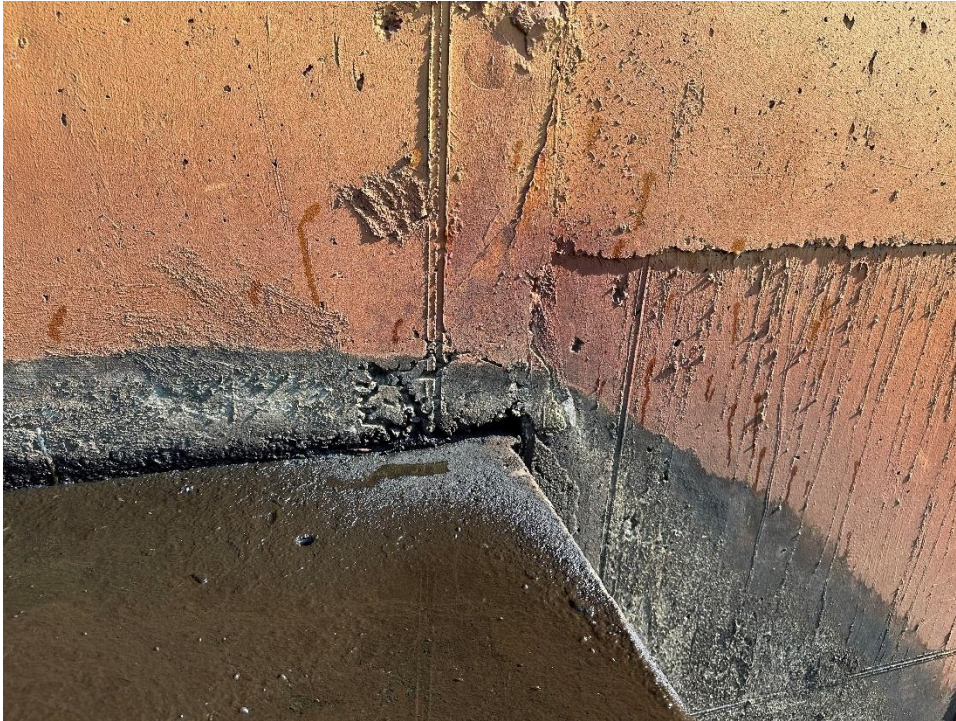
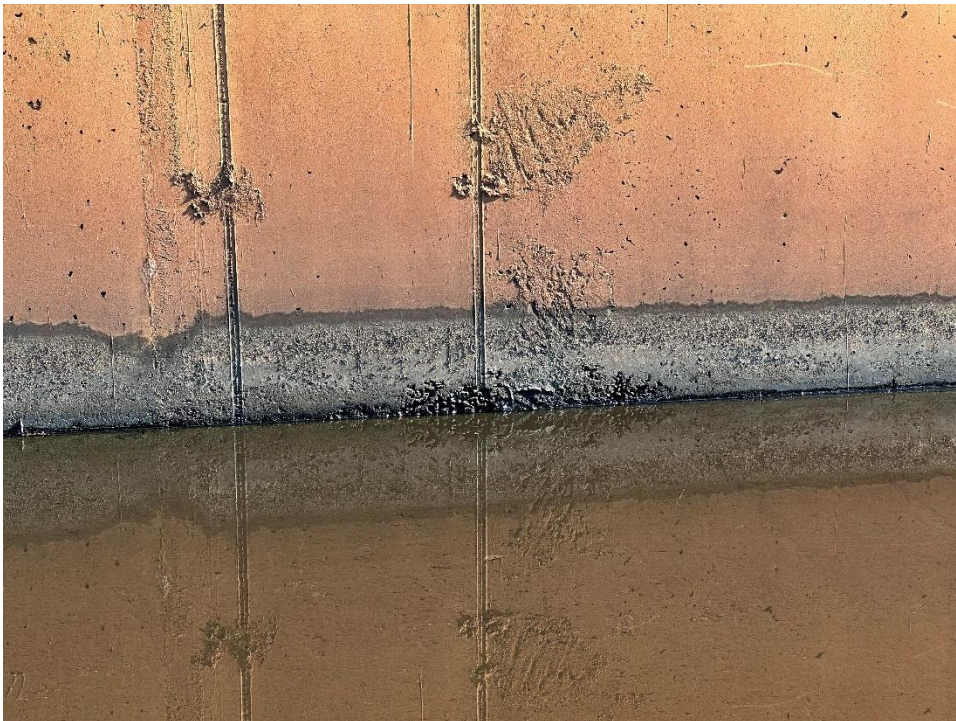
8. Repair concrete surface deterioration, including minor spalling, voids, bug holes, and exposed aggregate, where identified in the assessment and photograph log. Representative conditions are shown in Photographs 24 through 27.

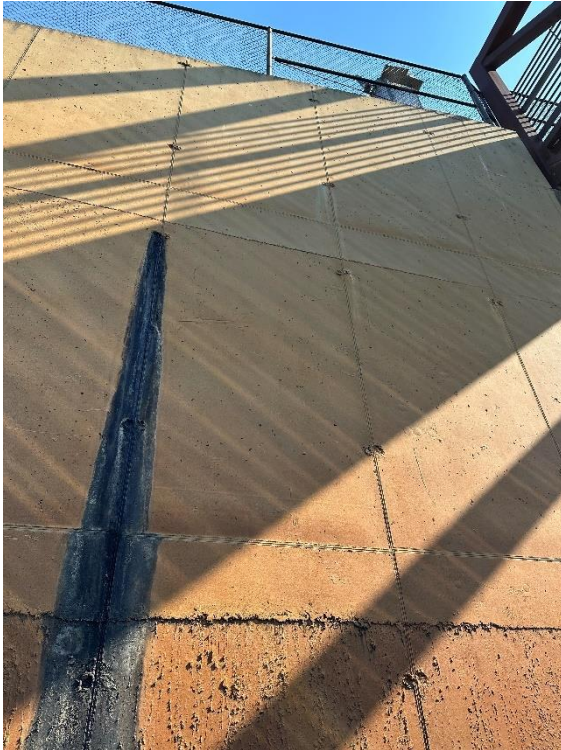
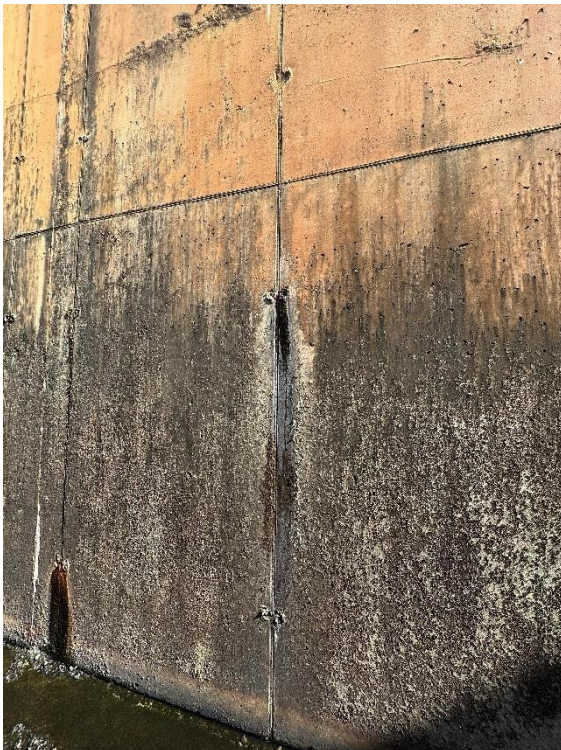
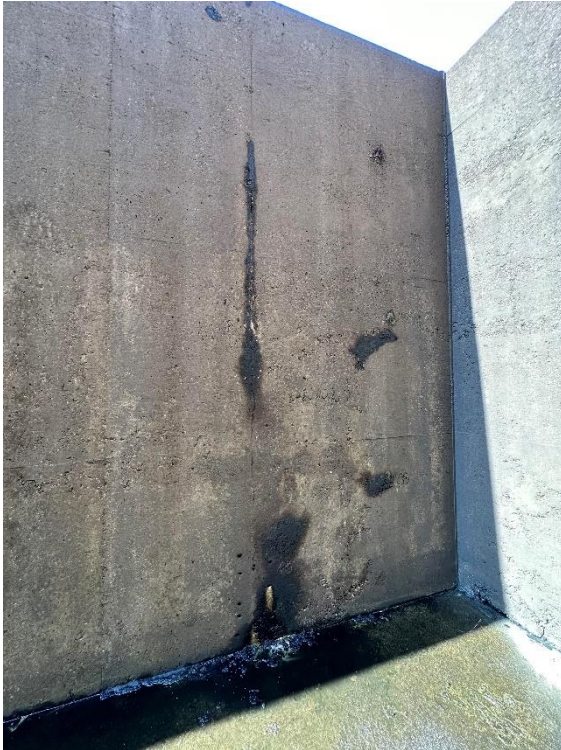
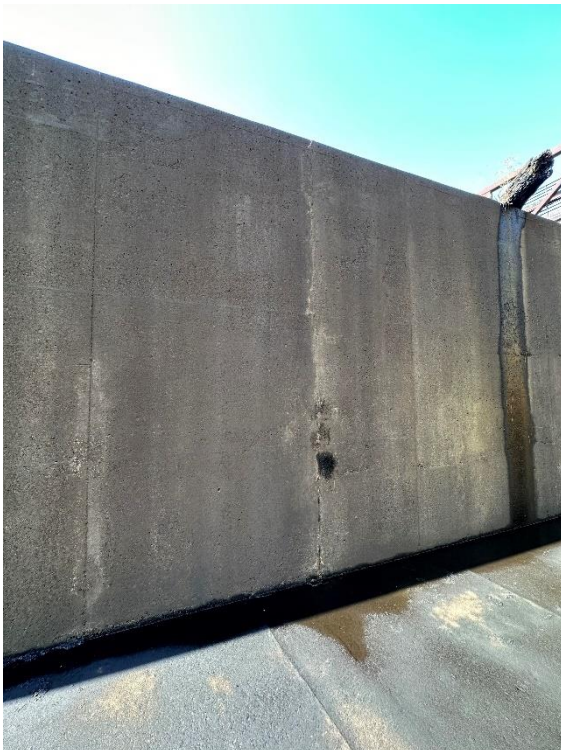
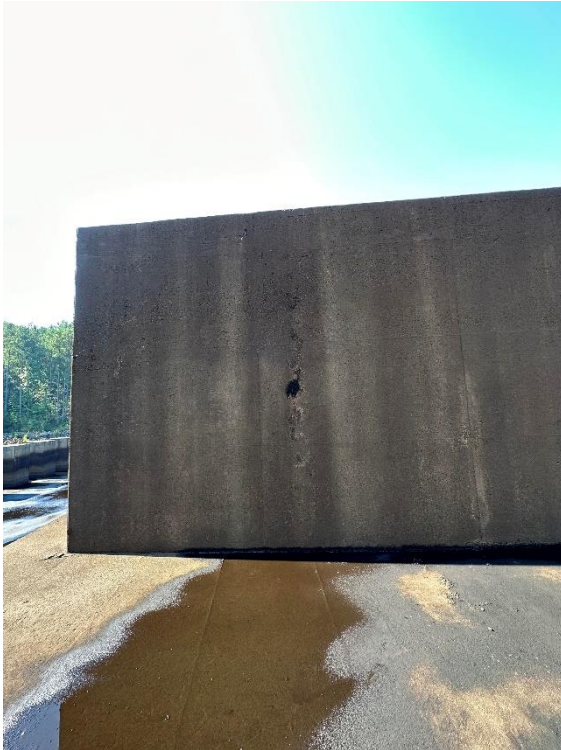
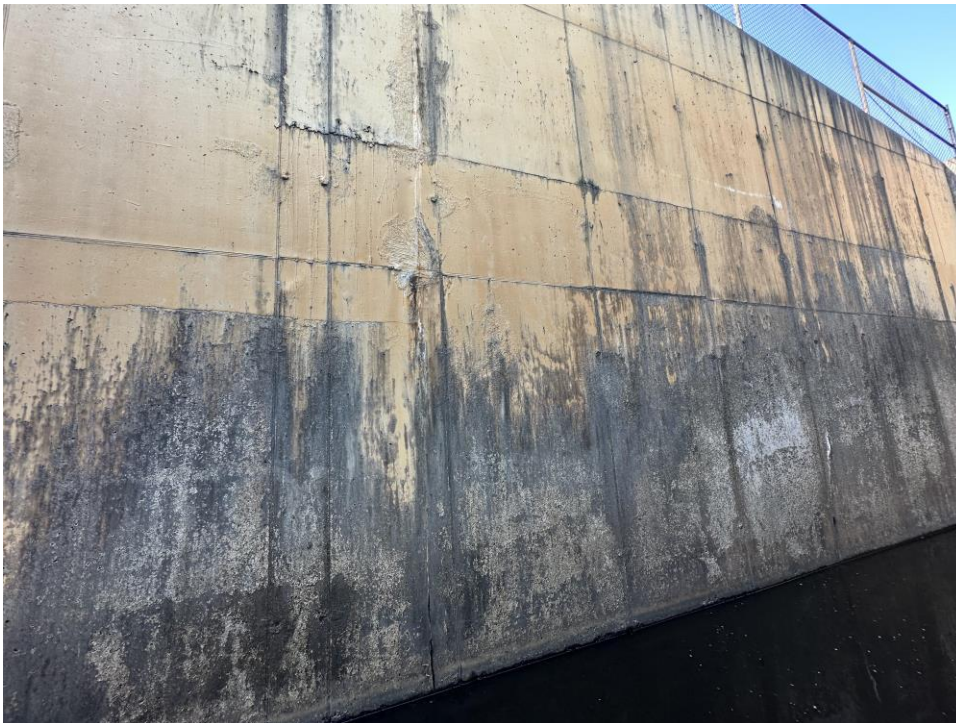
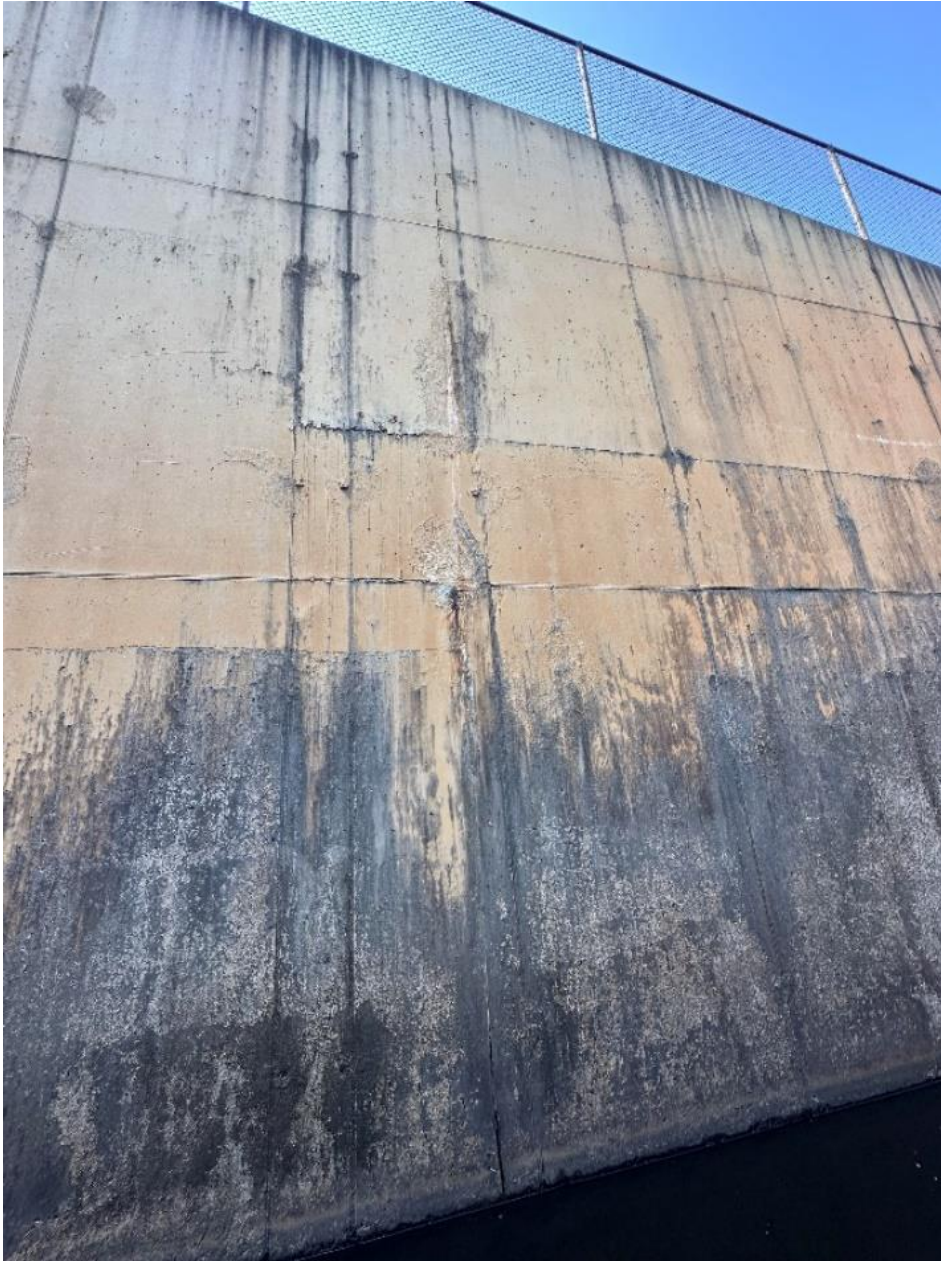
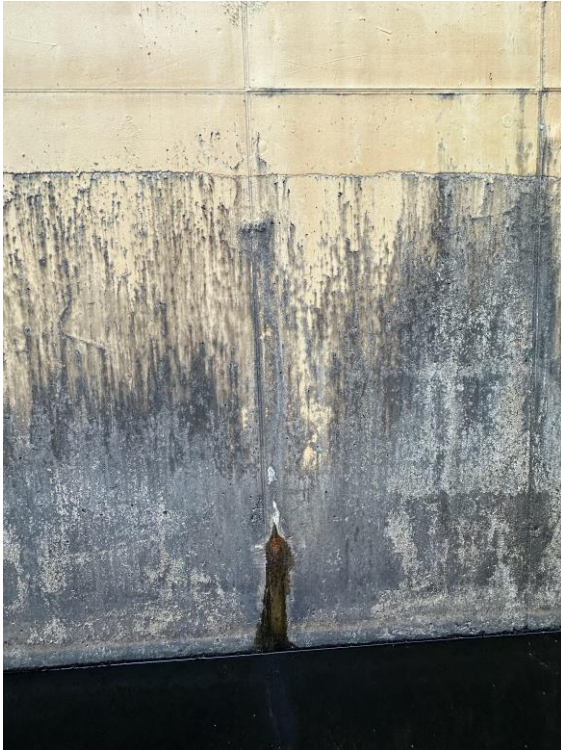
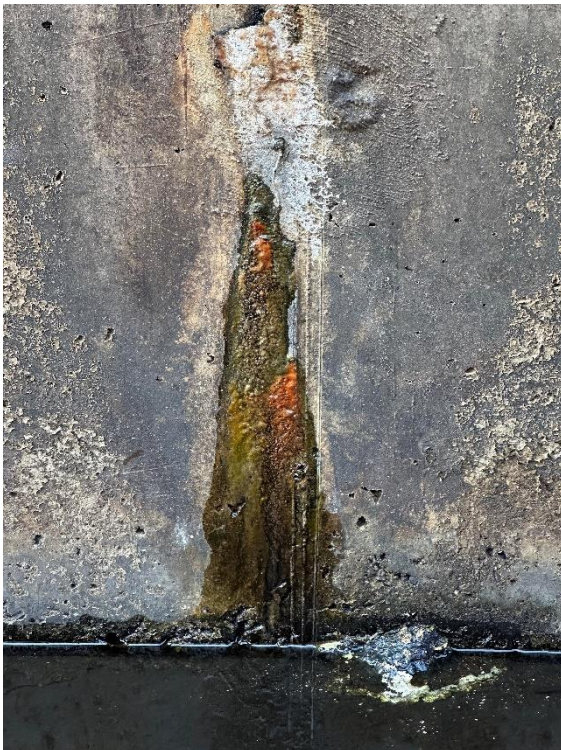
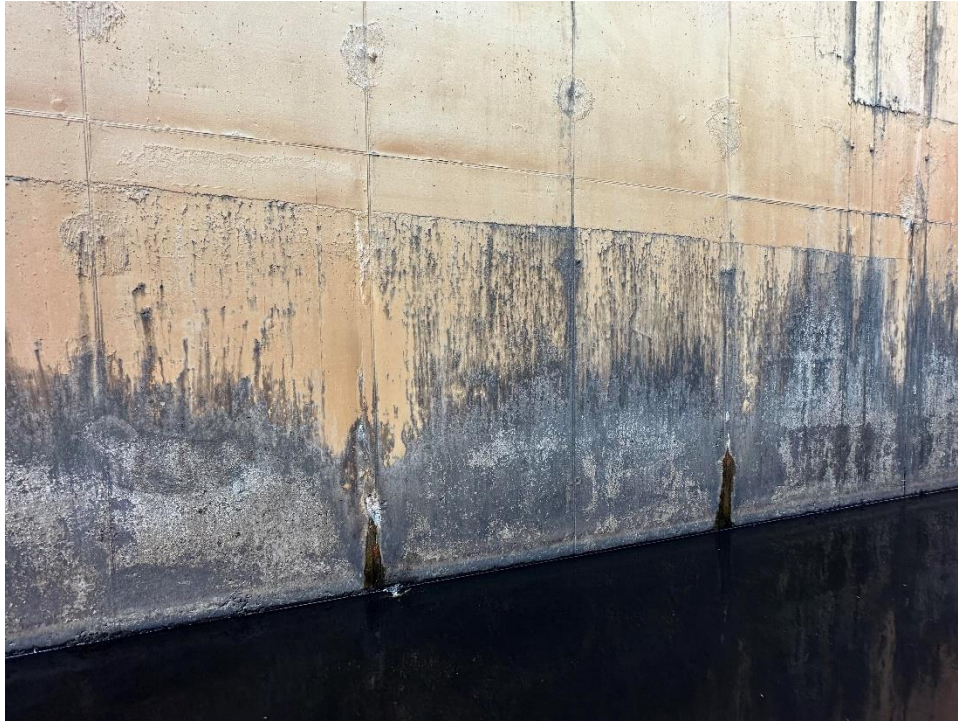
5. Repair leakage locations associated with construction joints, form ties, formwork joints, and other documented leakage paths on the north and south wall interior faces and labyrinth weir wall. Refer to Photographs 28 through 37 and the crack mapping figures for representative locations.
