Project: Emerald Lake Dam – 2017 SPLOST

RE: Emerald Lake Dam – Options for Repair Update

Emerald Lake Dam in the Woodlands Subdivision is classified by the Georgia Safe Dams Program as a Category 2 structure. It is approximately 600 feet long and impounds a 20-acre lake. Emerald Lake Drive is located on top of the dam and is the only means of ingress and egress for the 90+ homes within the subdivision. Fayette County owns and operates the dam.

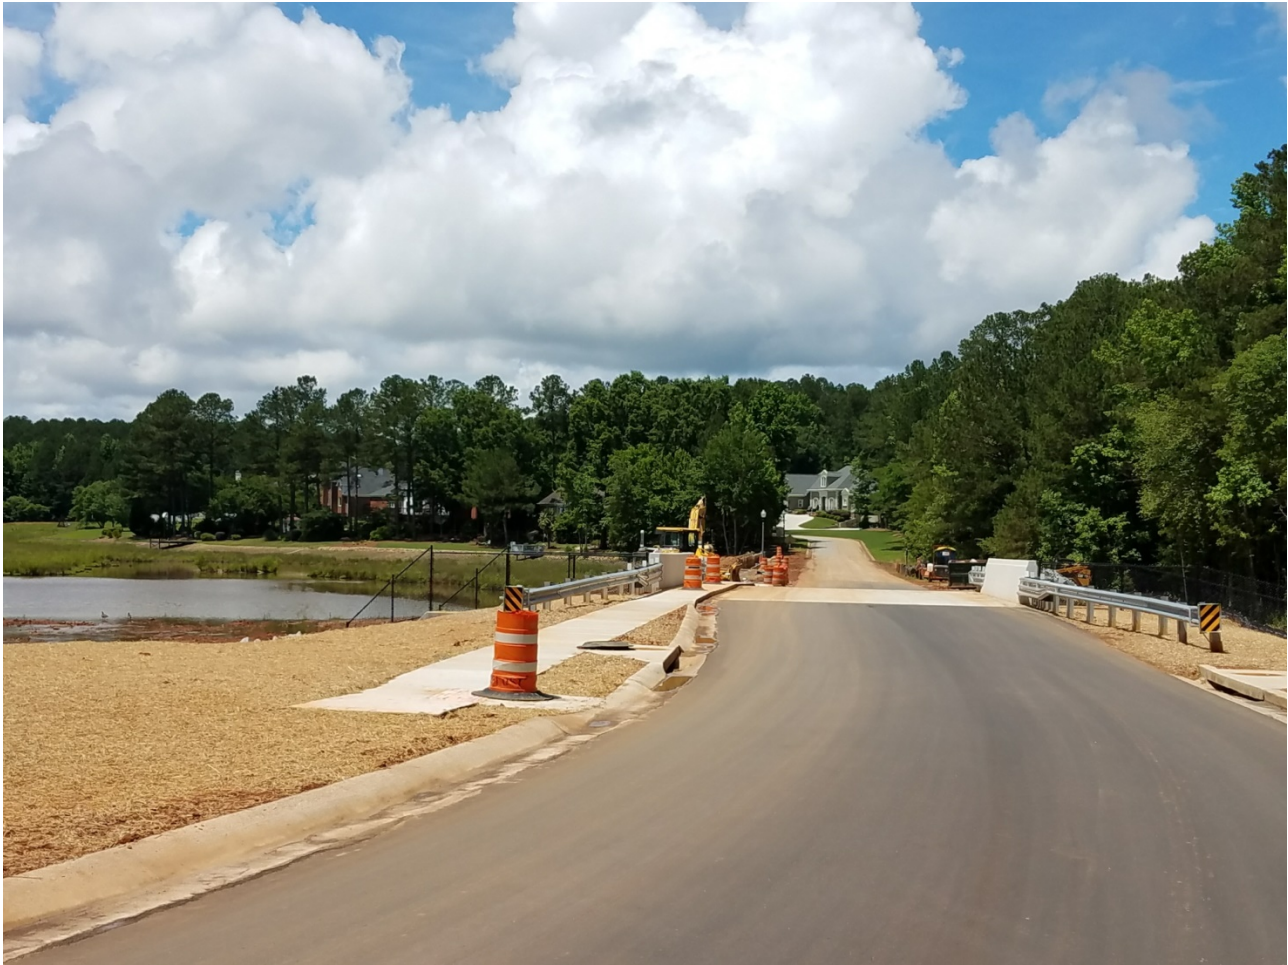
**Photo 1: Photo is of new dam, bridge and road. Remaining work activities include construction of retaining wall (see left side of road on far side of bridge), shoulder stabilization, and refilling of the lake.**

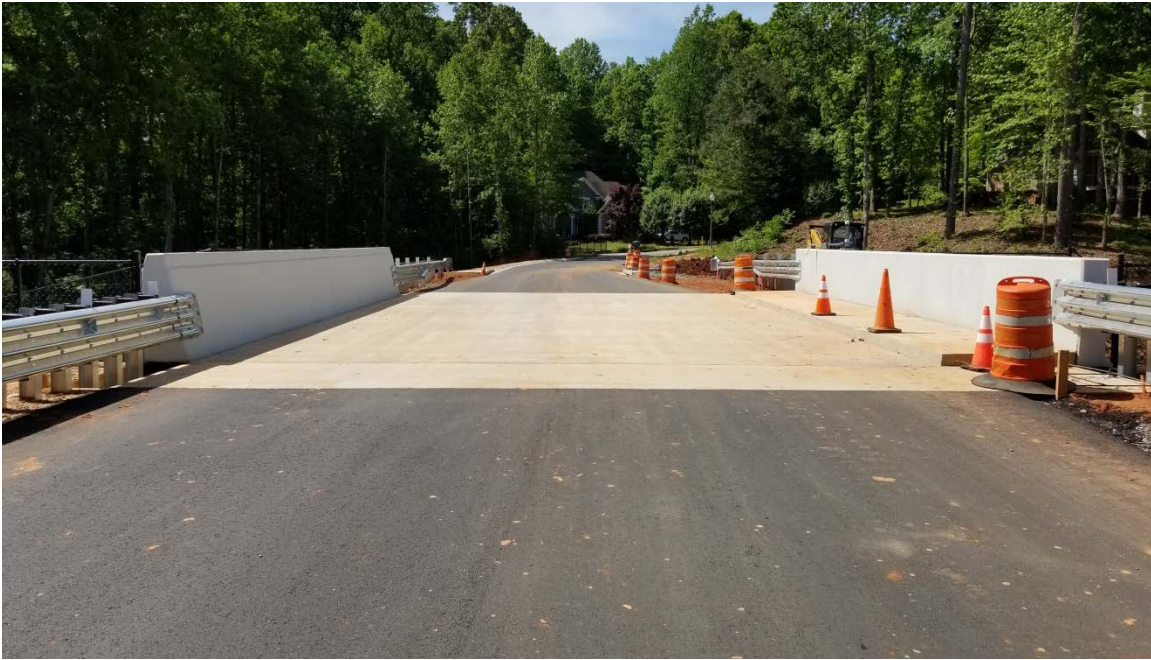
Photo 1: Bridge construction and paving activities over the spillway. (05/03/2018)

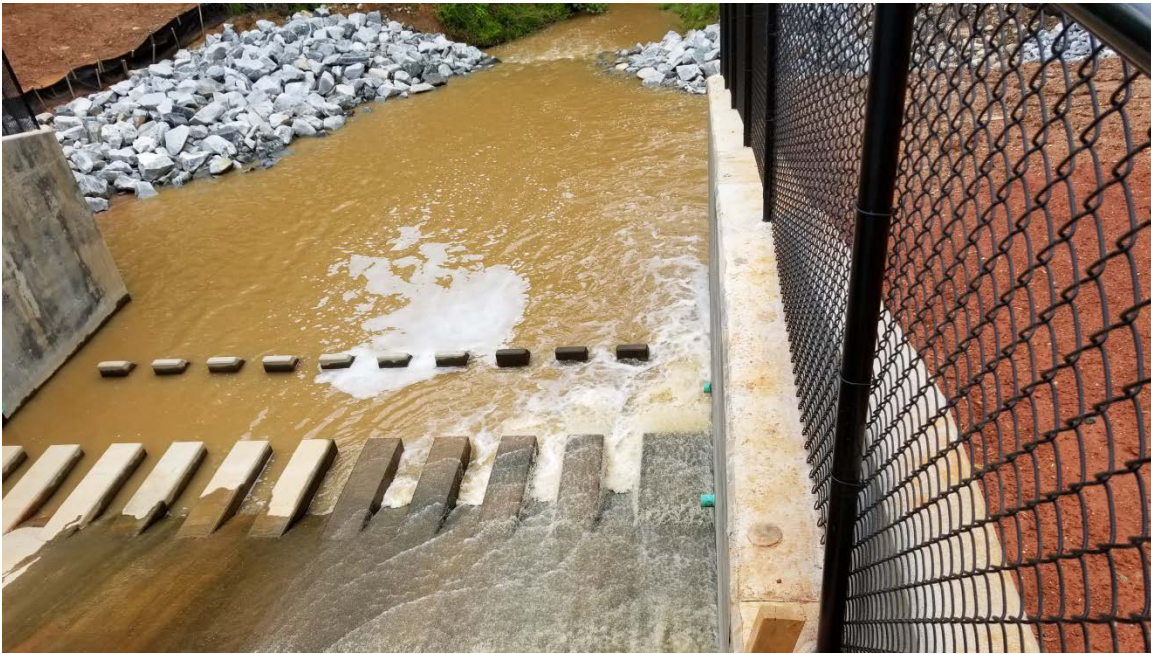
Photo 2: A fence and rock was placed at the project site, on the downstream side of the spillway. (04/26/2018)

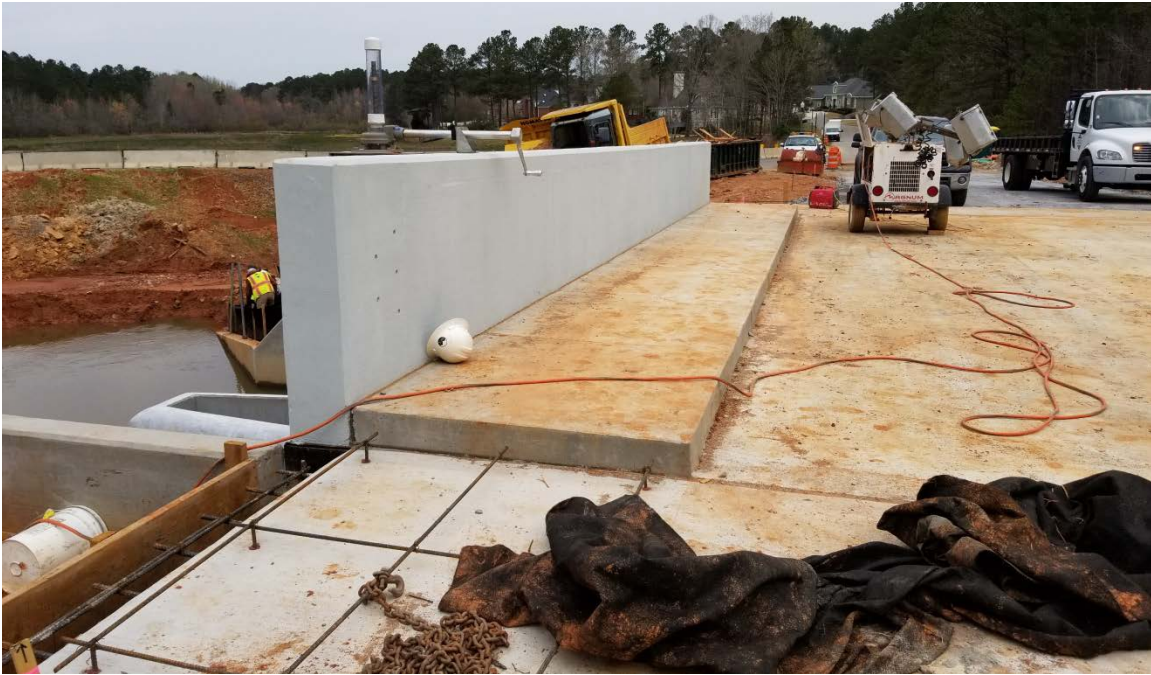
Photo 1: Bridge construction continues over the spillway. Utility work is also in progress. (03/23/2018)

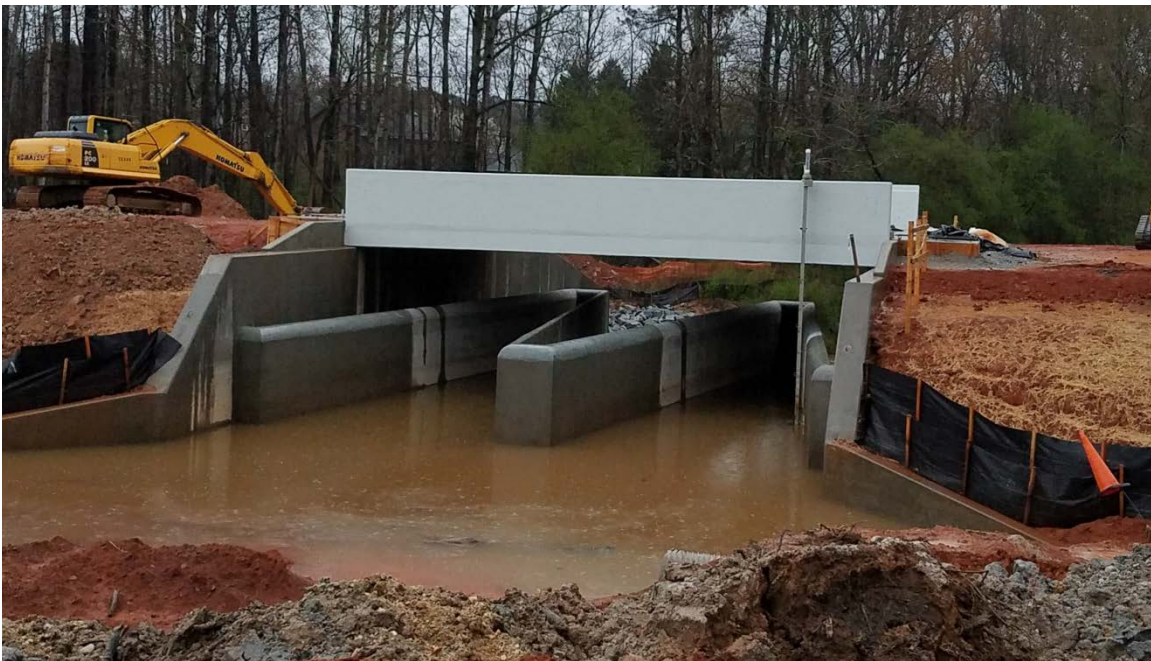
Photo 2: Bridge construction over new spillway. (02/26/2018)

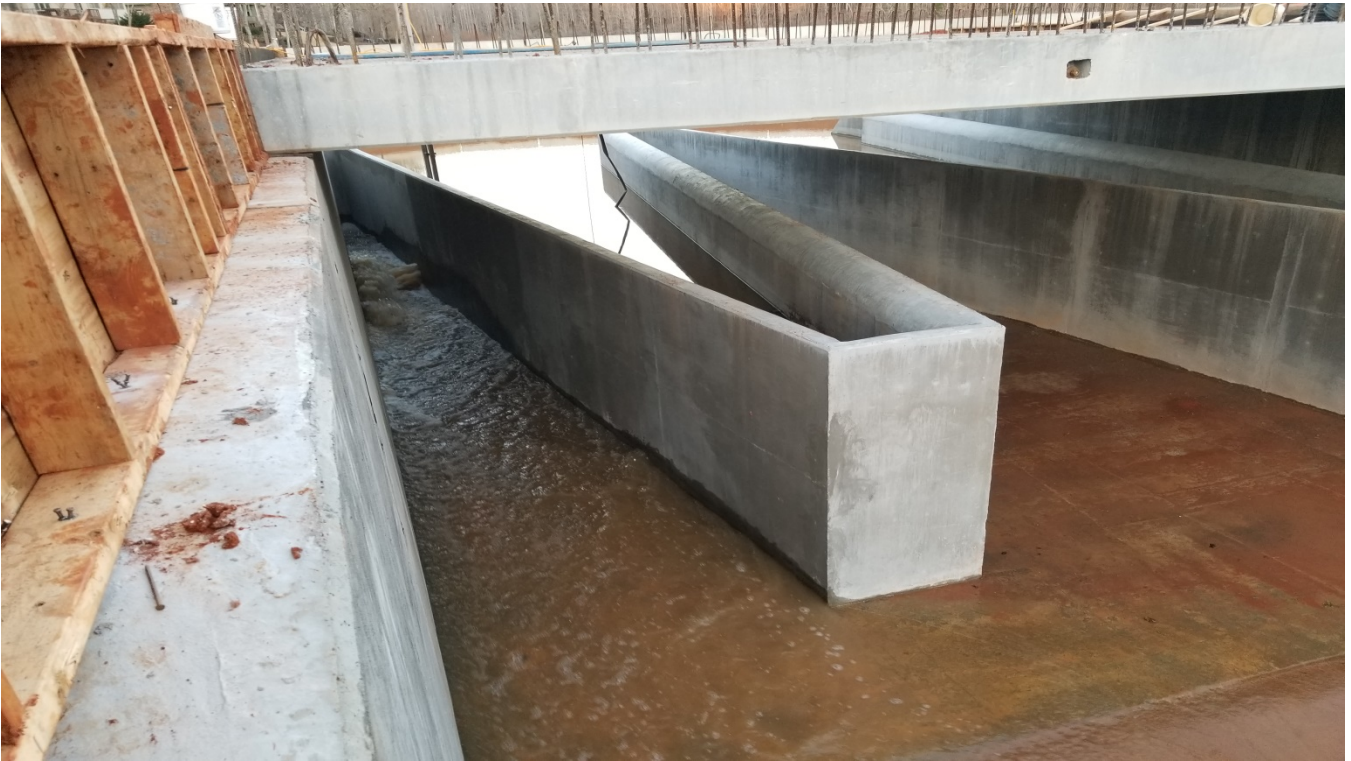
**Photo 1: View of water flowing downstream through the newly constructed spillway.**

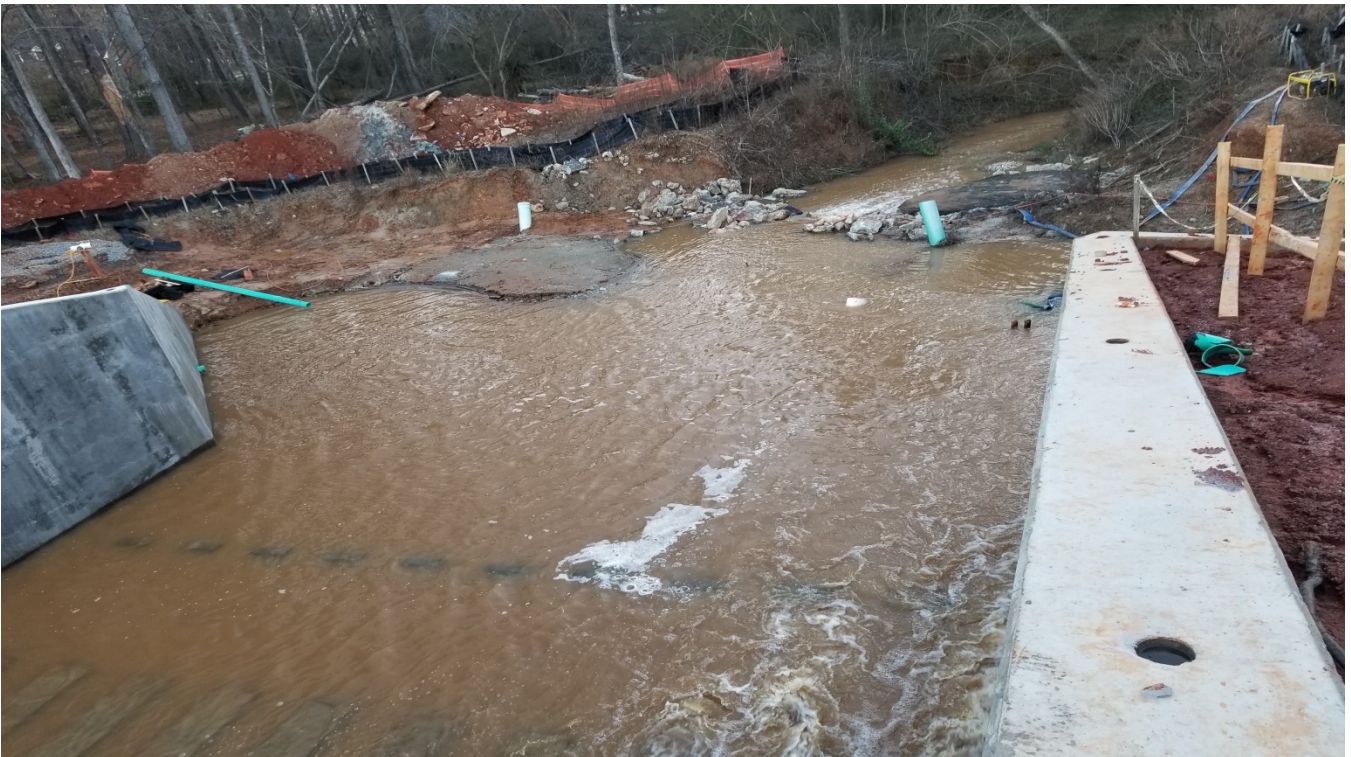
**Photo 2: View of water flowing downstream through the newly constructed spillway.**

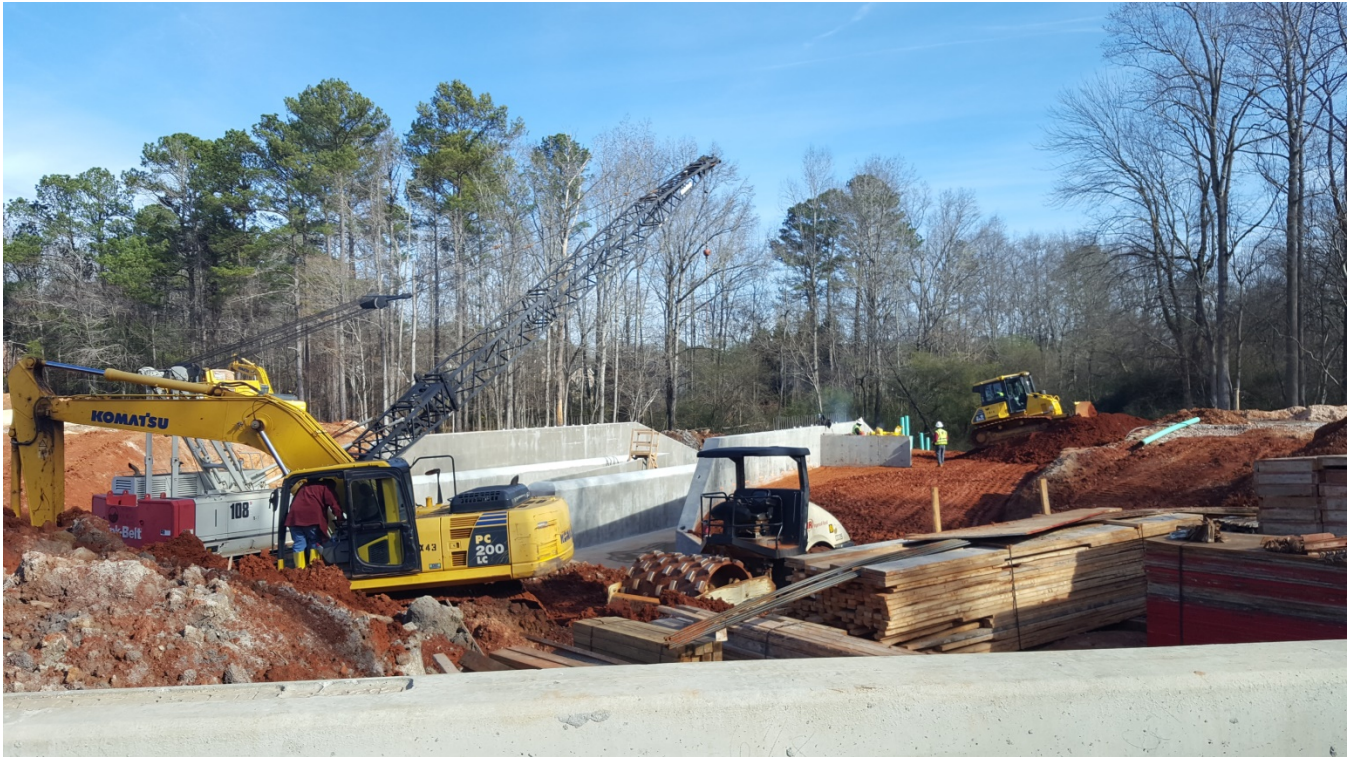
**Photo 1: View of Emerald Lake Dam spillway. Backfill operations underway after wall construction. (12/26/17)**

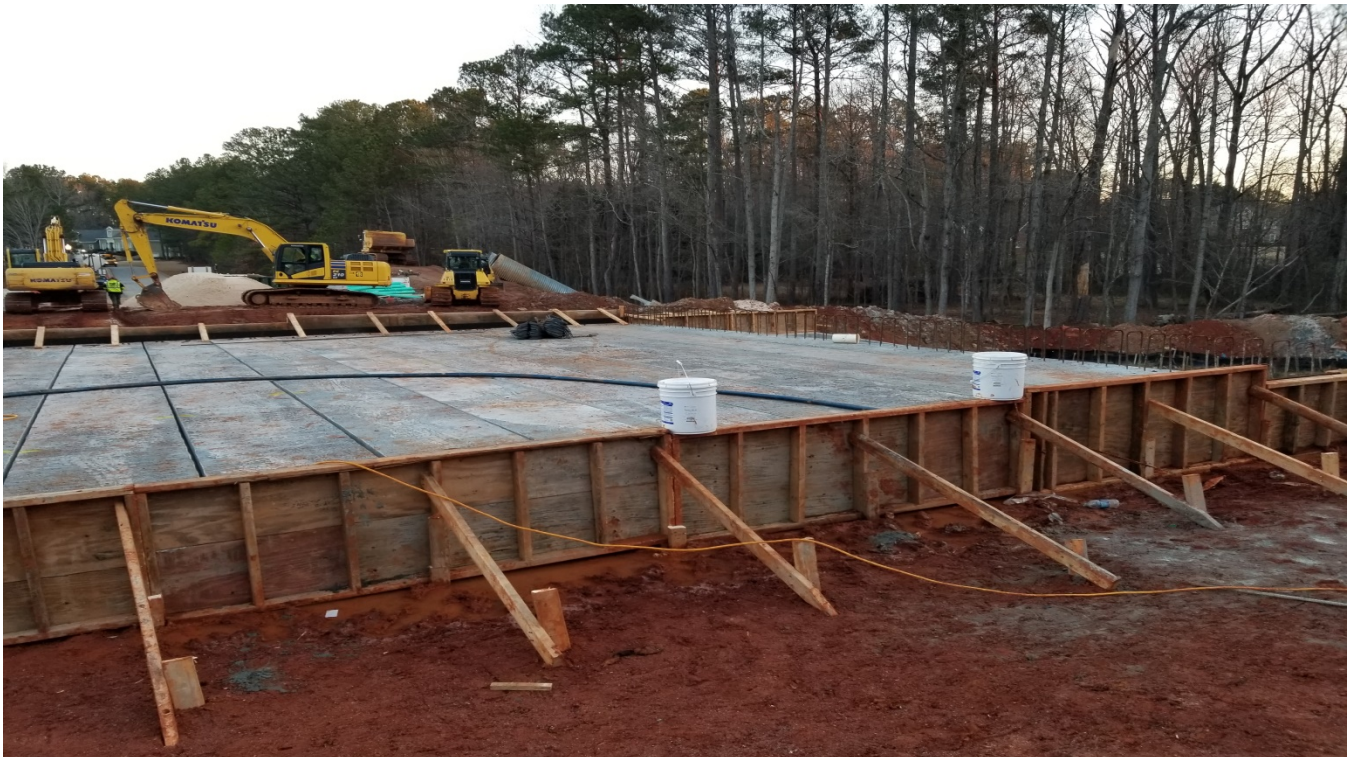
**Photo 2: Concrete placement to cover dam spillway. (1/30/18)**

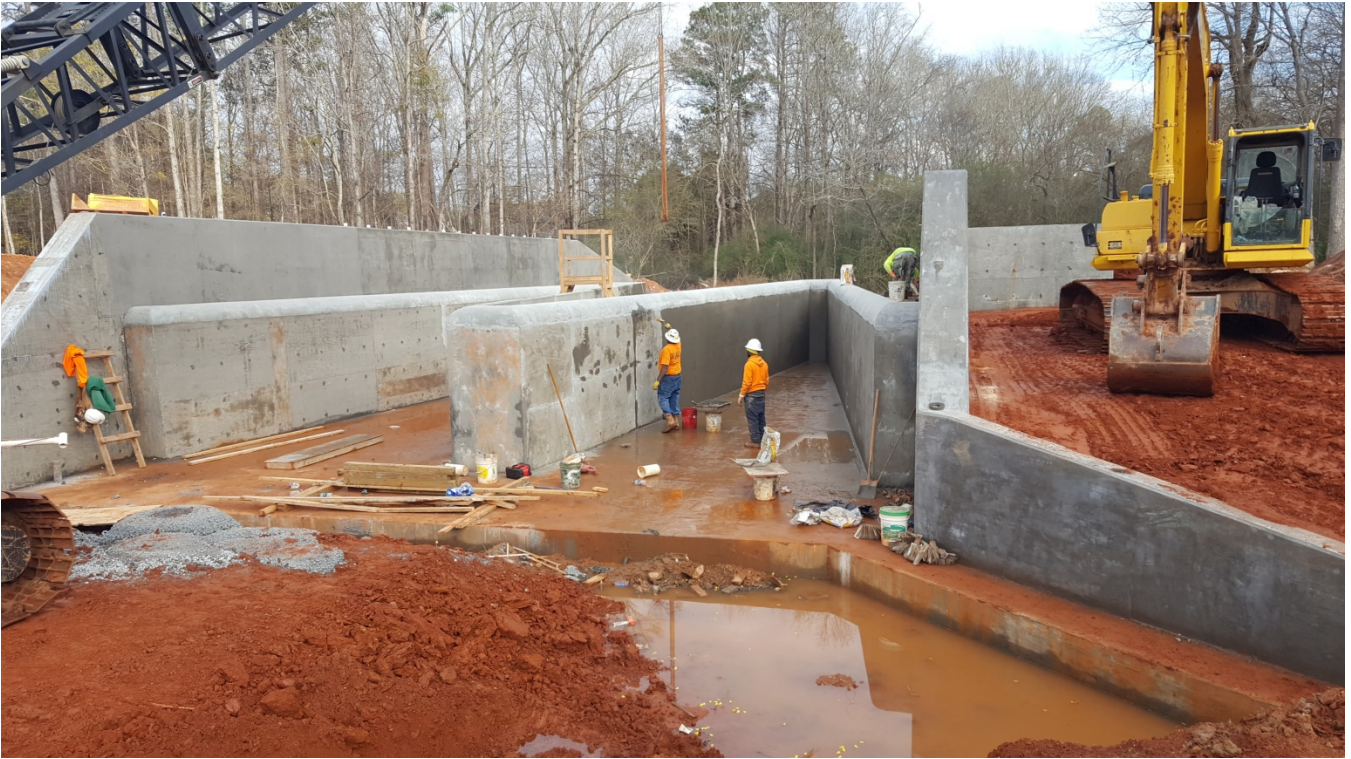
**Photo 1: View of Emerald Lake Dam spillway. This view is looking downstream.**

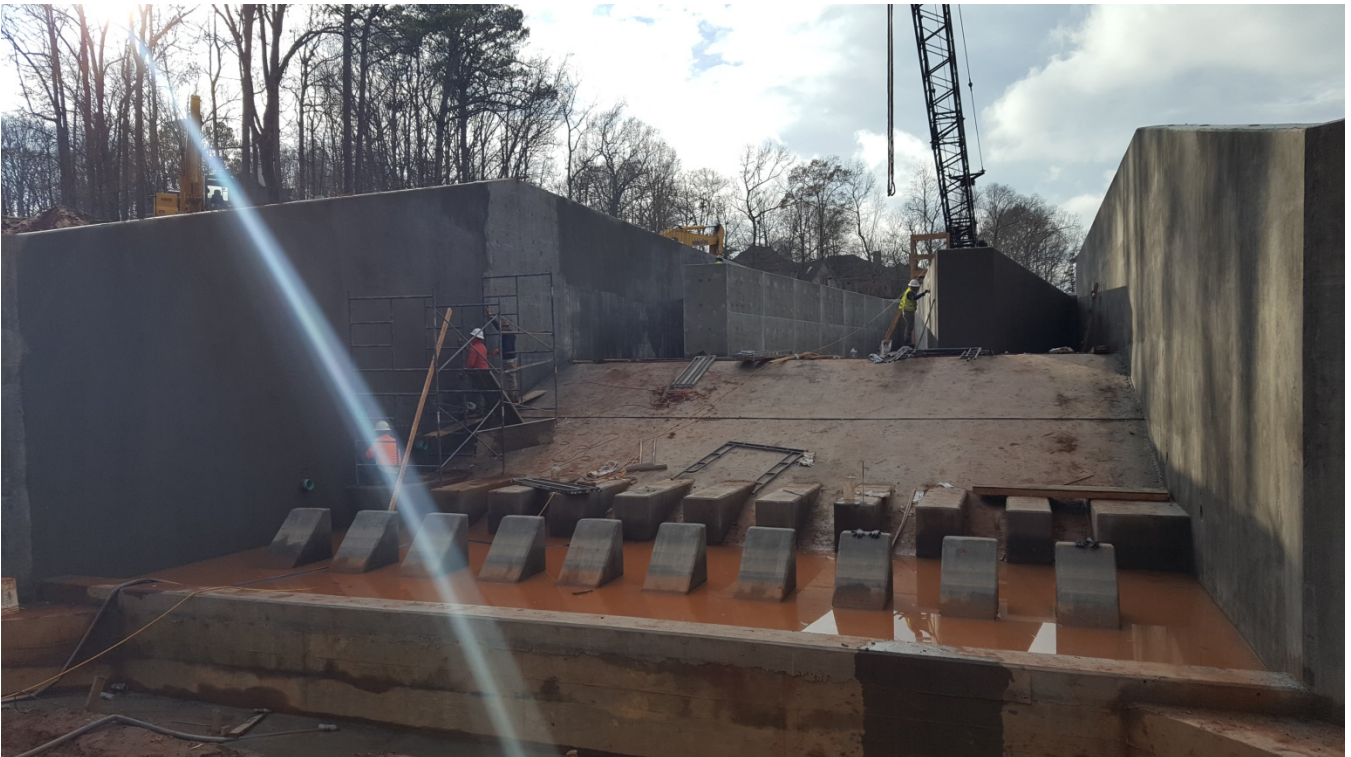
**Photo 2: View of Emerald Lake Dam spillway. This view is looking upstream.**

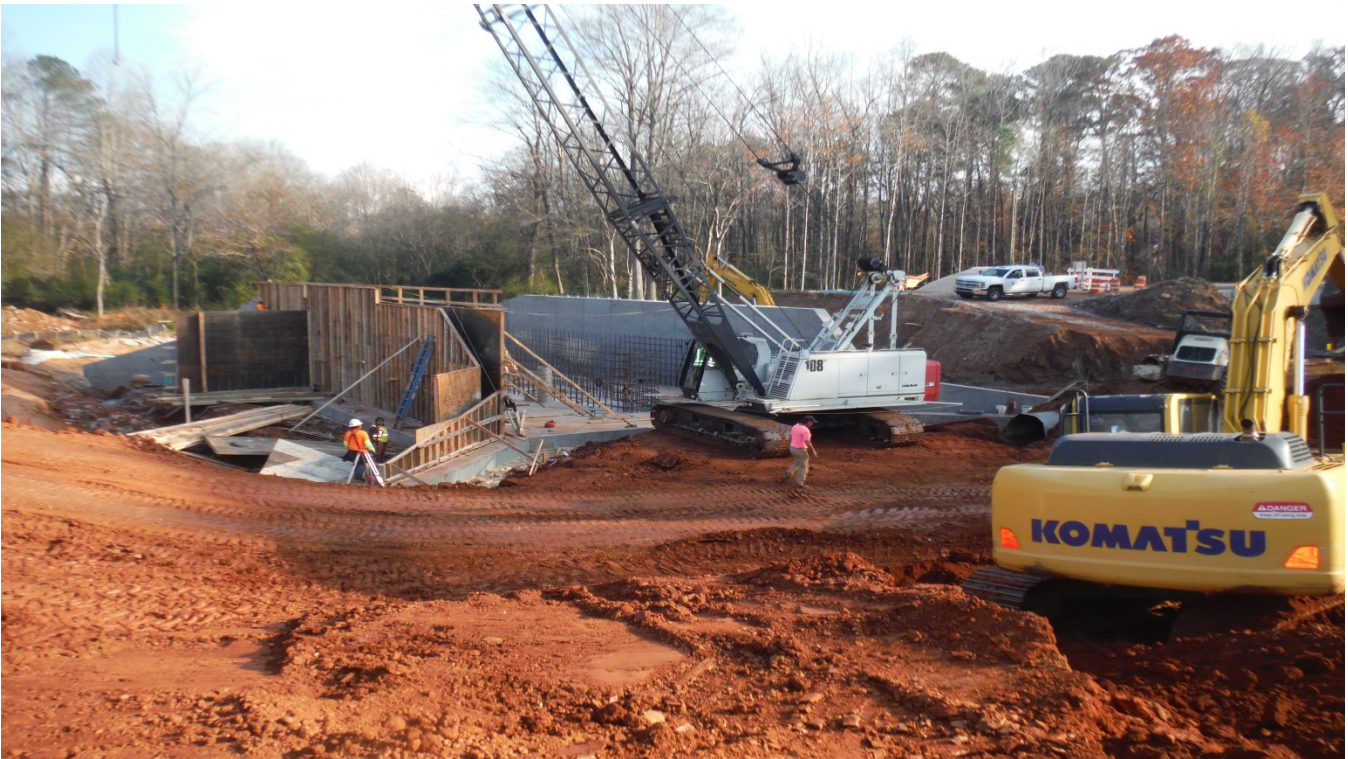
**Photo 1: Forming of one wall for concrete pouring. Second wall has been poured. (12/1/17)**

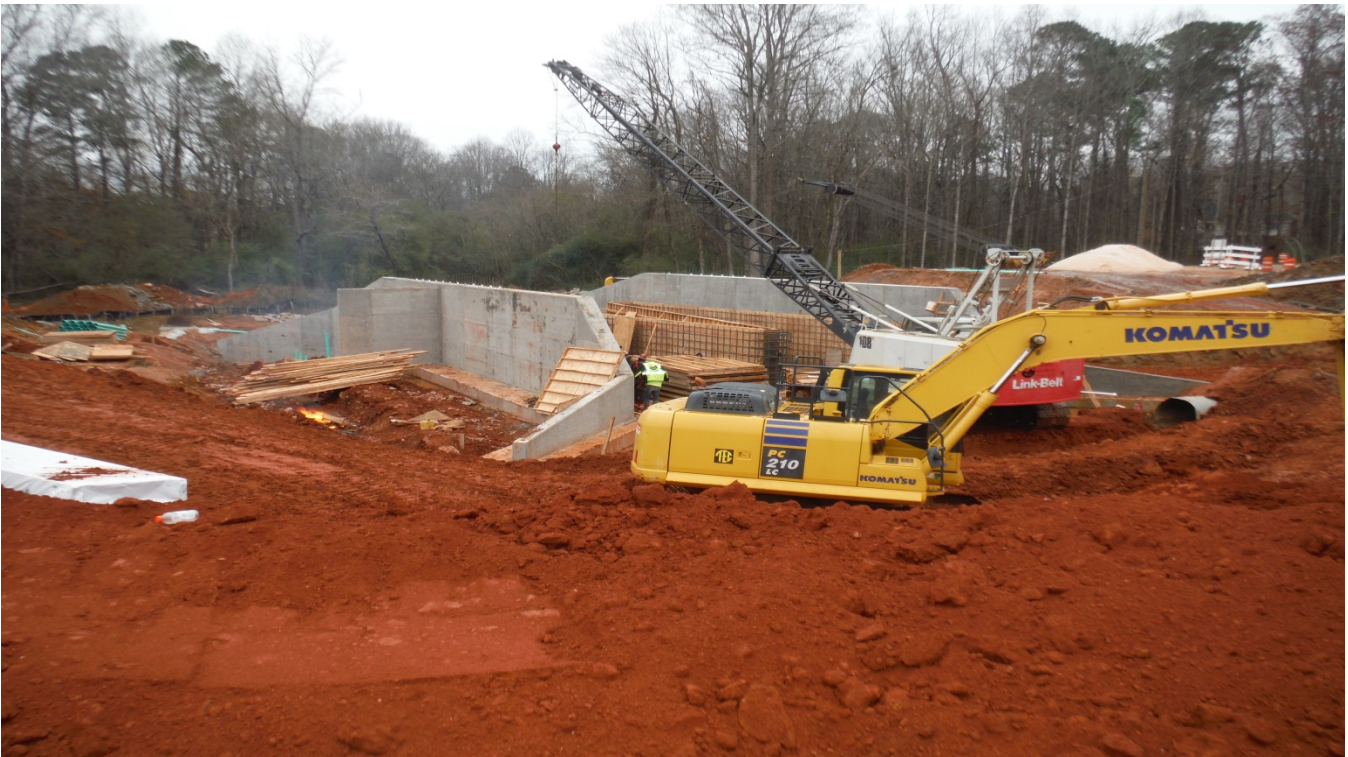
**Photo 2: Both walls have been poured. (12/7/17)**

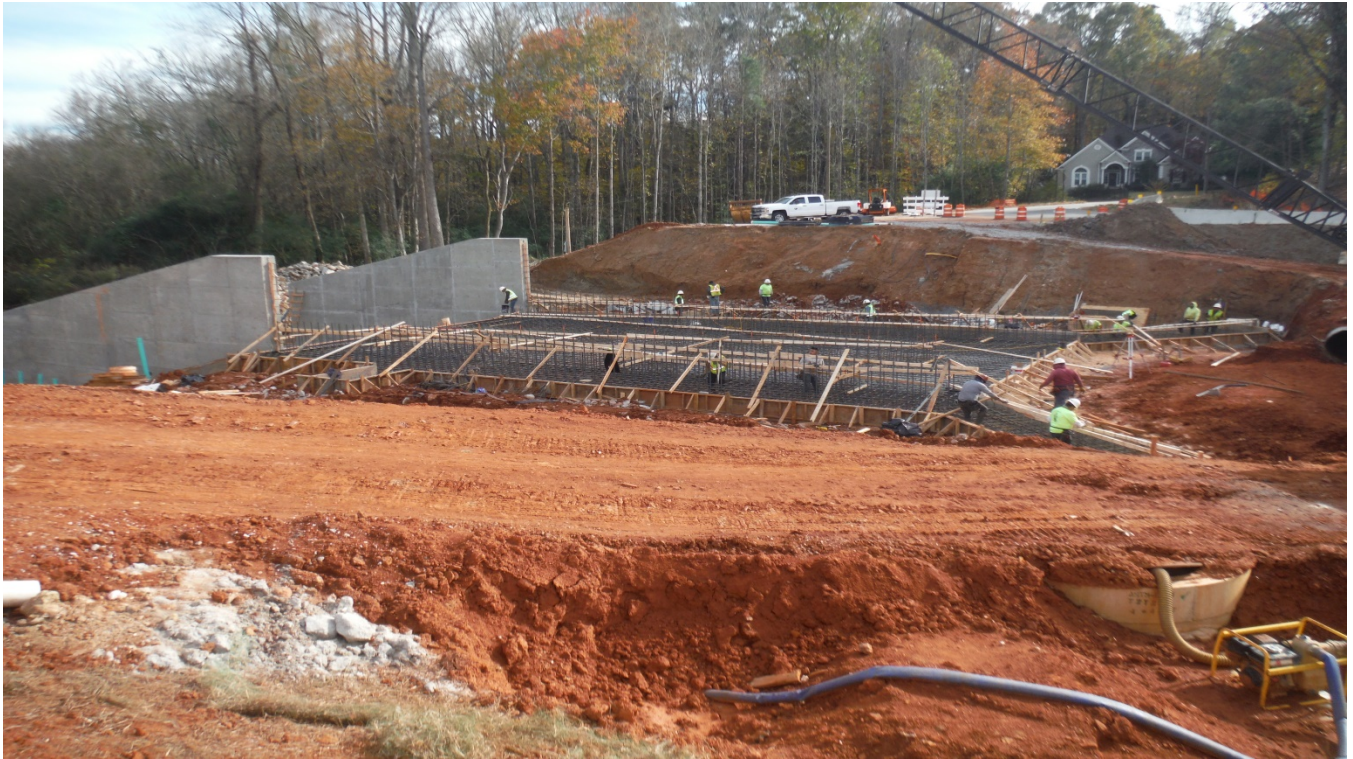
**Photo 1: Forming walls for concrete pouring. (11/20/17)**

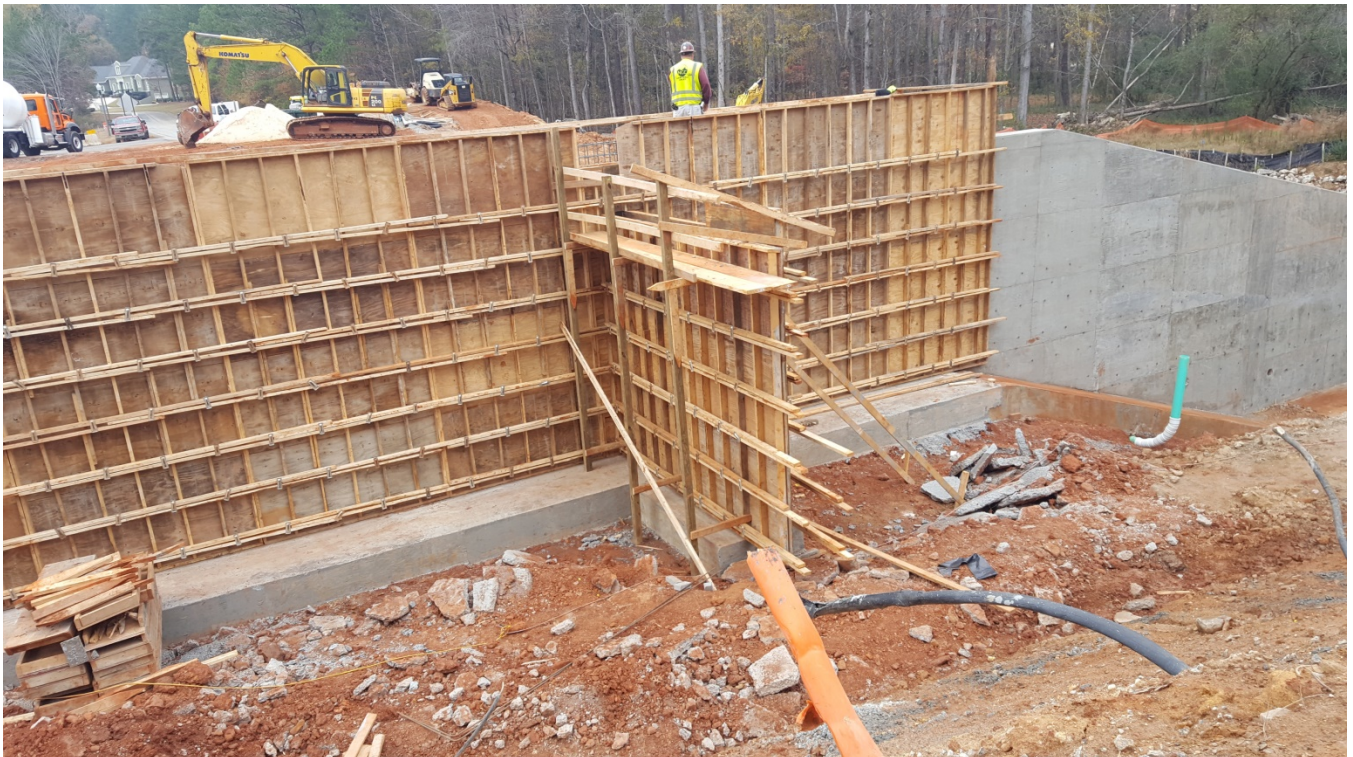
**Photo 2: Forming walls for concrete pouring. (11/29/17)**

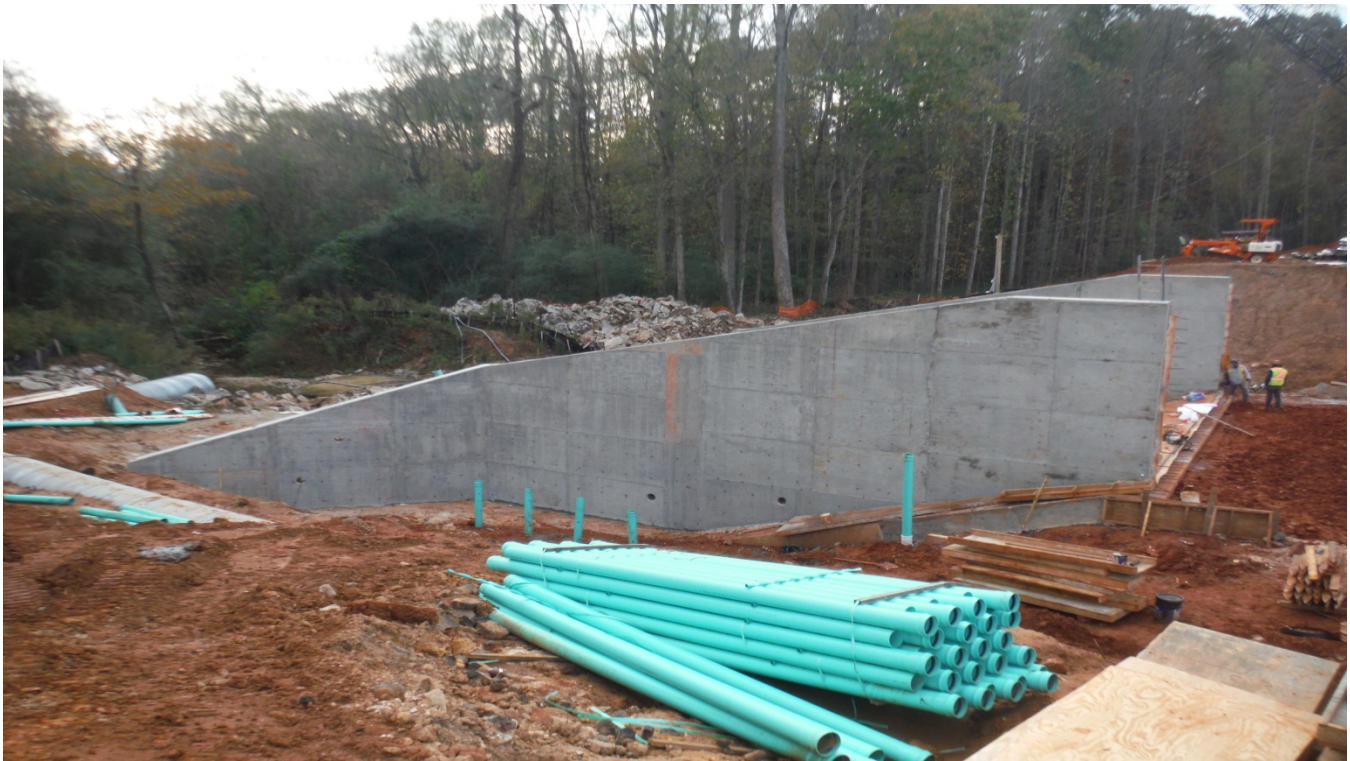
**Photo 1: View of Emerald Lake Dam spillway. This is the downstream side of the dam.**

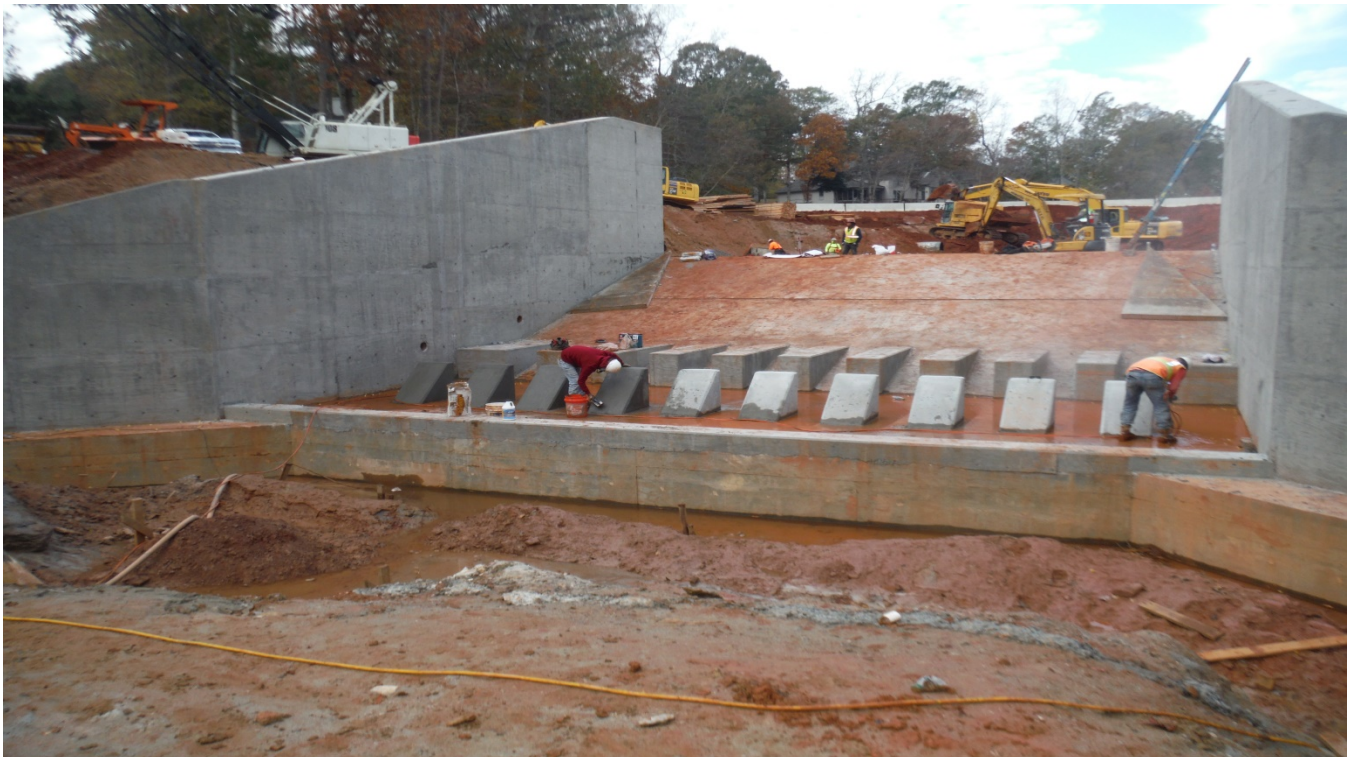
**Photo 2: View of Emerald Lake Dam spillway. This is the downstream side of the dam and a view of the energy dissipaters.**

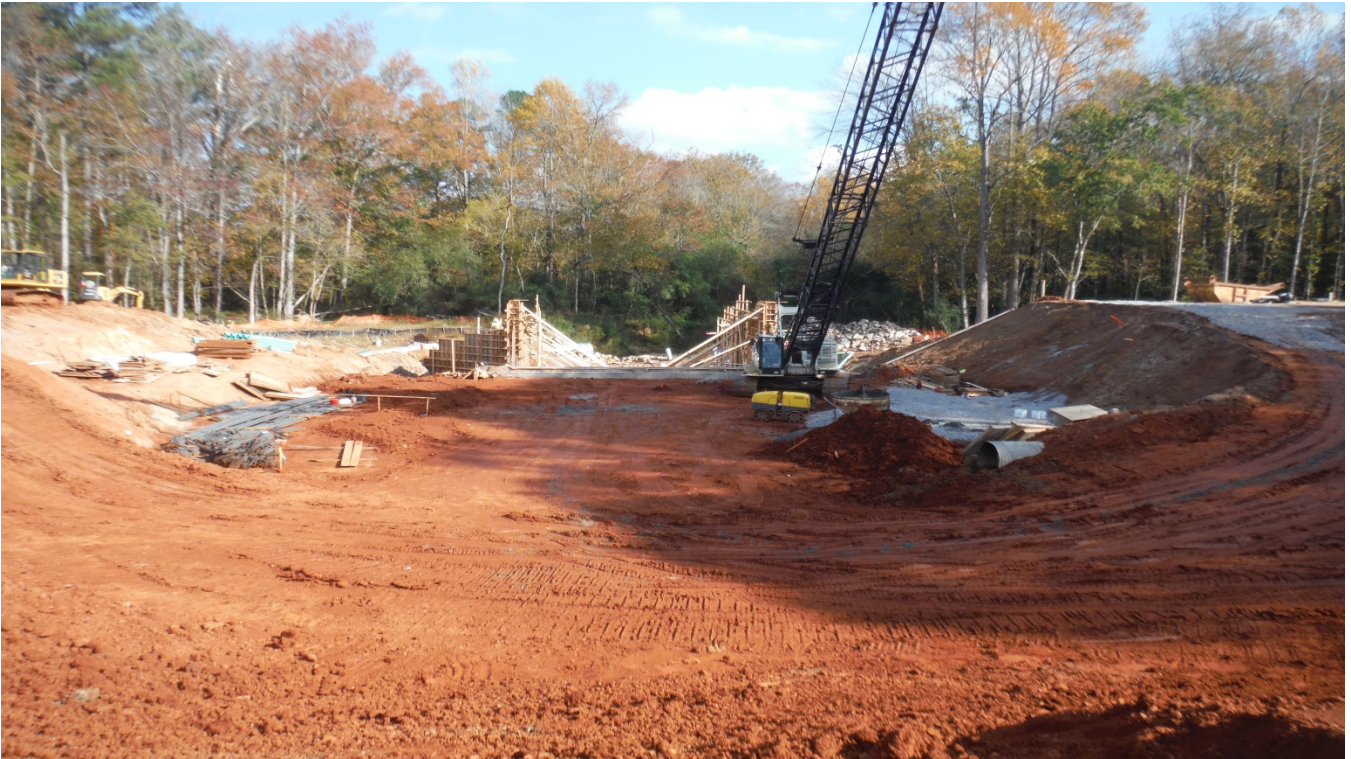
**Photo 1: Forming walls to dam spillway (looking downstream).**

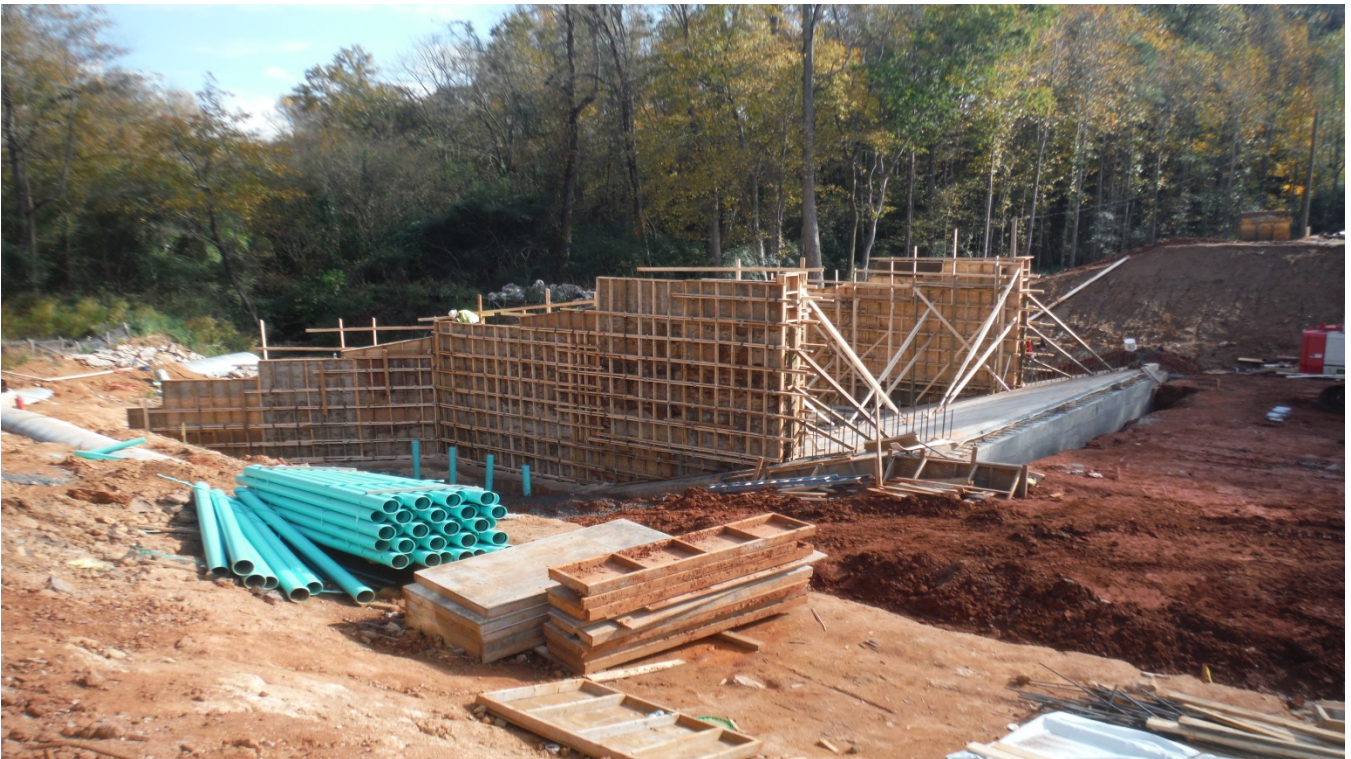
**Photo 2: Forming walls to dam spillway.**

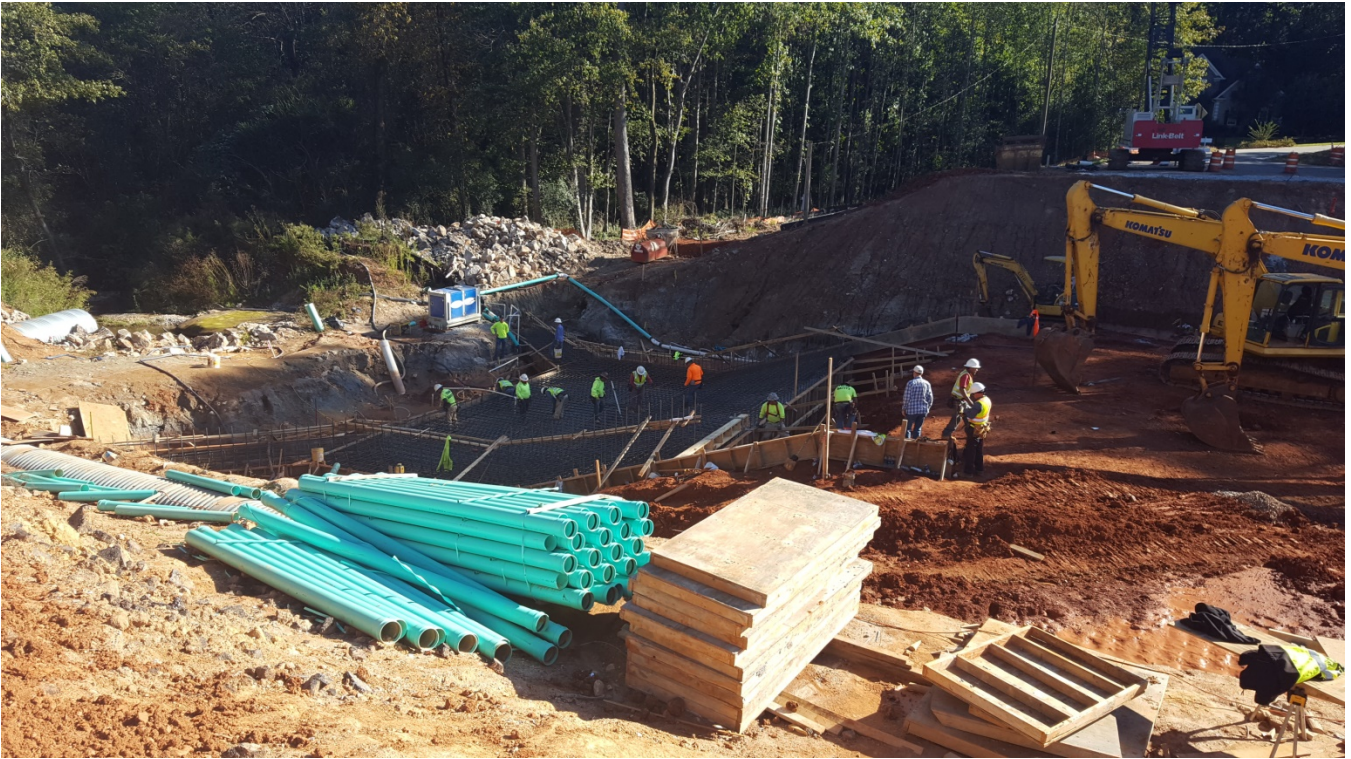
**Photo 1: Framing of the spillway on downstream side of the dam. (10/24/17)**

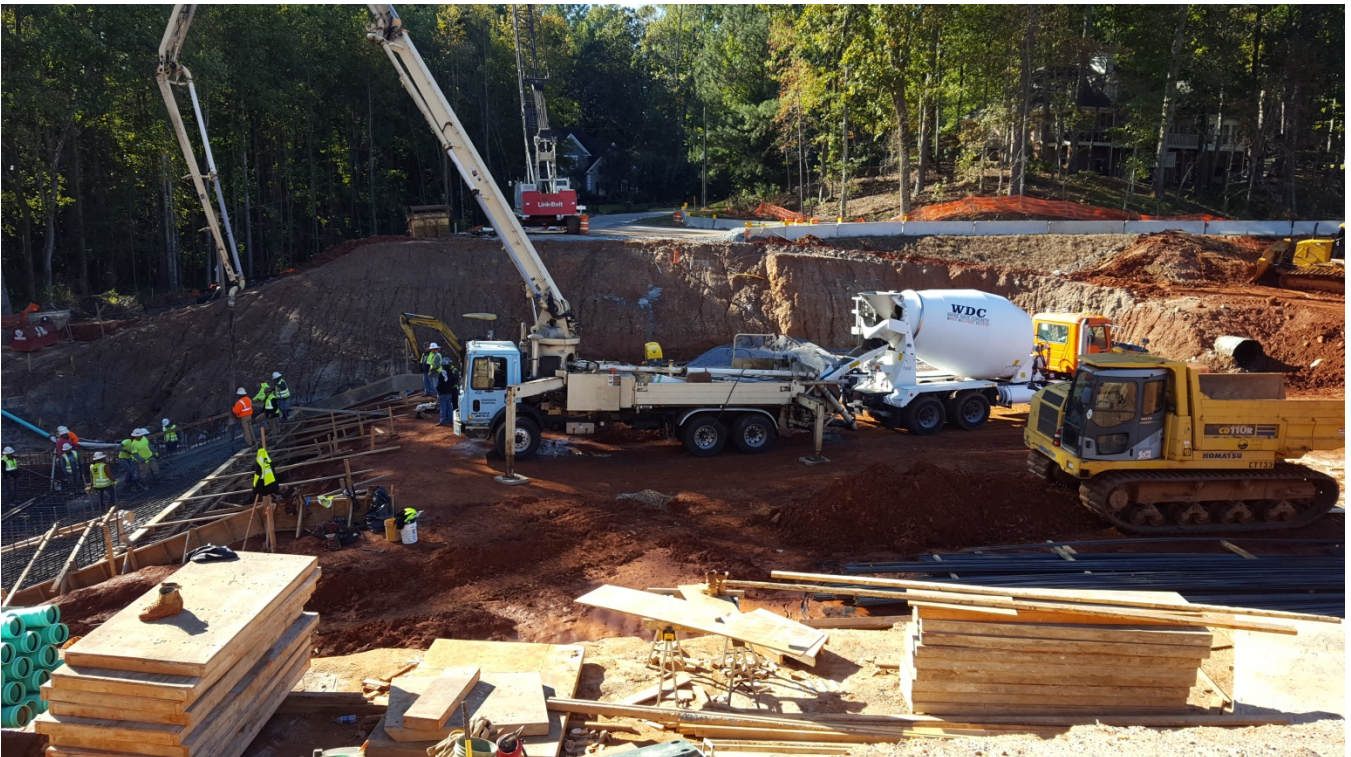
**Photo 2: Concrete pouring of spillway on downstream side of the dam. (10/26/17)**

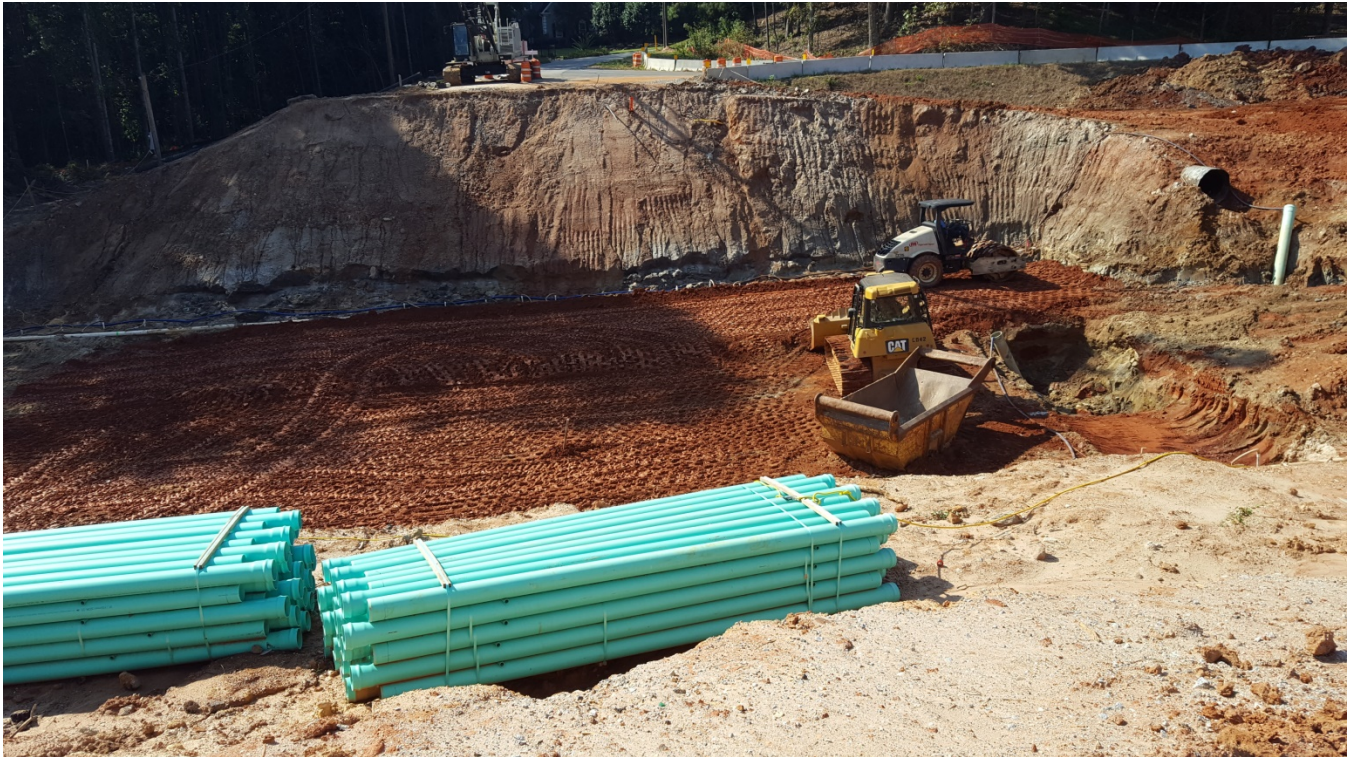
**Photo 1: Initial backfilling activities. (9/22/17)**

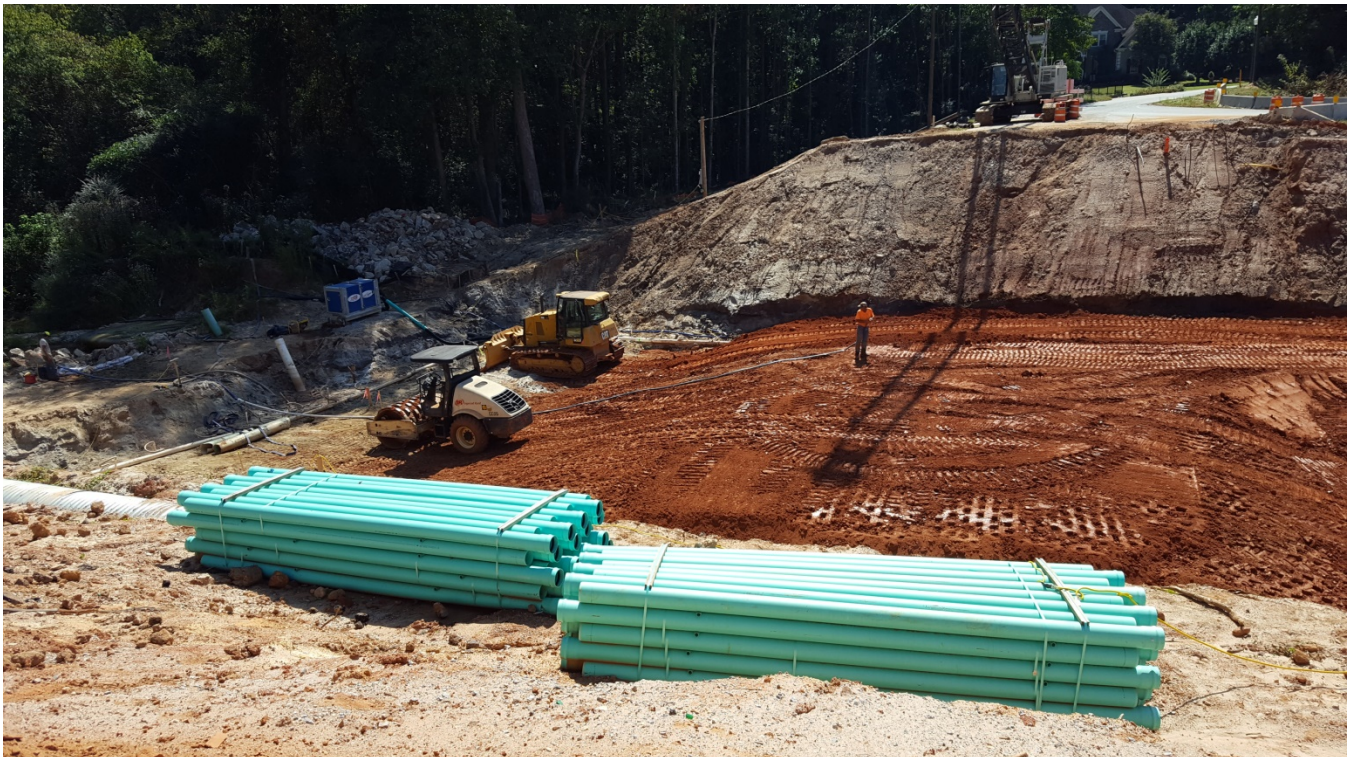
**Photo 2: Initial backfilling activities. (9/28/17)**
