Project: Emerald Lake Dam – 2017 SPLOST

RE: Emerald Lake Dam – Options for Repair Update

Emerald Lake Dam in the Woodlands Subdivision is classified by the Georgia Safe Dams Program as a Category 2 structure. It is approximately 600 feet long and impounds a 20-acre lake. Emerald Lake Drive is located on top of the dam and is the only means of ingress and egress for the 90+ homes within the subdivision. Fayette County owns and operates the dam.

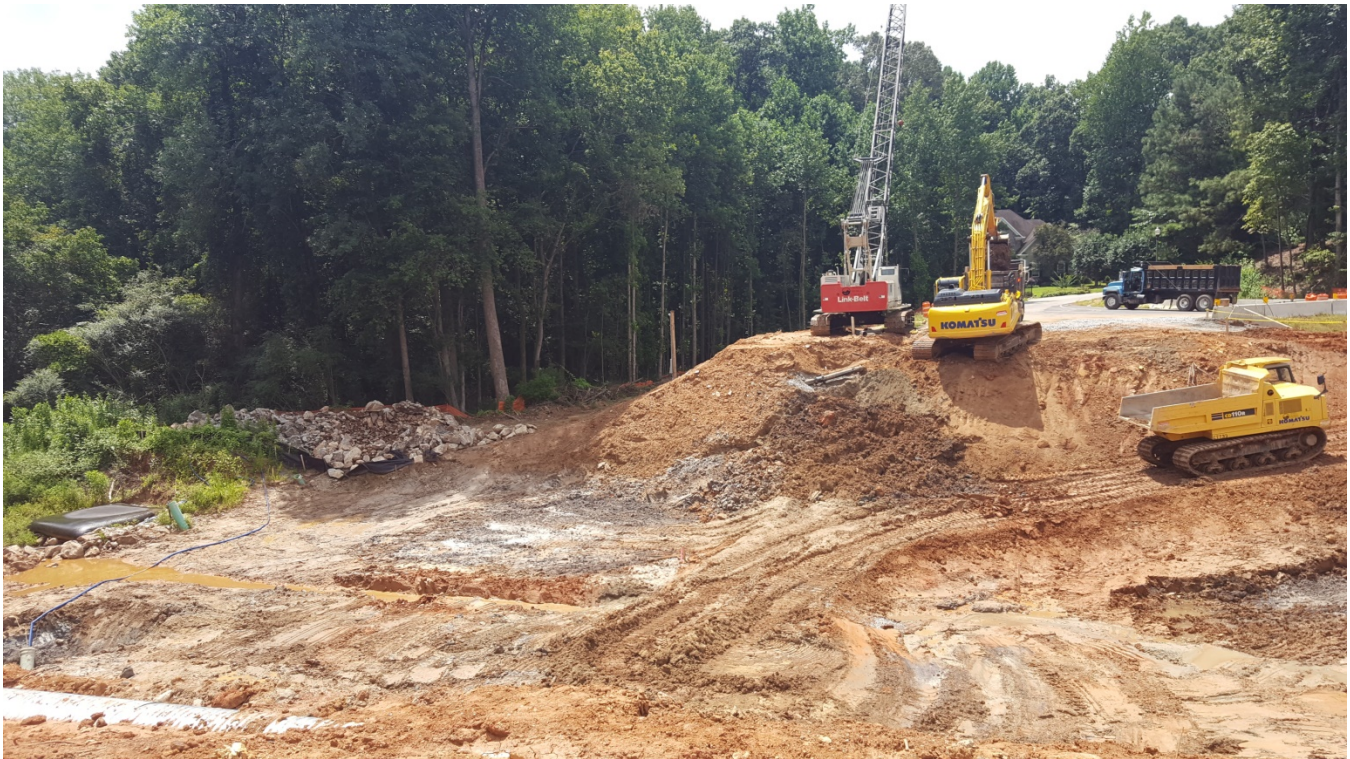
**Photo 1:** Picture shows location of former road and dam with demolition complete. Dewatering pumps and pipes and diversion pipe are on far left. Contractor is removing bad soils until a solid base is established on which the new dam can be built.

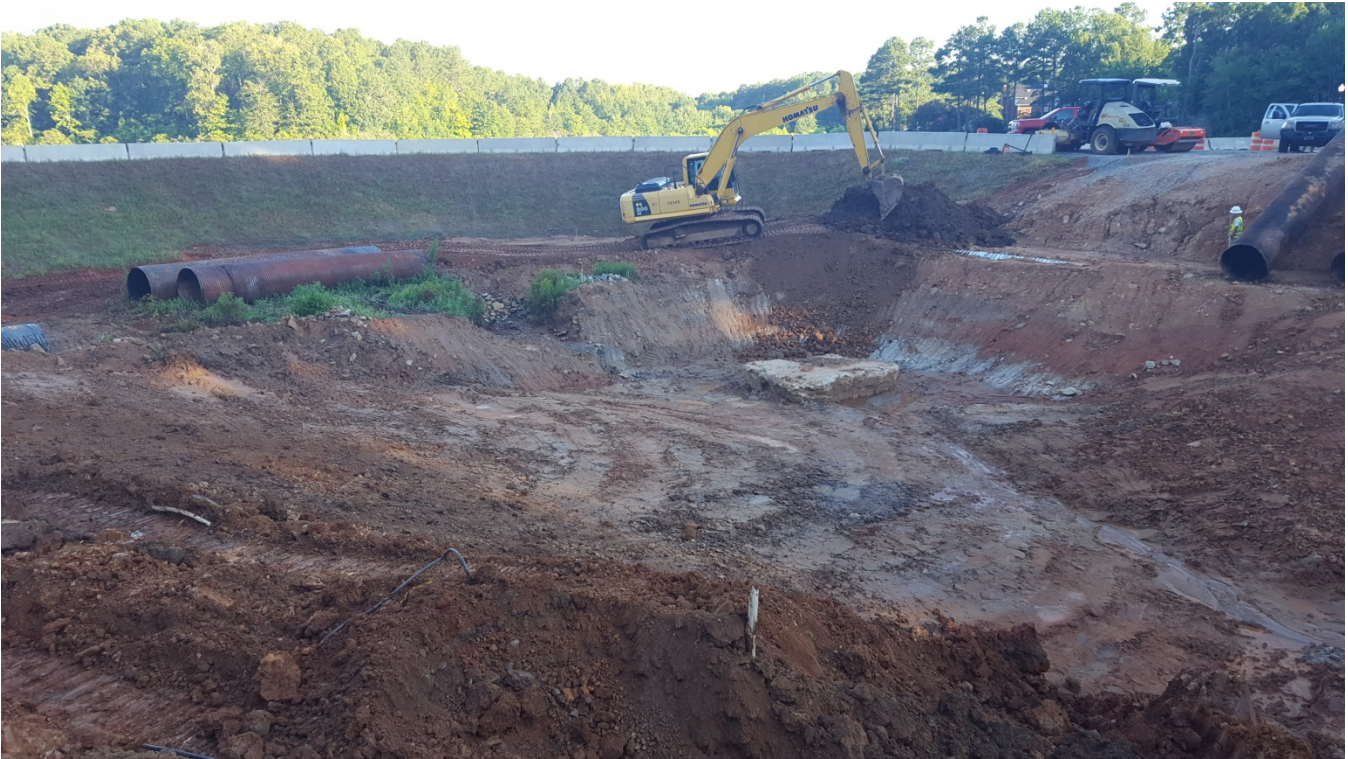
**Photo 1: Emerald Lake Dam after the demolition and removal of former spillway and outlet control structure. The temporary cofferdam and road detour is visible in the background.**

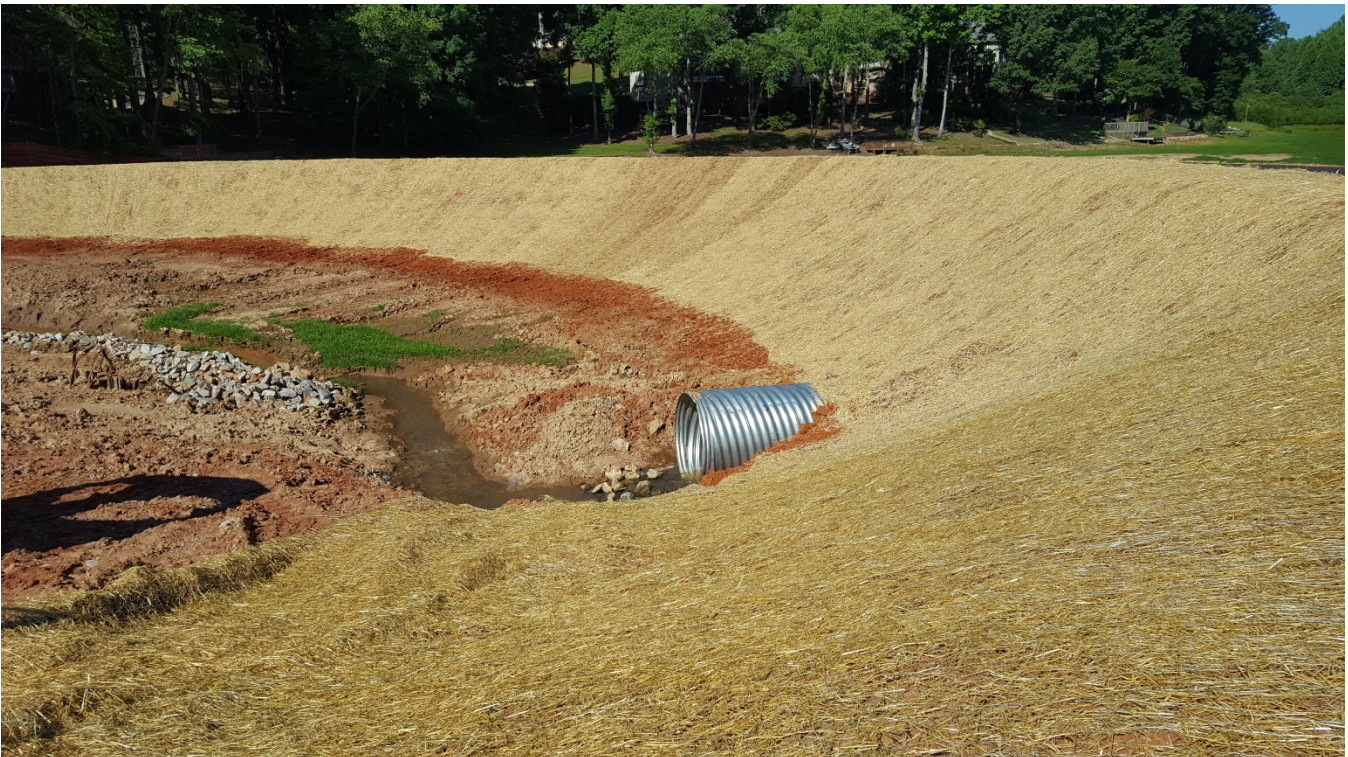
**Photo 2: Temporary cofferdam and road detour following temporary stabilization. The metal pipe is part of the dewatering system to be used during construction of the new spillway.**

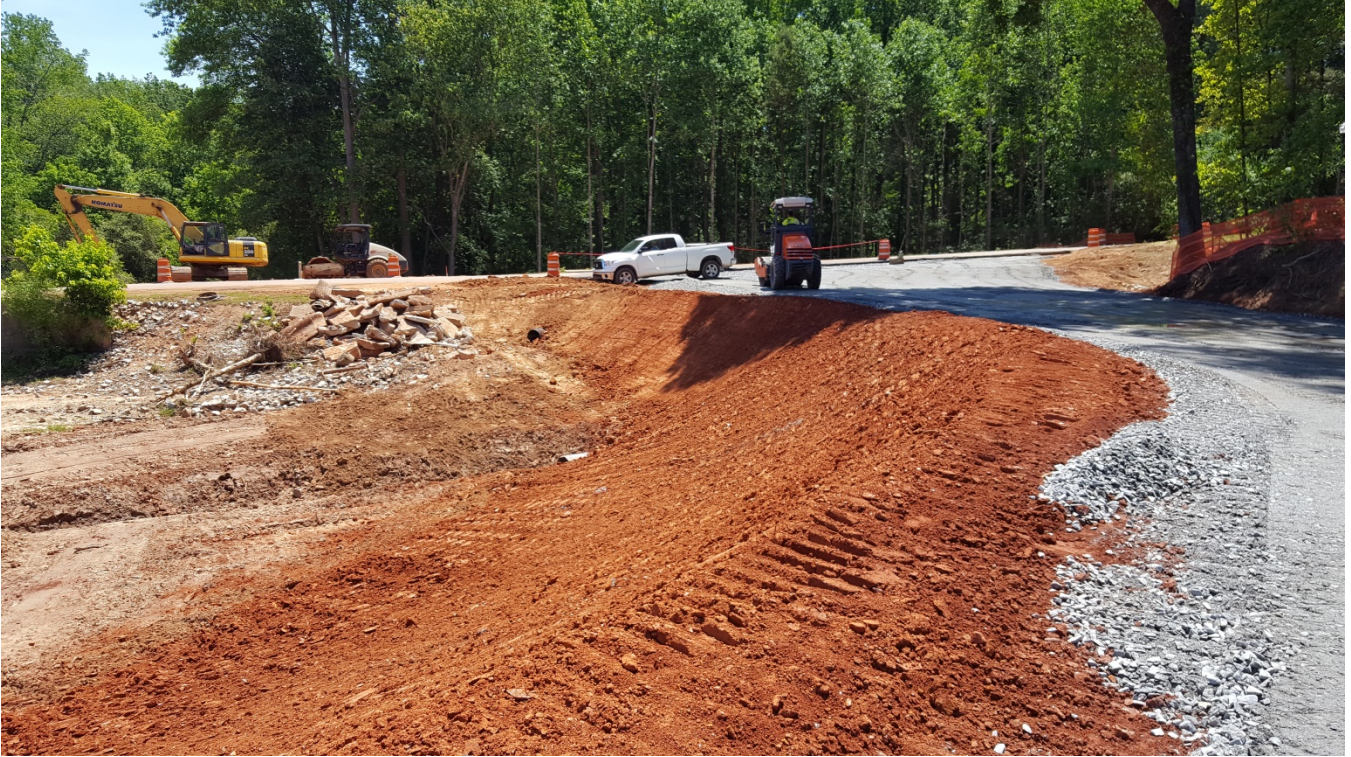
**Photo 1: Construction of road detour. (May)**

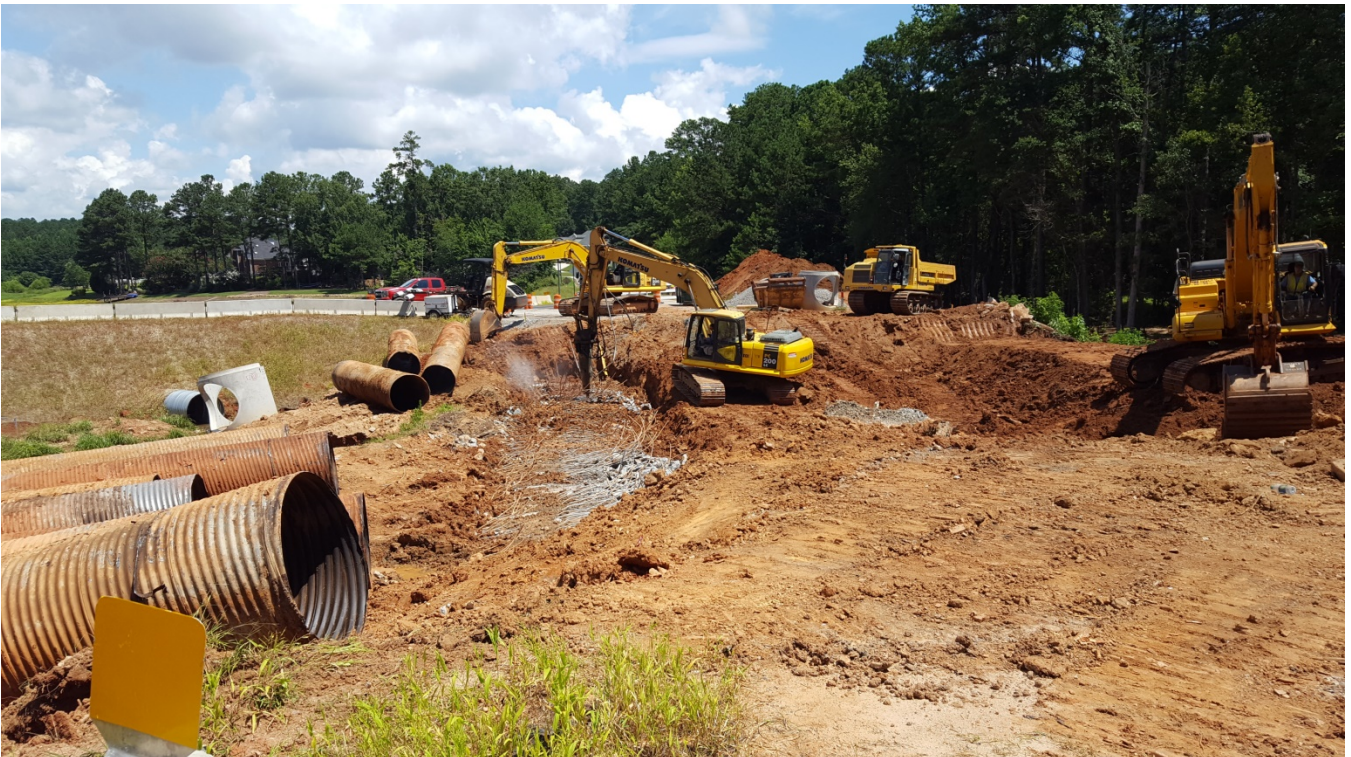
**Photo 2: Emerald Lake Dam during demolition. (July)**

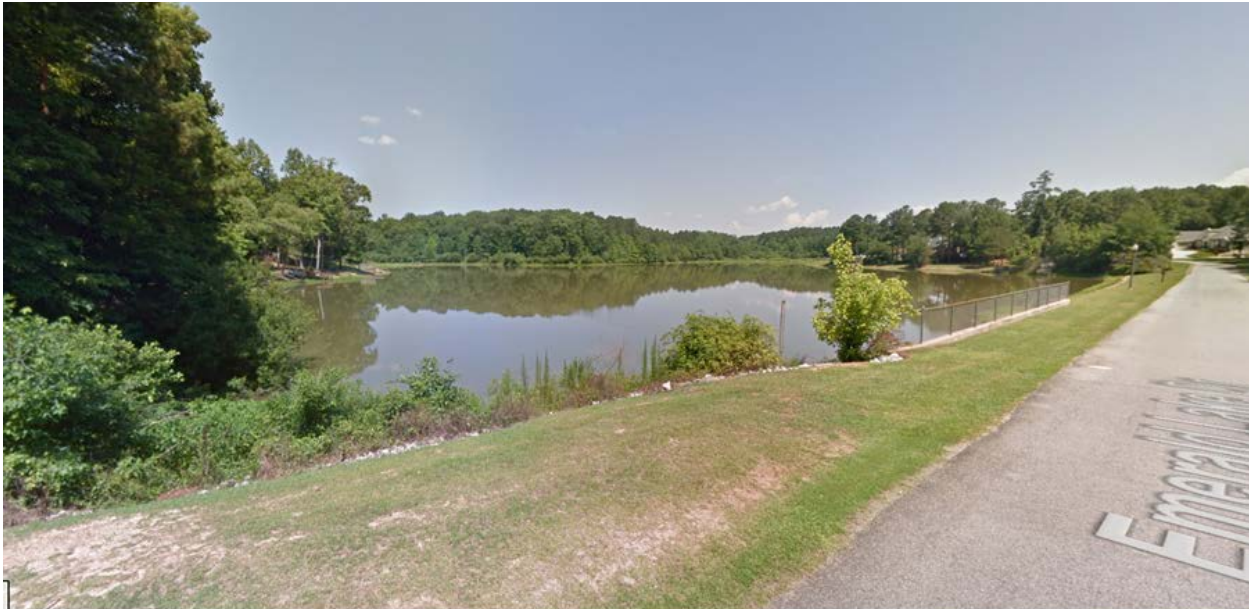
**Photo 1: Emerald Lake Dam prior to construction.**

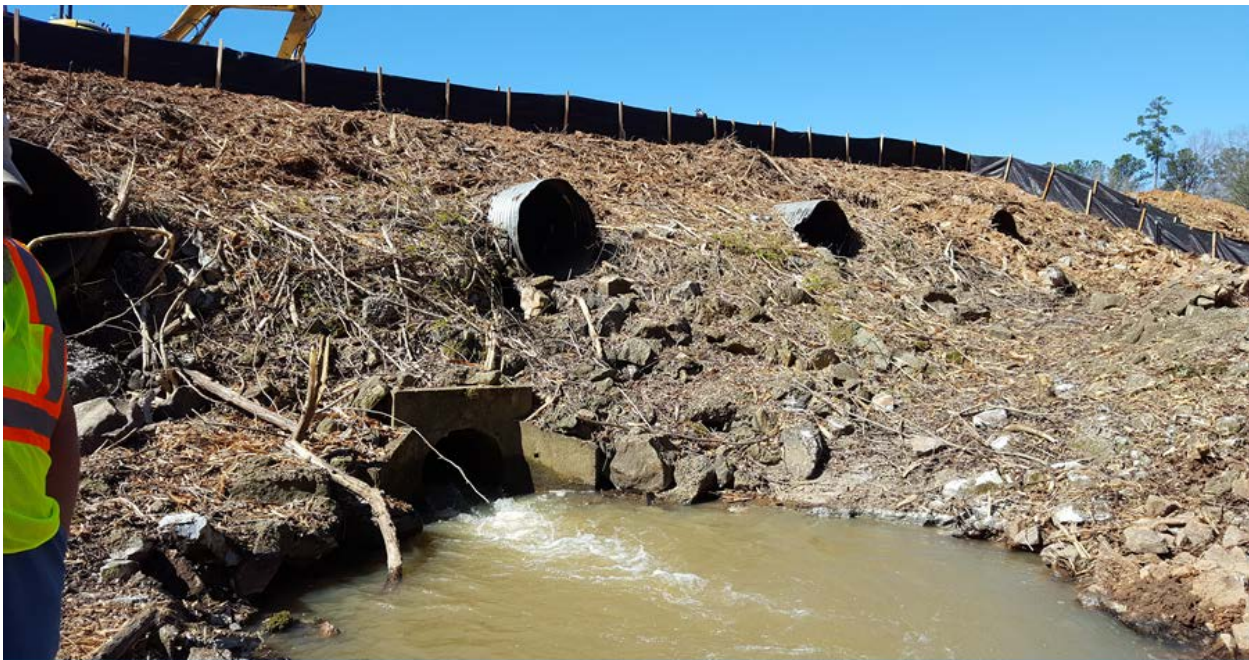
**Photo 2: Emerald Lake Dam during the initial clearing prior to construction.**
