**Subject: ITB #26071-B Justice Center Roof Replacement  
Addendum #3**

# ROOF MOISTURE SCAN REPORT

**Fayette County Justice Center**  
**1 Center Drive**  
**Fayetteville, Georgia 30214**  
February 3, 2026

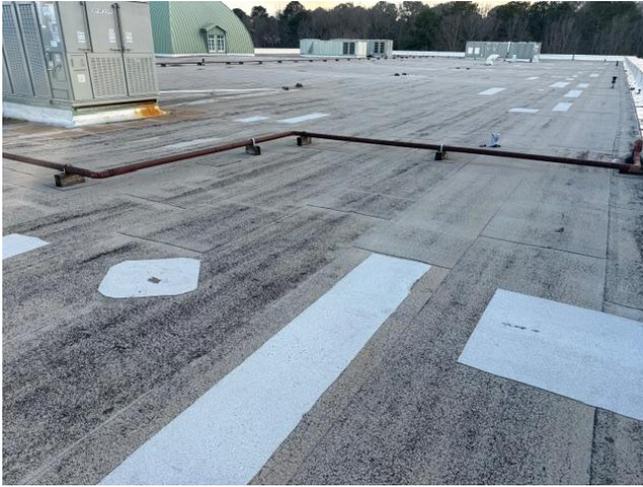
Photo 1: Roof Overview.

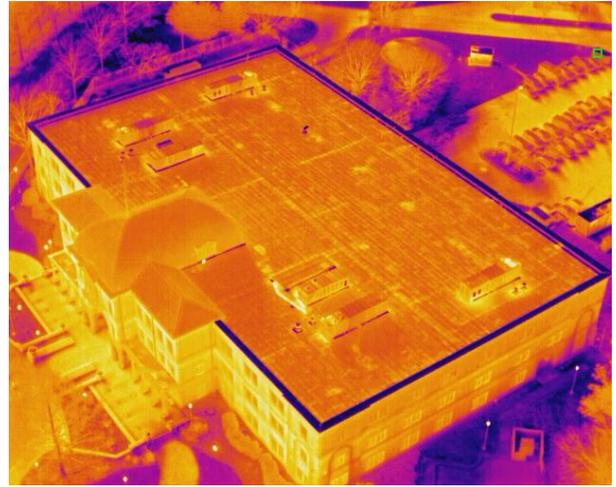
Photo 2: Thermal overview.

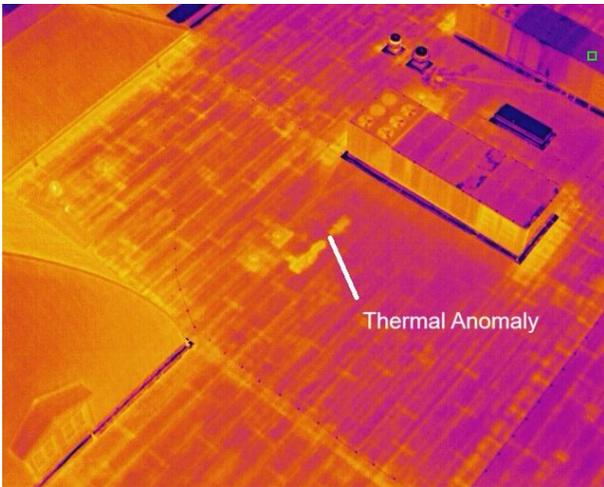
Photo 3: Thermal anomaly identified.

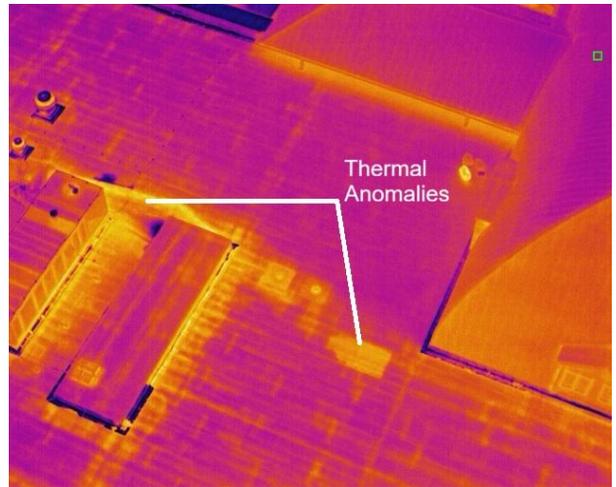
Photo 4: Thermogram with two temperature anomalies.

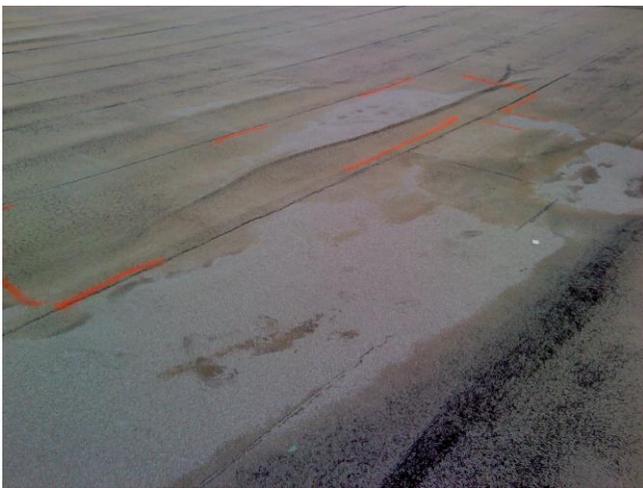
Photo 5: View of an area containing wet insulation.

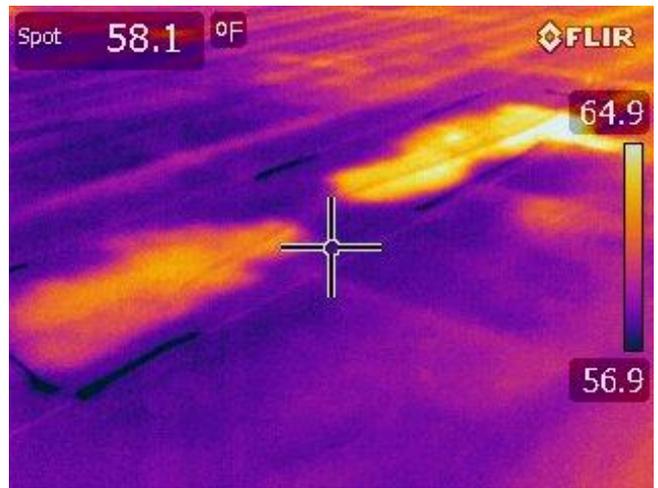
Photo 6: Thermogram of the previous photo.

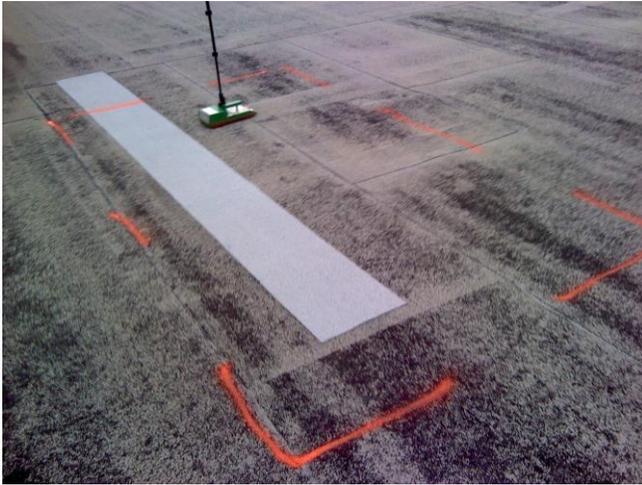
Photo 7: View of an area containing wet insulation.

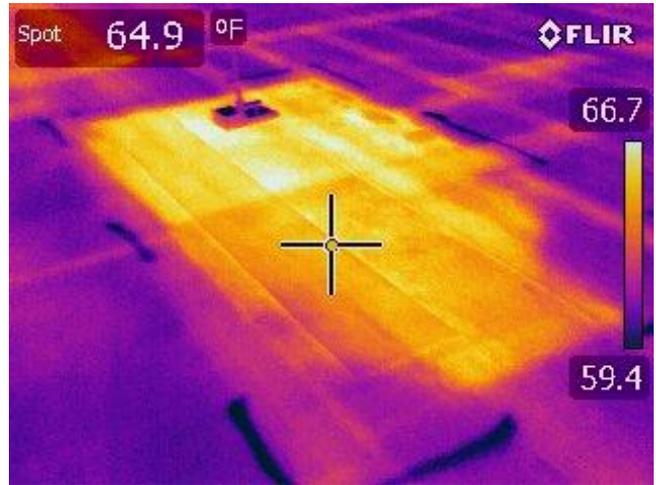
Photo 8: Thermogram of the previous photo.

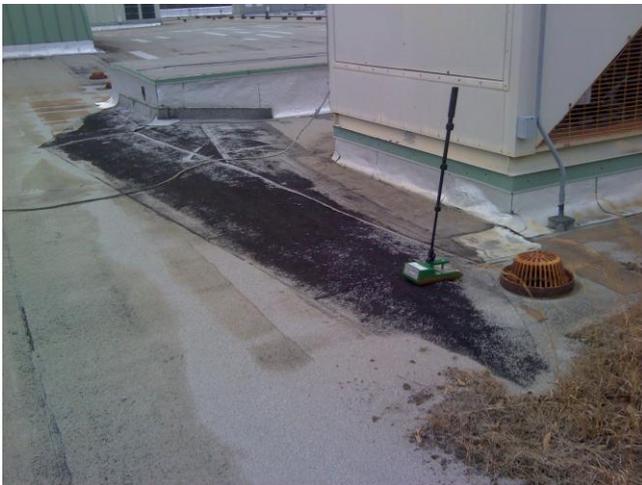
Photo 9: View of an area containing wet insulation. This area may not contain wet insulation below the repair.

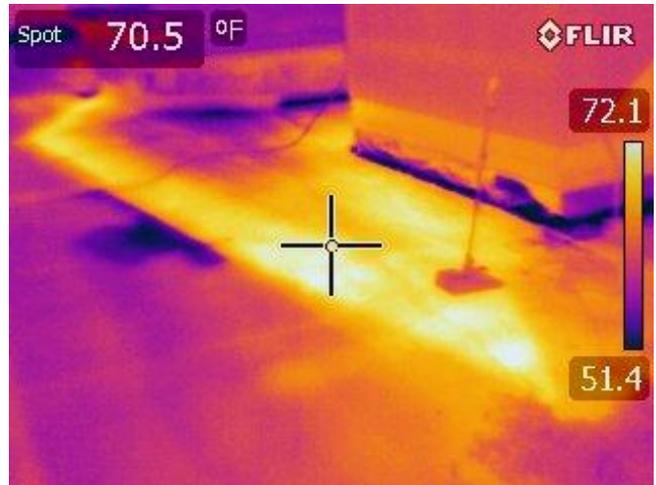
Photo 10: Thermogram of the previous photo.

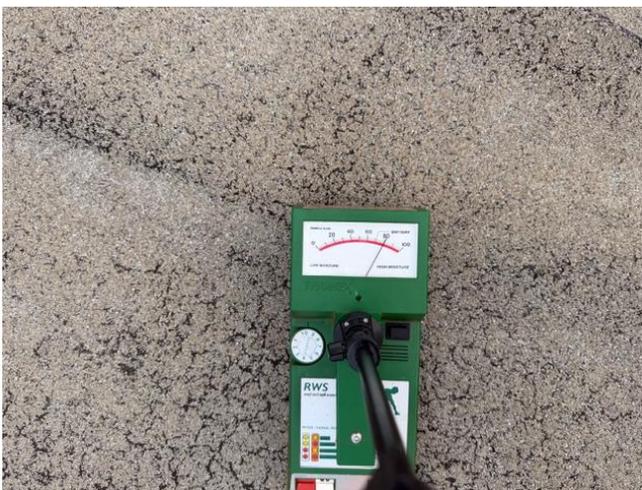
Photo 11: Tramex RWS indicating elevated electrical impedance readings.

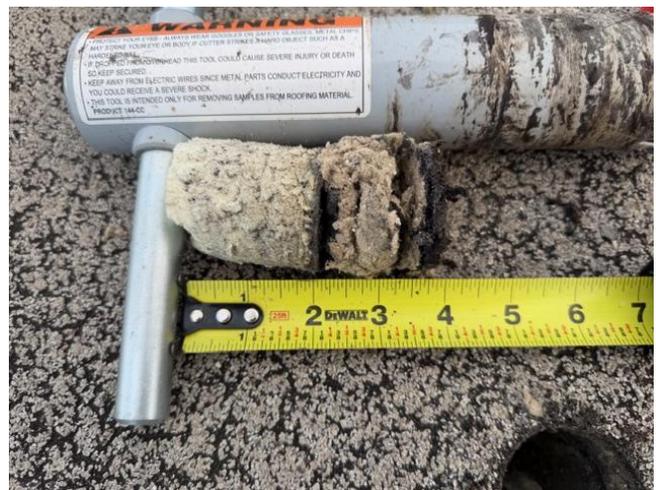
Photo 12: Core components. 2" polyiso, .75" perlite. Approx total core 3.25"
