# ***Report of Subsurface Exploration and Geotechnical Engineering Evaluation***

## ***Margaret Phillips Lake Dam Improvements Fayetteville, Fayette County, Georgia PGC Project No. 118337***

December 3, 2019

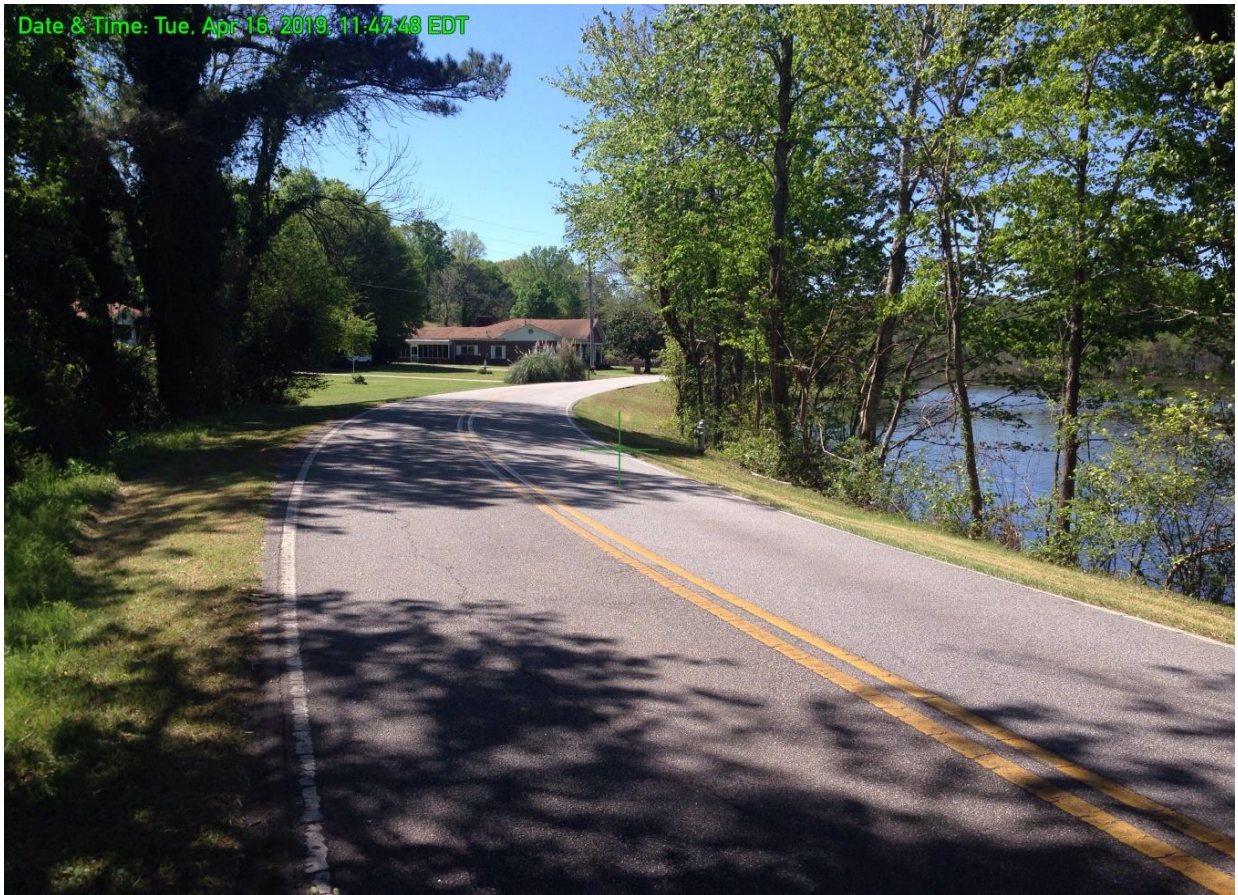
VIEW LOOKING SOUTH ALONG LONGVIEW ROAD FROM NEAR SOUTH END OF DAM.

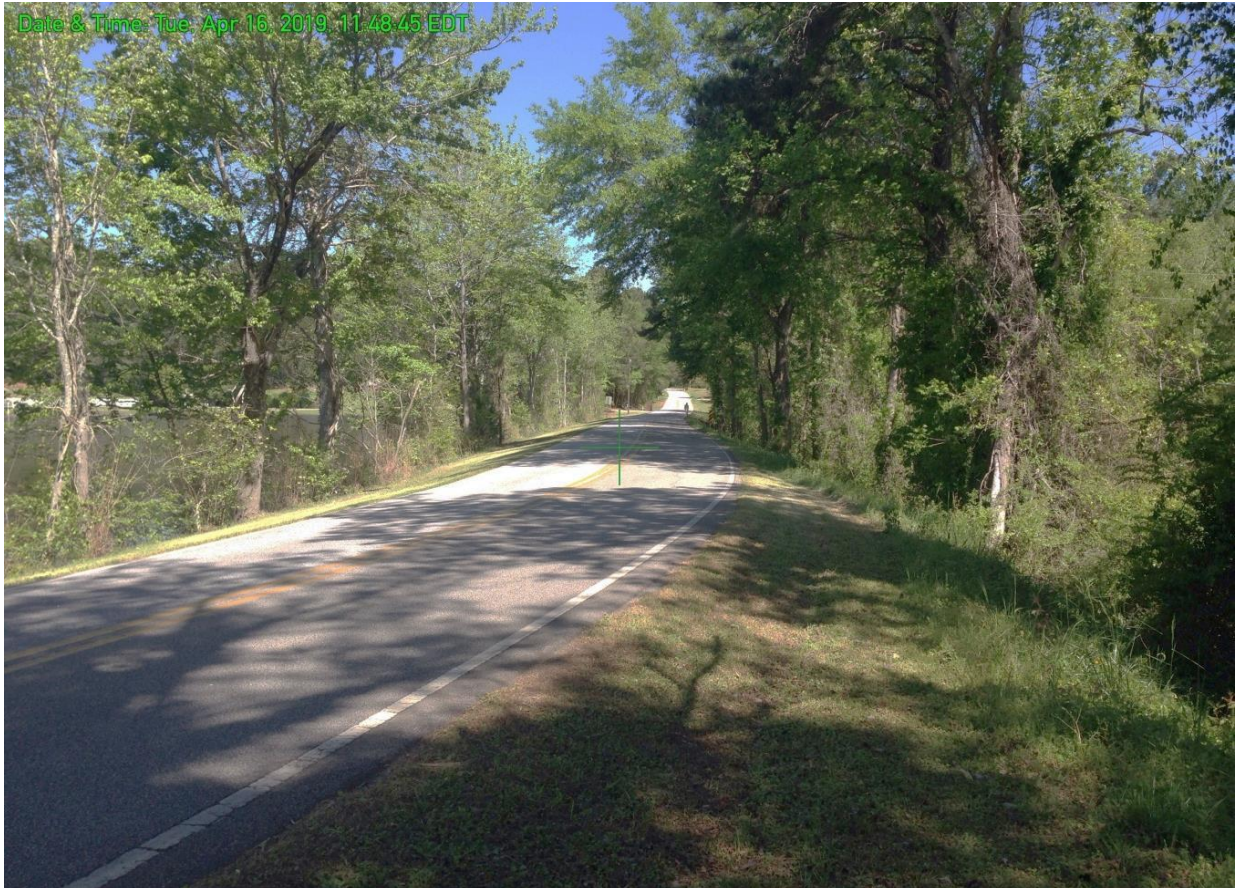
VIEW LOOKING NORTH ALONG LONGVIEW ROAD FROM NEAR SOUTH END OF DAM.

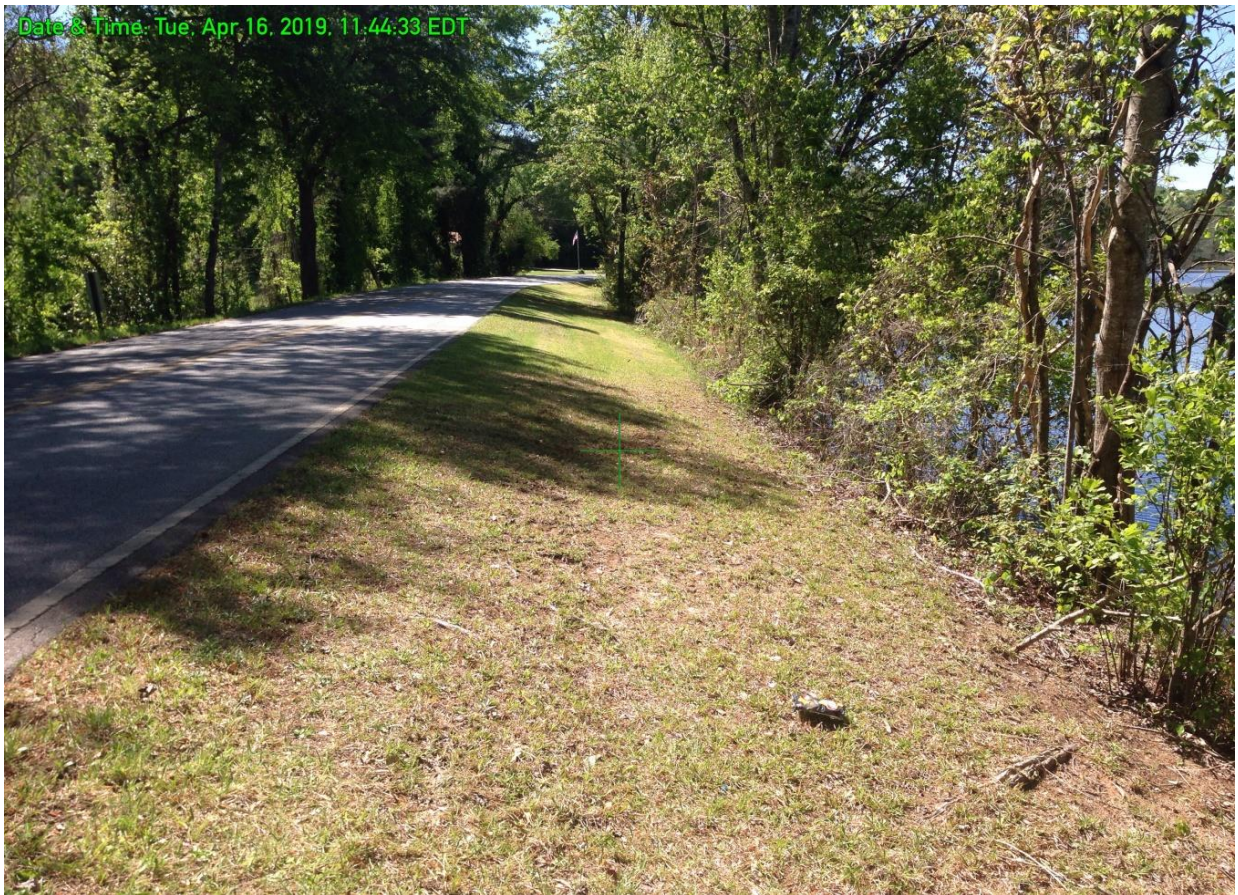
VIEW LOOKING SOUTH ALONG THE UPSTREAM SLOPE FROM NEAR THE NORTH END OF THE DAM.

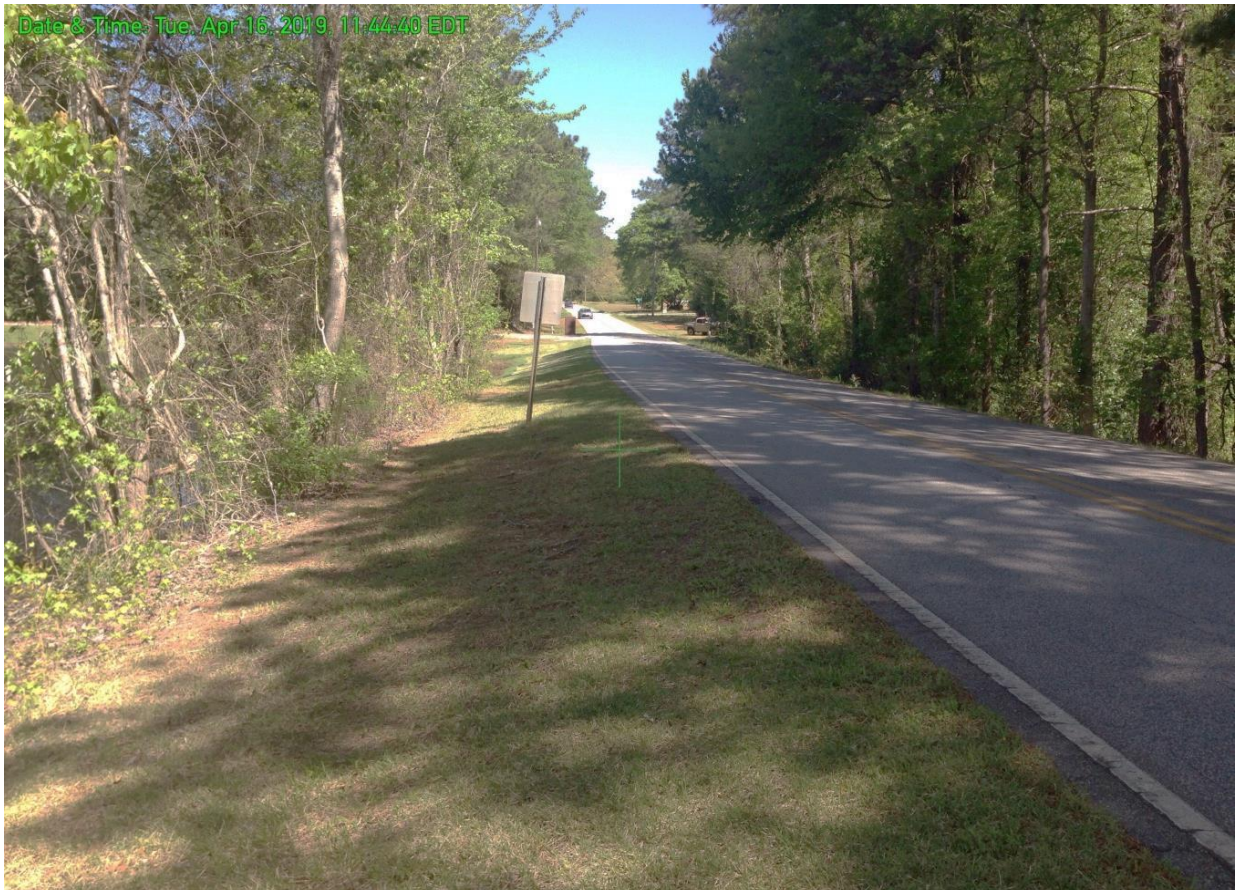
VIEW LOOKING NORTH ALONG UPSTREAM SLOPE FROM NEAR THE NORTH END OF THE DAM.

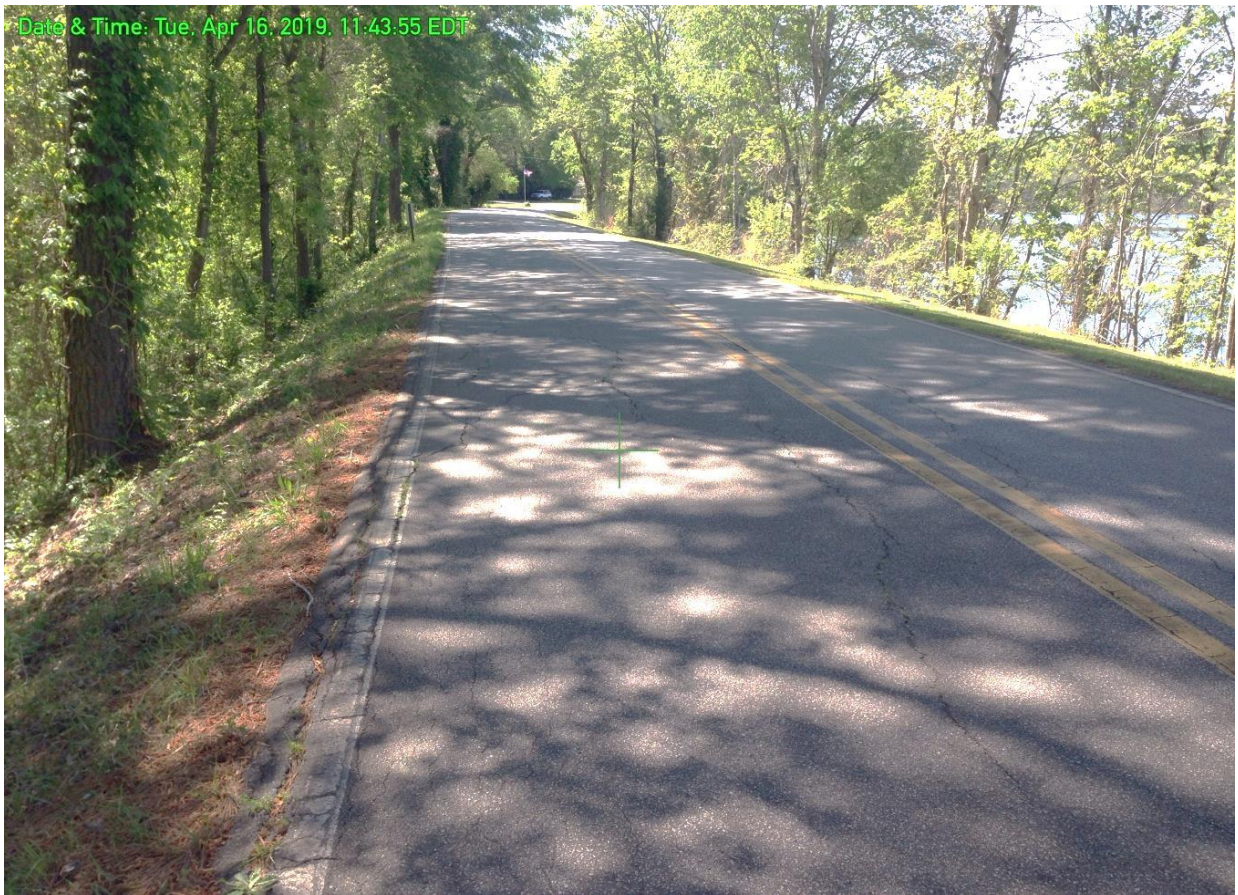
3. The downstream slope is overgrown with medium to large trees, briars and underbrush. The slope face is somewhat irregular and relatively steep. The general slope configuration for much of the dam length is approximately 1(H):1(V). No obvious evidence of significant seepage through the embankment was observed on the downstream slope, but the trees and vegetation could be masking minor flow. Some seepage was observed in 2012 near the Principal Spillway Pipe alignment. There is currently a considerable flow of water along the downstream toe from the spillway. Some of this water is likely seepage related.

VIEW LOOKING SOUTH ALONG THE DOWNSTREAM SLOPE FROM ABOUT MIDWAY OF THE DAM.

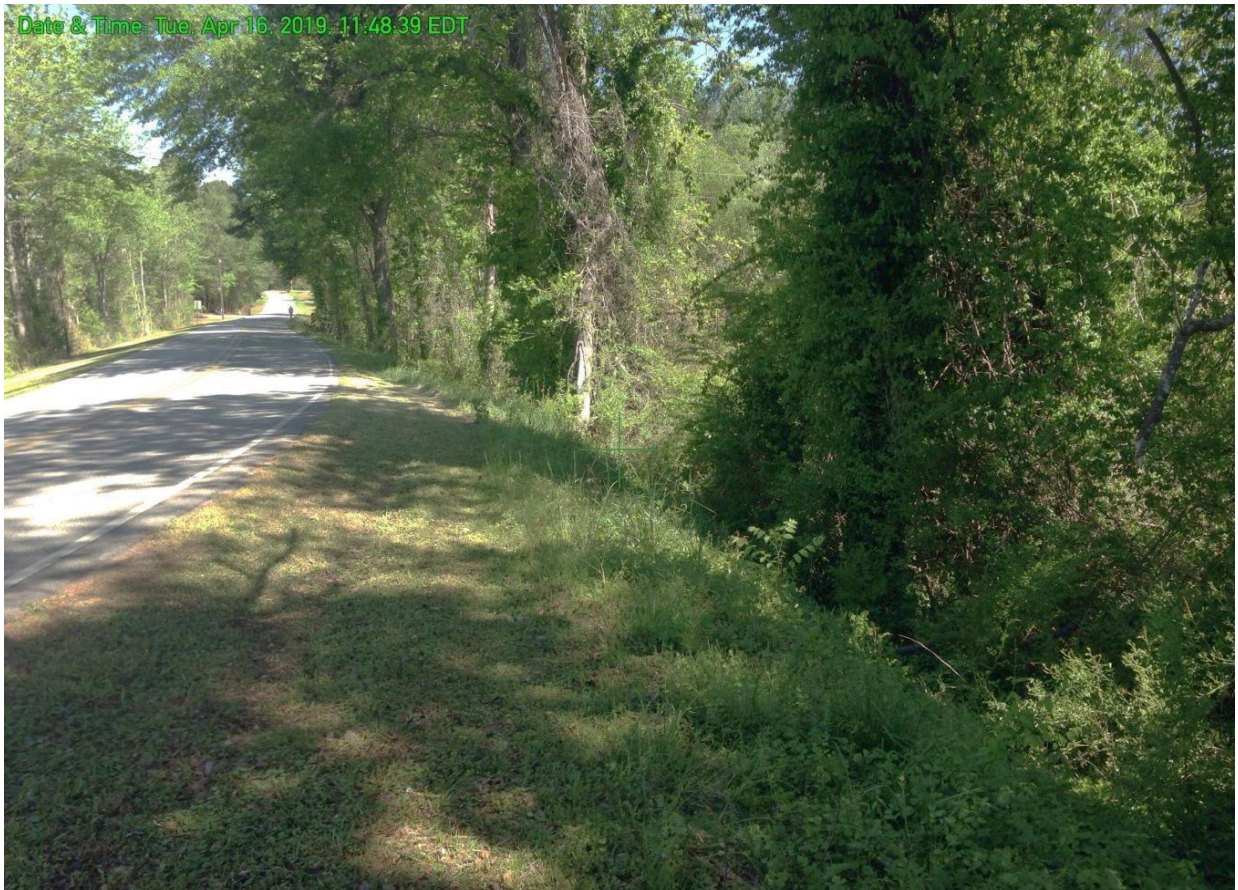
VIEW LOOKING NORTH ALONG THE DOWNSTREAM SLOPE FROM NEAR THE SOUTH END OF THE DAM.

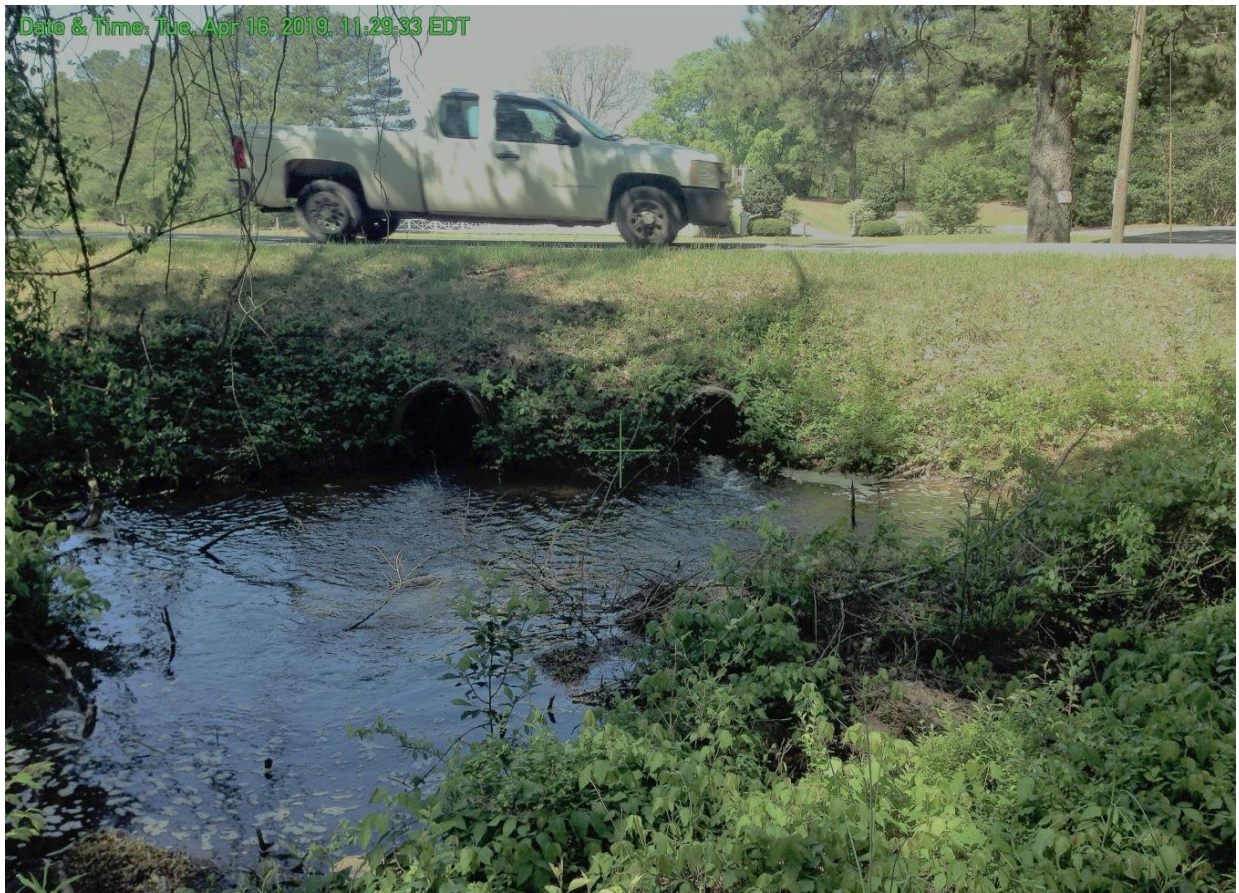
5. The original Emergency (Auxiliary) Spillway consist of two 24-inch concrete pipes buried shallow near the left end of the dam and under Longview Road. Due to the current condition of the PSP, the lake appears to be draining mostly through these two pipes. There are no trash guards over the pipes. Drainage from these pipes then flows down the left abutment in a meandering, eroded channel to the floodplain and original stream bed. As these flows enter the floodplain, they spread from a single narrow channel to multiple channels. Water flow slows as it ponds/meanders through the floodplain area before getting to the original stream channel and turning downstream. Rock/PWR materials were observed along the channel near the left end of the embankment. No other rock was observed.

VIEW OF TWO CONCRETE PIPES LOCATED NEAR THE NORTH (LEFT) END OF THE DAM. PIPES ARE CURRENTLY SERVING AS SERVICE SPILLWAY (ORIGINALLY EMERGENCY SPILLWAY PIPES).

The two existing concrete spillway pipes located near the left end of the dam will be removed as part of the planned dam modifications. A common excavation should be used to remove these pipes. The excavation should extend to the widest dimension of both pipes plus 5 feet and include a minimum 1.5(H): 1(V) entrance/exit slope. The plunge pool at these pipes appears to be at least 2+ feet deeper than the surround ground surface. Remedial subgrade preparation will include the plunge pool area and drainage ditch. High consistency residual materials were observed in near proximity to these pipes. While no geotechnical data is available for this area, we anticipate some remedial undercutting and subgrade preparation will be necessary. For planning purposes, we recommend the excavation to remove the pipes extend a minimum of 20 feet wide down to a minimum elevation 824 feet. A deeper and wider excavation may be required based on the actual conditions encountered. Additional subgrade preparation measures, including rock surface cleaning using compressed air or water jet may be required prior to filling, if an irregular PWR/rock materials surface is exposed.

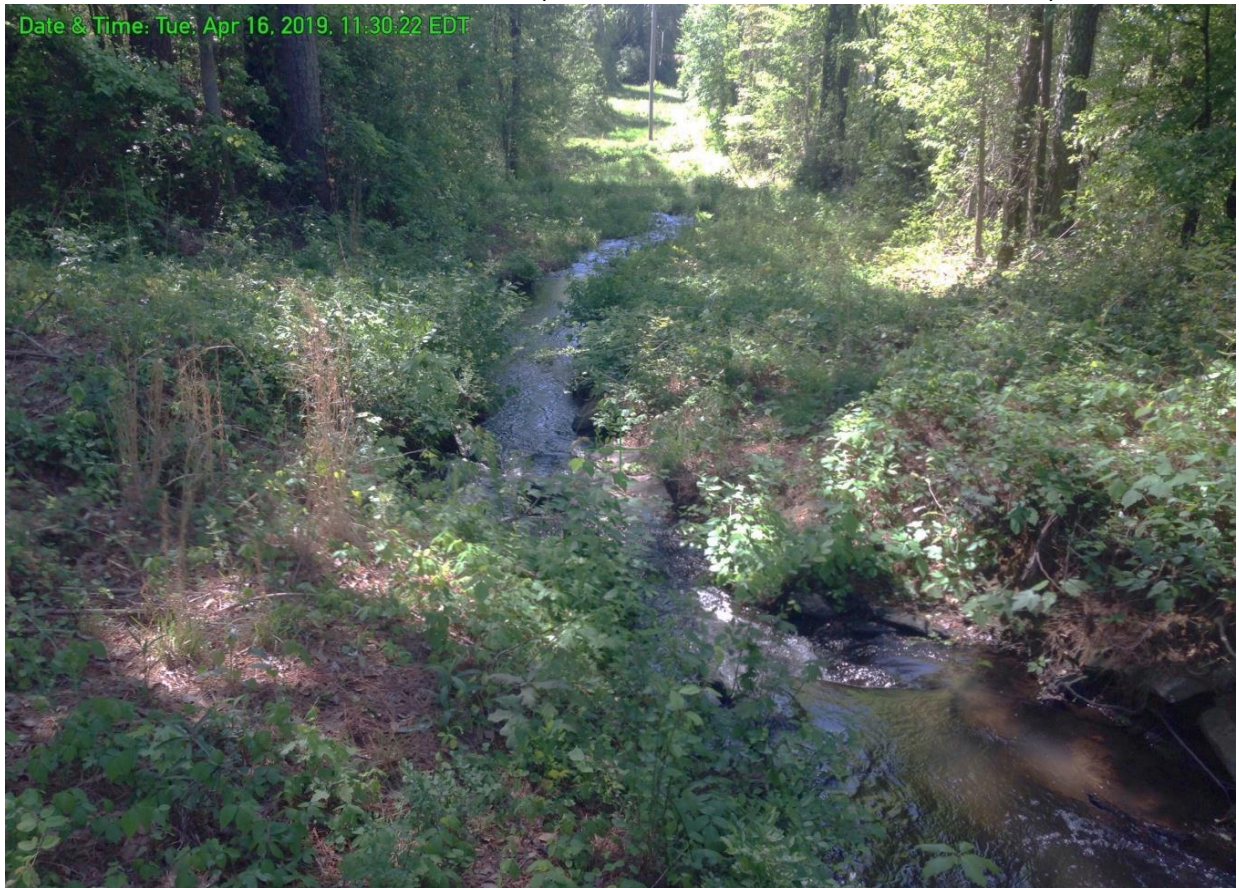
VIEW FACING SOUTH ALONG THE DOWNSTREAM TOE OF DAM WITHIN POWERLINE EASEMENT. WATER FLOWS WITHIN THE EASEMENT FOR ABOUT 400 FEET BEFORE ENTERING STREAM.

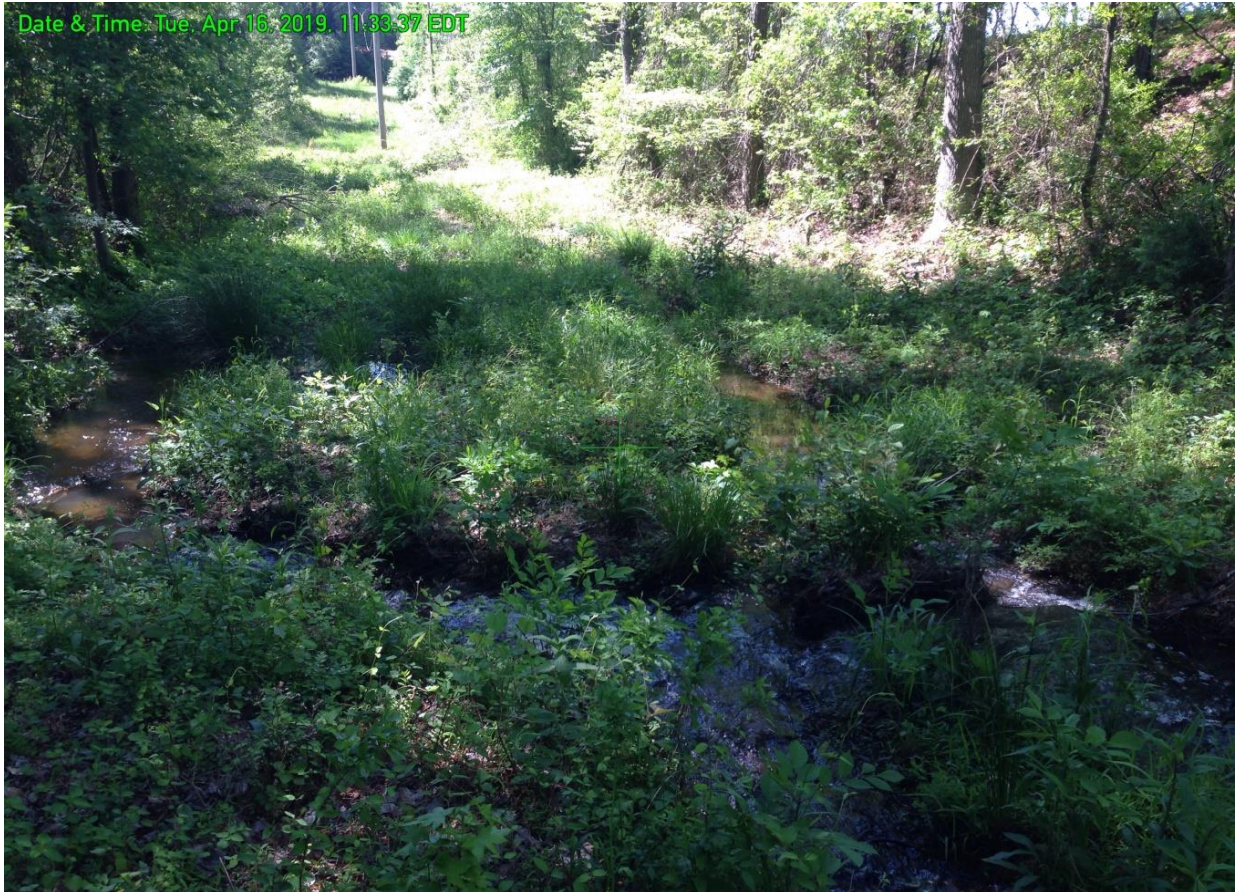
WATER FLOW MEANDERS ONCE THE FLOODPLAIN IS ENCOUNTERED. THE DAM IS TO THE RIGHT.

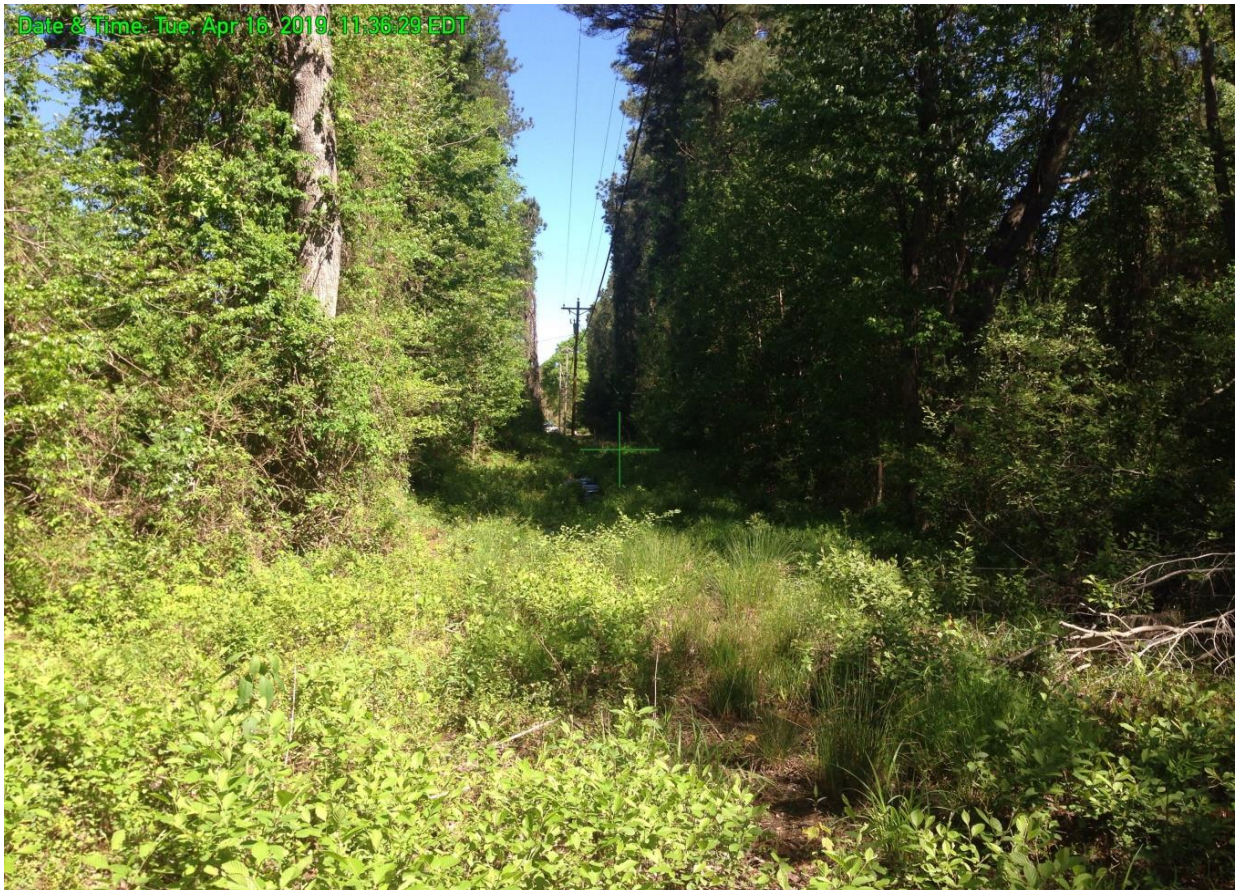
VIEW FACING NORTH ALONG THE POWERLINE EASEMENT FROM NEAR THE STREAM CHANNEL.

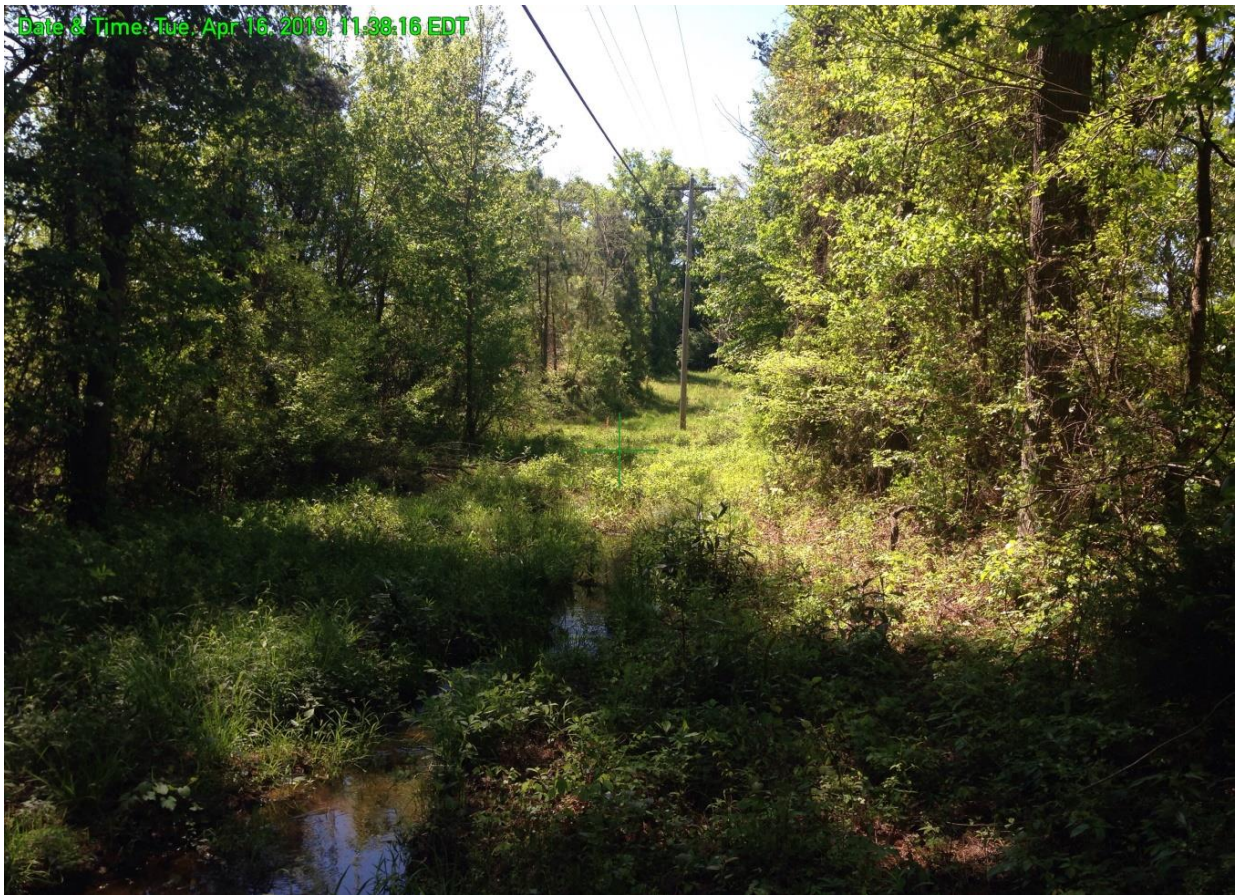
VIEW FACING SOUTH ALONG THE POWERLINE EASEMENT FROM NEAR THE STREAM CHANNEL.

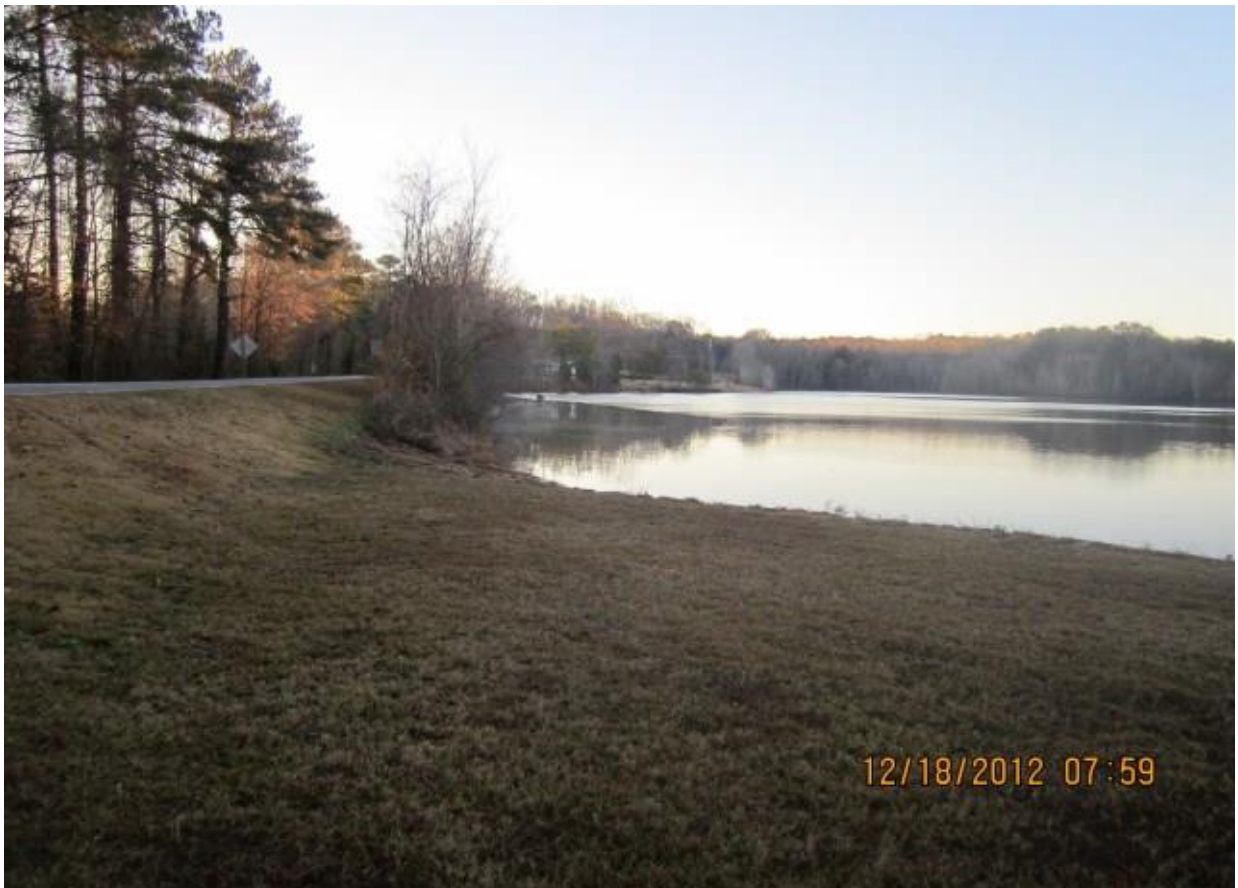
2012 PHOTO OF LAKE FROM NEAR THE EMERGENCY SPILLWAY PIPES AT THE LEFT END OF THE DAM. THE LAKE IS APPROXIMATELY 2 FEET BELOW ITS NORMAL POOL.

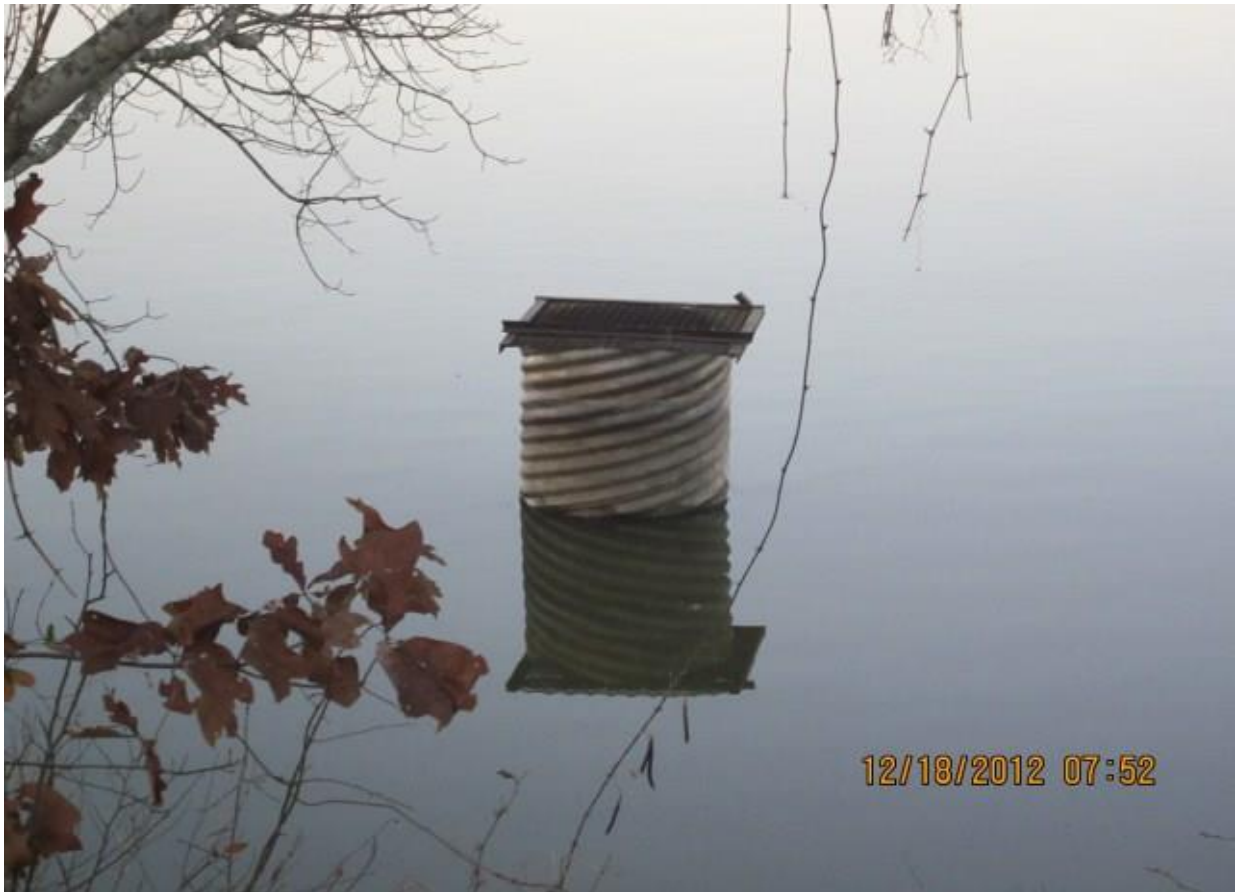
4. The original Principal Spillway System is reported to be a 30-inch corrugated metal riser connected to a 12-inch corrugated metal low level pipe through the dam. In December 2012 the lake level was down +/- 2 feet and the riser pipe was visible. During the 2019 study, the top of the riser pipe was still visible, but submerged by about 6 to 12 inches of water from the elevated lake. During the course of this study, no obvious flow was observed at the downstream end of this spillway pipe, which was also submerged. We are unsure of the conditions that caused the 2012 leaking pipe to become clogged/blocked, resulting in the currently elevated lake level.

2012 PHOTO: VIEW OF ORIGINAL CORRUGATED METAL OVERFLOW PIPE. LAKE LEVEL IS ABOUT 2 FEET BELOW NORMAL POOL DUE TO LEAKAGE THROUGH THE PIPE.

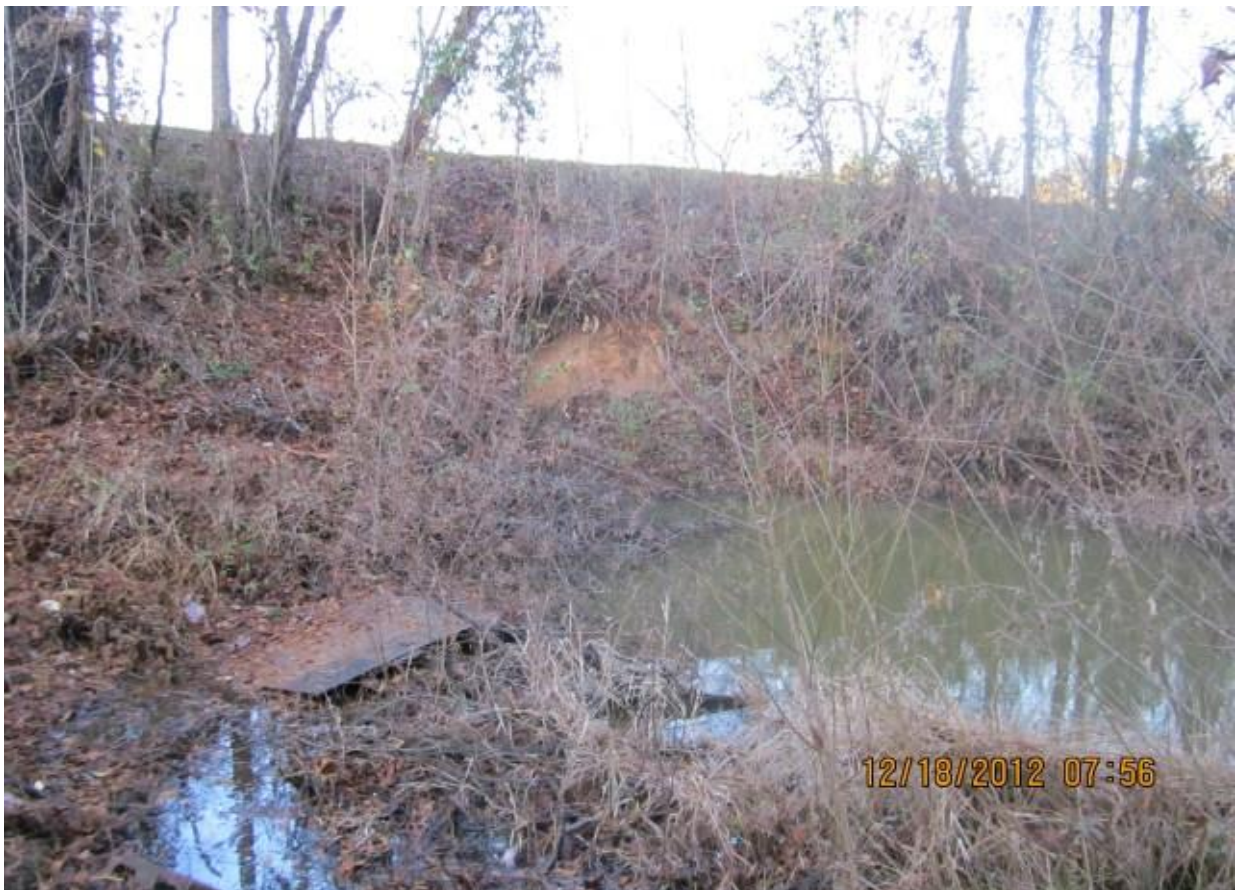
2012 PHOTO: VIEW OF DOWNSTREAM AREA WHERE THE PSP DISCHARGES. THE DOWNSTREAM END OF THE PIPE IS SUBMERGED.
