***Report of Subsurface Exploration and
Geotechnical Engineering Evaluation***

***Kozisek Lake Dam Improvements
Fayetteville, Fayette County, Georgia
PGC Project No. 119193***

December 17, 2019

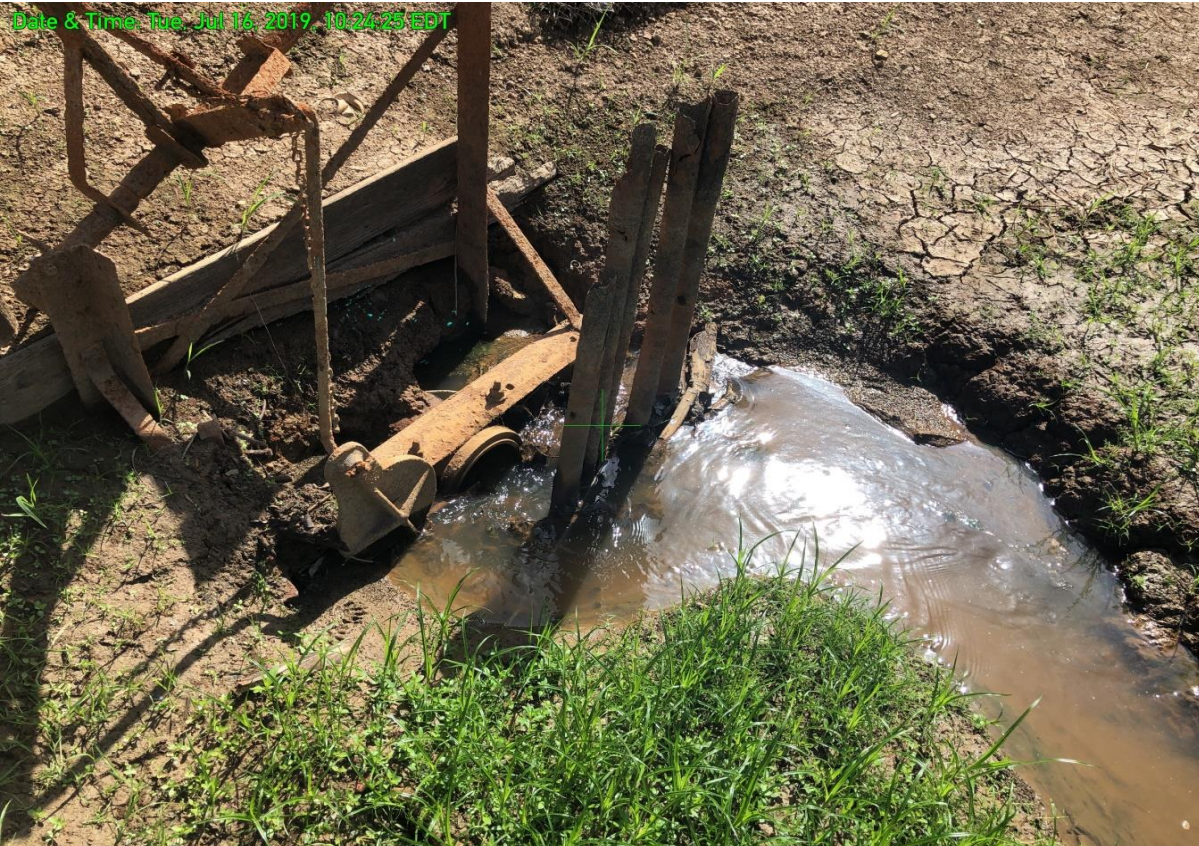
VIEW OF SMALL DIAMETER LOW LEVEL DRAIN PIPE WITH SLIDE GATE OPEN. NORMAL STREAM FLOWS EXIT LAKE AREA THROUGH THIS PIPE. THE OUTLET END OF THIS PIPE WAS NOT LOCATED.

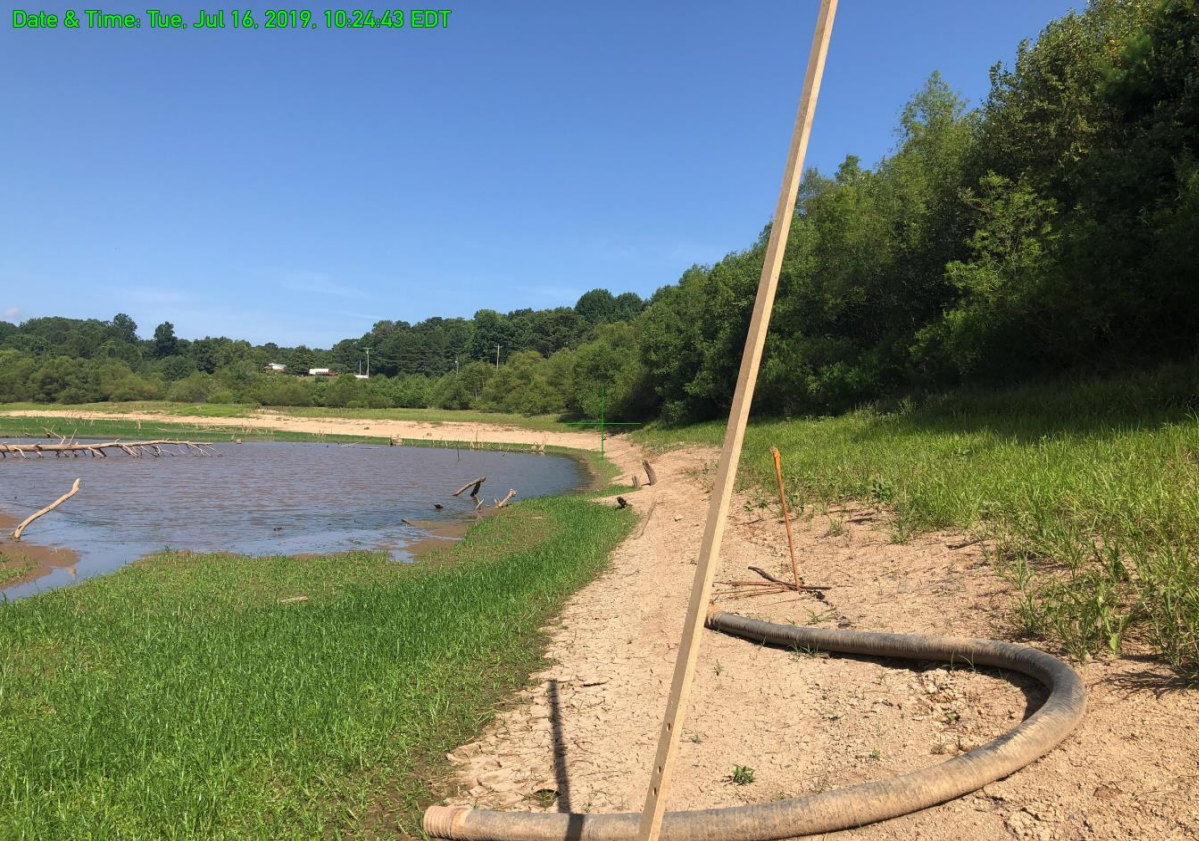
VIEW LOOKING LEFT ALONG UPSTREAM SHORELINE FROM NEAR LOW LEVEL PIPE WITH LAKE ESSENTIALLY DRAINED. REMNANTS OF OLD PVC AND RUBBER PUMP PIPE PRESENT IN THIS AREA.

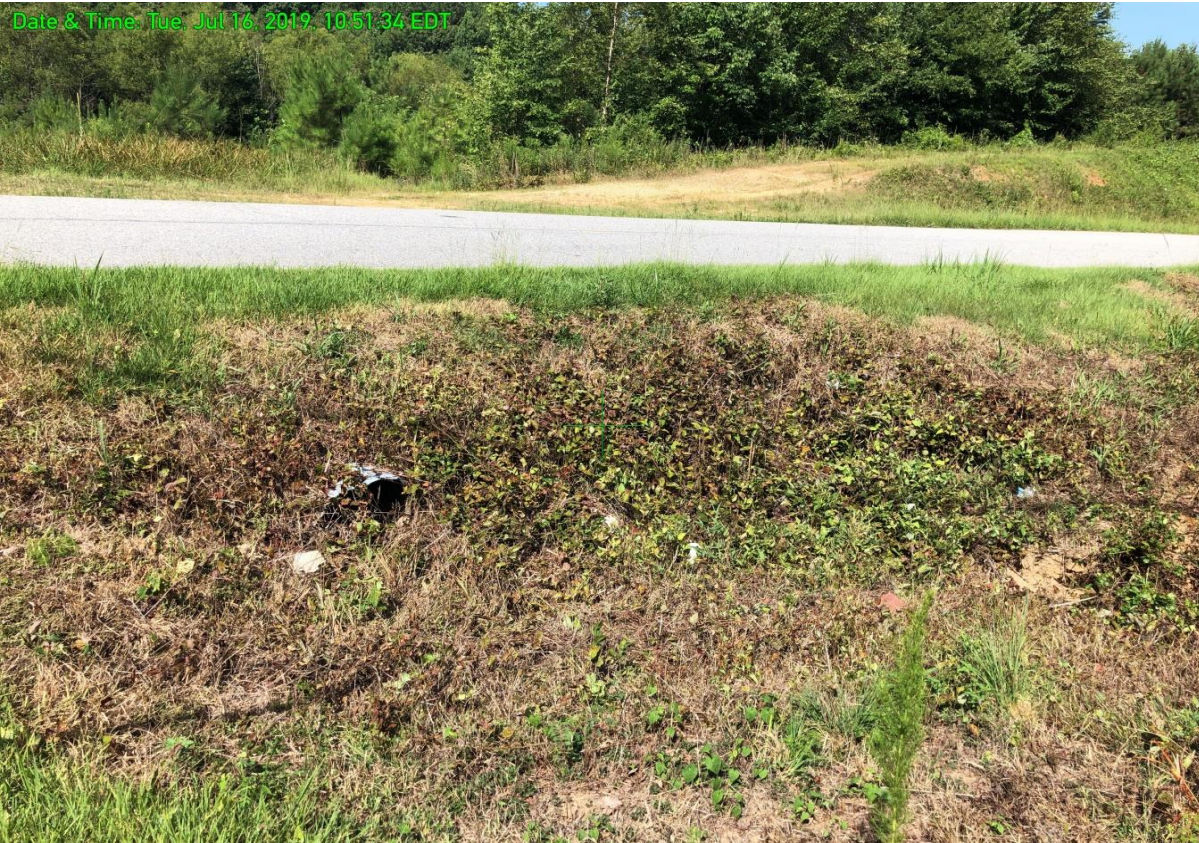
VIEW OF DOWNSTREAM SIDE OF AUXILIARY SPILLWAY PIPE AT NEELY ROAD. THE RIGHT END OF THE DAM CAN BE OBSERVED AT THE TOP OF THE PHOTO ACROSS NEELY ROAD.

The existing Principal Spillway Pipe allows the current pool level to remain at an elevation of about 830 feet, which is an essentially drained condition. The historical normal pool elevation was at about 849 feet. The Auxiliary Spillway system needs to be upgraded. The existing pipes should be removed and replaced.

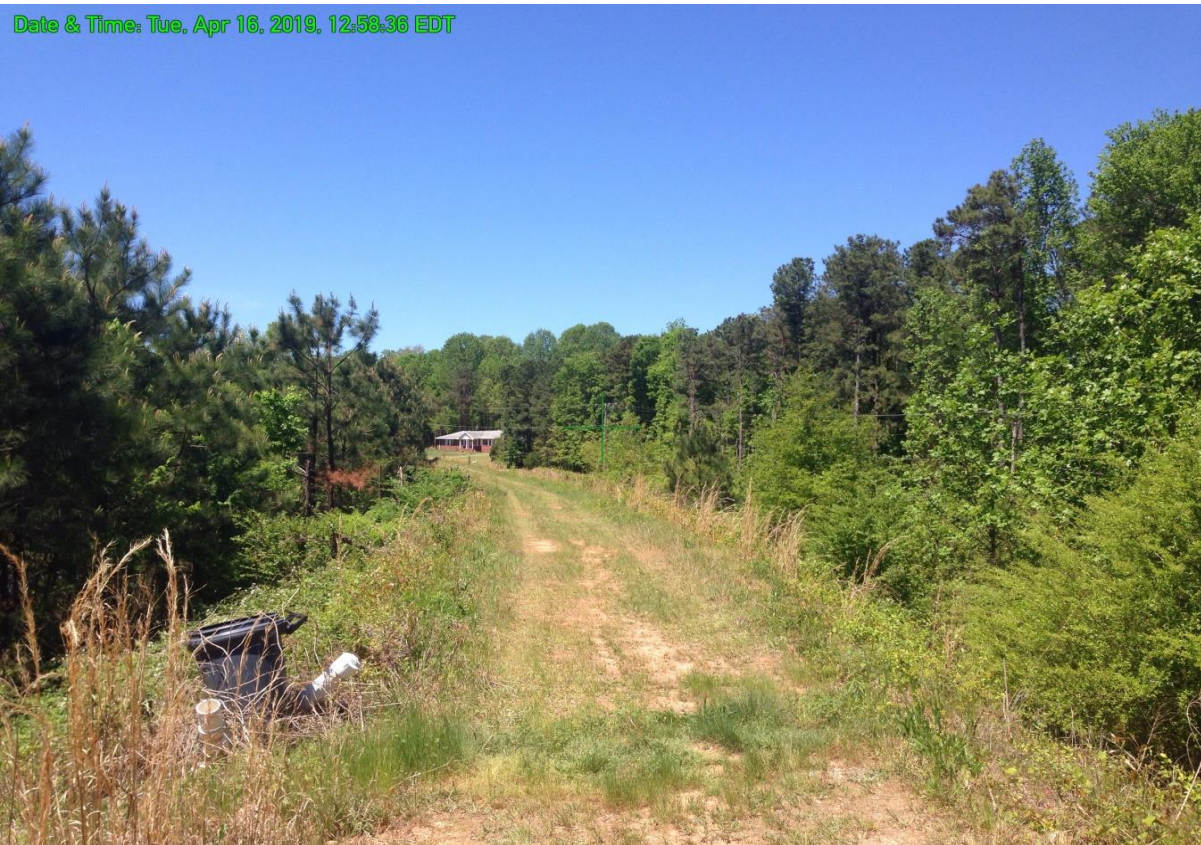
VIEW ALONG THE DAM CREST FROM NEAR THE MID-POINT. REMNANTS OF SIPHONS OR PUMP PIPE PRESENT. RESIDENCE NEAR MIDDLE TOP IS ACROSS NEELY ROAD FROM THE LEFT END OF DAM.

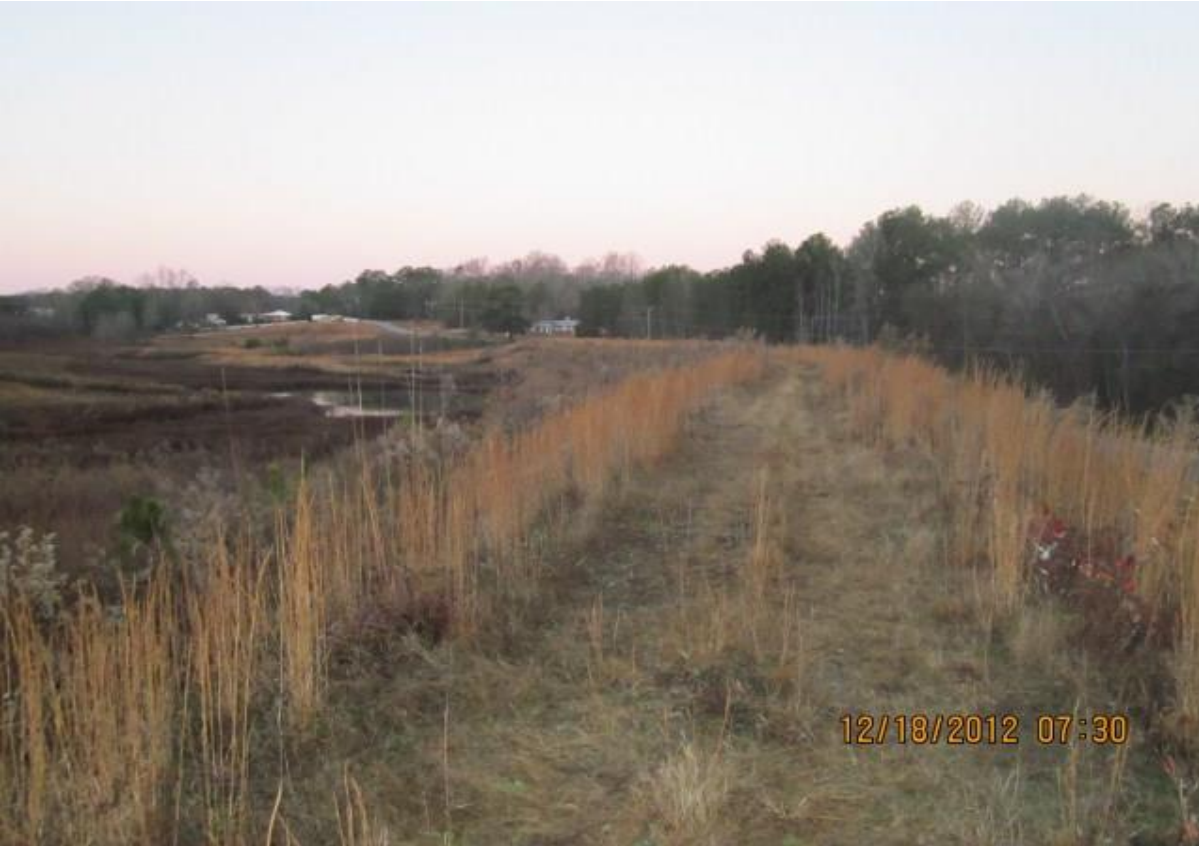
2012 VIEW OF DAM LOOKING RIGHT TO LEFT ALONG THE CREST. VEGETATION WAS BETTER MAINTAINED AT THAT TIME.

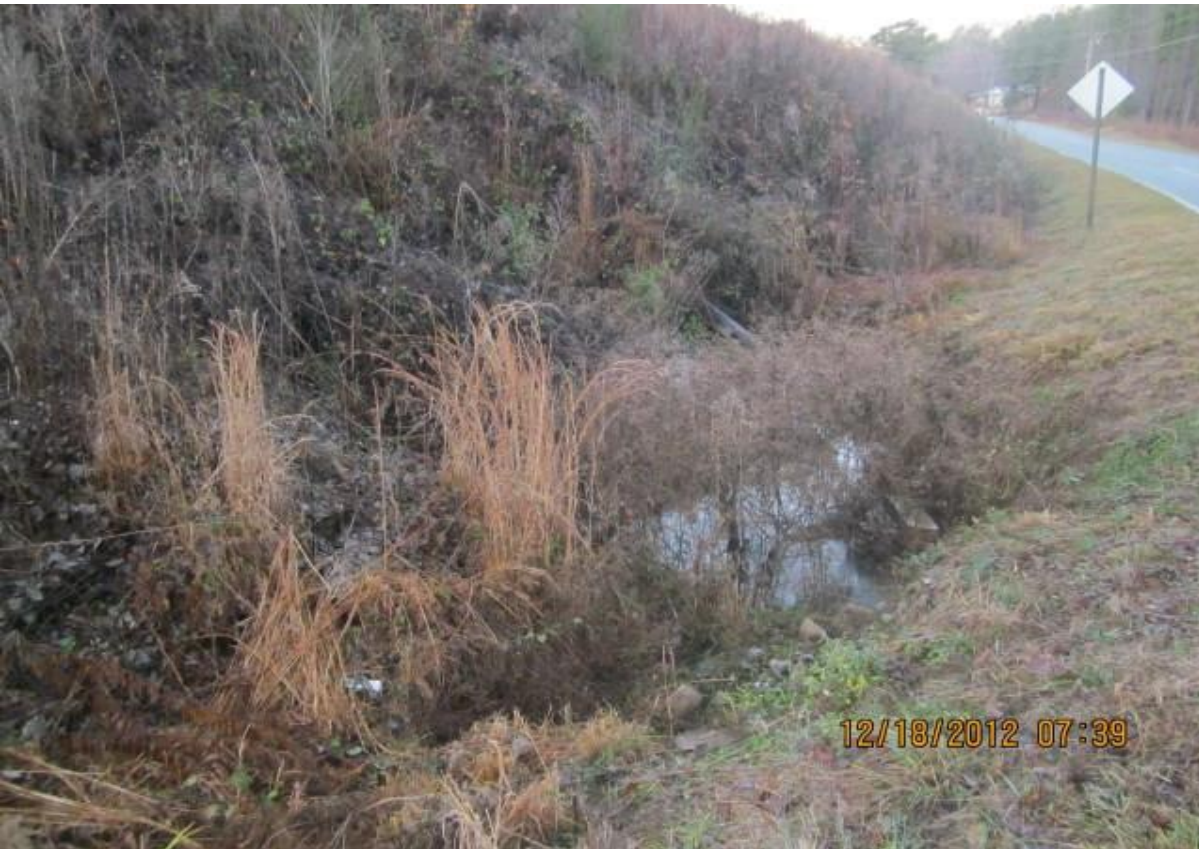
3. During our 2012 site visit, we observed seepage and flowing water along portions of the downstream toe of slope along Neeley Road.
4. The original Primary Spillway reportedly consisted of an 18-inch CMP riser connected to an 8-inch low-level DIP. The riser no longer exists, so water now flows freely through the existing low-level pipe. The upstream end of pipe is located near the center of the dam. The riser location and the downstream end of pipe were not observed. We suspect this pipe crosses through the dam and discharges to an area just upstream of an 18-inch reinforced concrete pipe (RCP) culvert that crosses under Neely Road. This low-level pipe is fitted with a slide gate in the open position. This open pipe without the riser pipe keeps the lake in an essentially drained condition during normal flows.

2012 VIEW OF WATER AT THE DOWNSTREAM SIDE OF THE DAM NEAR THE DRAIN PIPE. SIPHON OR PUMP PIPE(S) WERE PRESENT AT THAT TIME. FLOWING WATER OBSERVED ALONG NEELY ROAD.

The actual amount and location of embankment/foundation seepage was difficult to determine due to the lake currently being in an essentially drained condition. When the lake was initially inspected in 2012, we recall the downstream toe area along Neely Road being wet. In general accordance with GSDP guidelines, we recommend a seepage collection system consisting of an all aggregate Toe/Foundation/Blanket drain connected to a full height (to normal pool) Chimney Drain be incorporated into the planned dam improvements.
