# Brittany Way

Date Updated:	7/13/2016
Cost Estimate:	\$75,000.00
Est. Project Length:	3 Weeks
Construction:	In-House
Property Access:	Complete
Utilities:	Complete
Preliminary Eng:	Complete
Right Of Way:	
Construction:	In-House
Contractor:	Fayette County
Const Start Date:	5/27/2014
Completion Date:	9/14/2014
Problem:	Road floods during the 2-year storm event.
Proposed Solution:	Install a 3'x6' concrete box culvert 60' long under Brittany Way.
Percent Complete:	100
Current Status:	Complete
Total Cost:	\$67,432

Project: Brittany Way – 2017 SPLOST

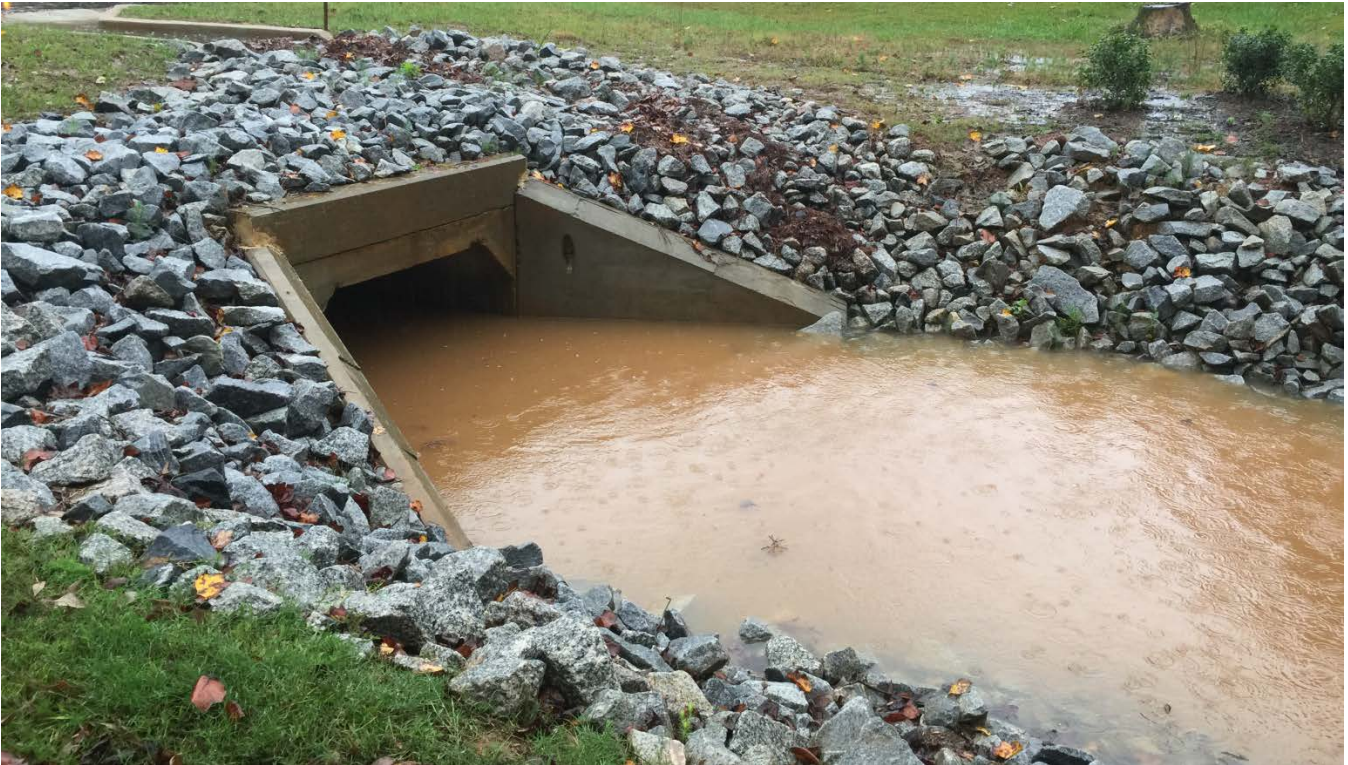
**Photo 1: View of outlet side of new culvert. Rain event shows the culvert operating successfully.**

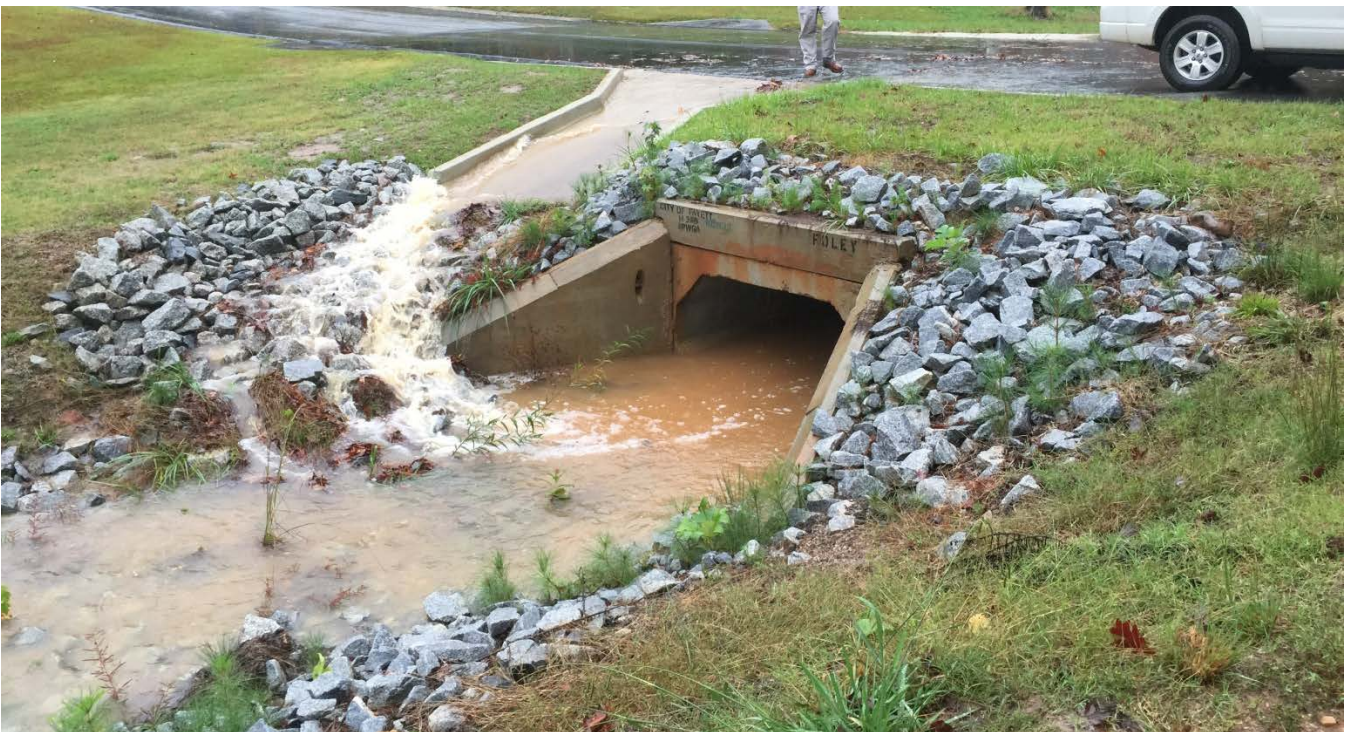
**Photo 2: View of inlet side of new culvert. Rain event shows the culvert and curb and gutter operating successfully.**

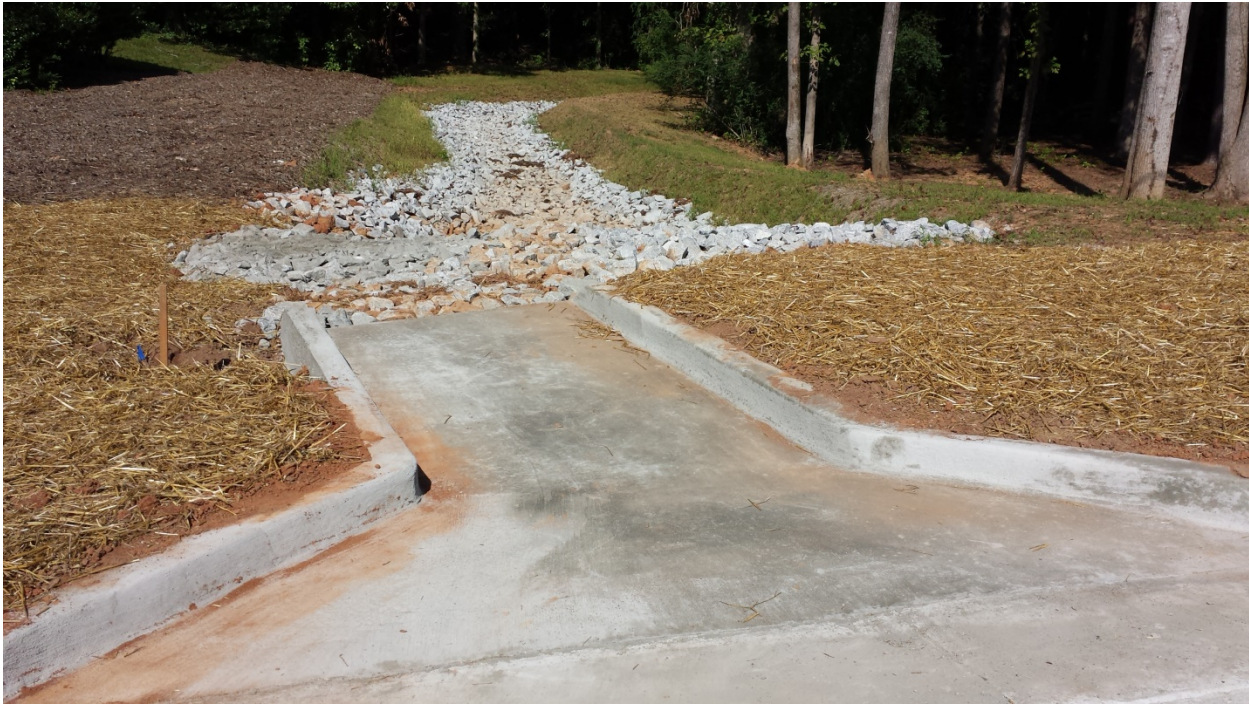
**Photo 1: New curb and gutter directs stormwater to flow over new culvert and into the stream. (08/27/2014)**

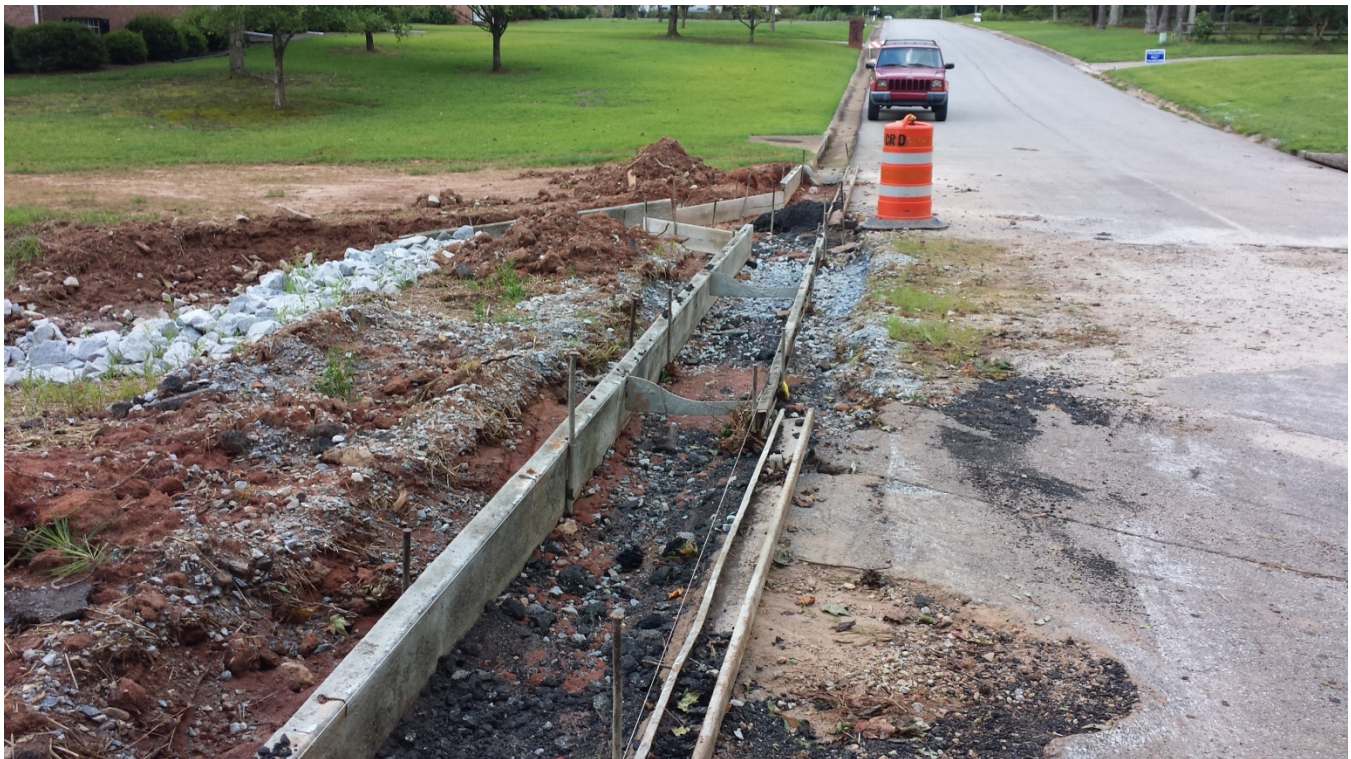
**Photo 2: Curb and gutter are being framed to prep for concrete pouring. (08/21/2014)**

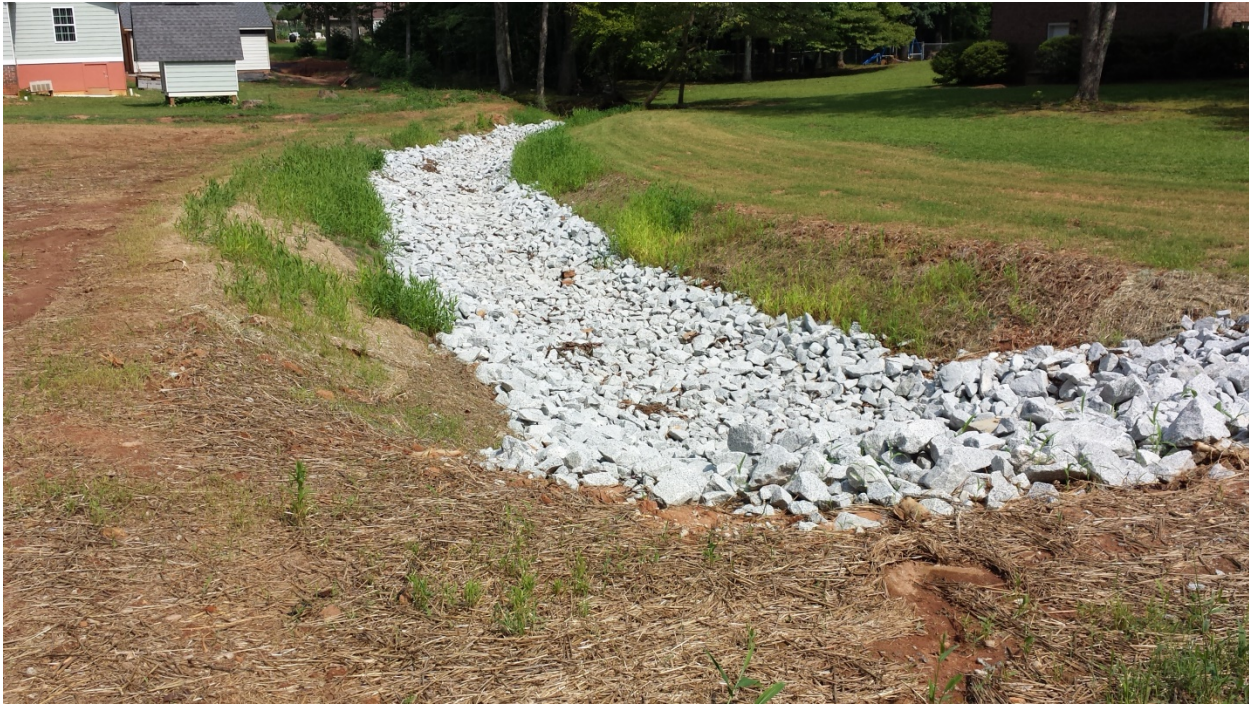
**Photo 1: Grass growth continues to be monitored. (07/25/2014)**

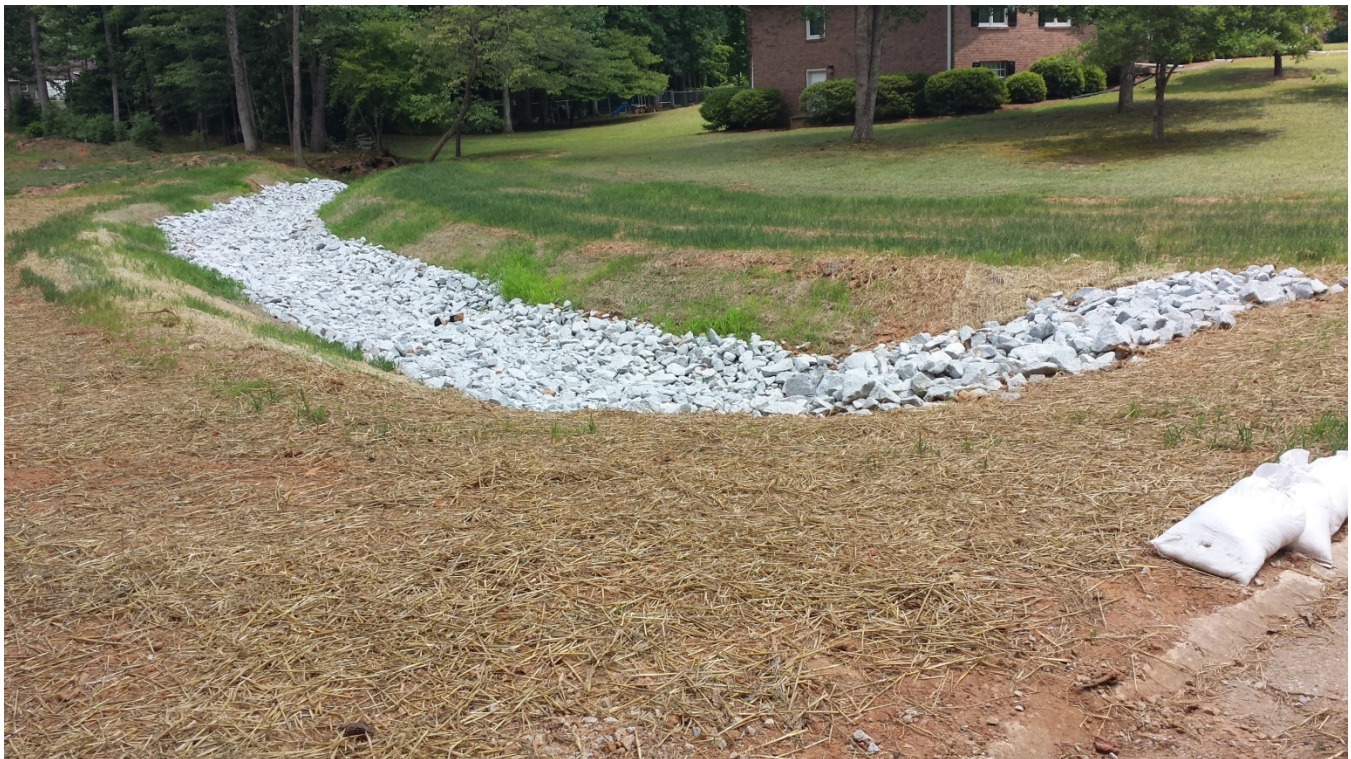
**Photo 2: Grass is beginning to grow alongside the new culvert and stream. (07/08/2014)**

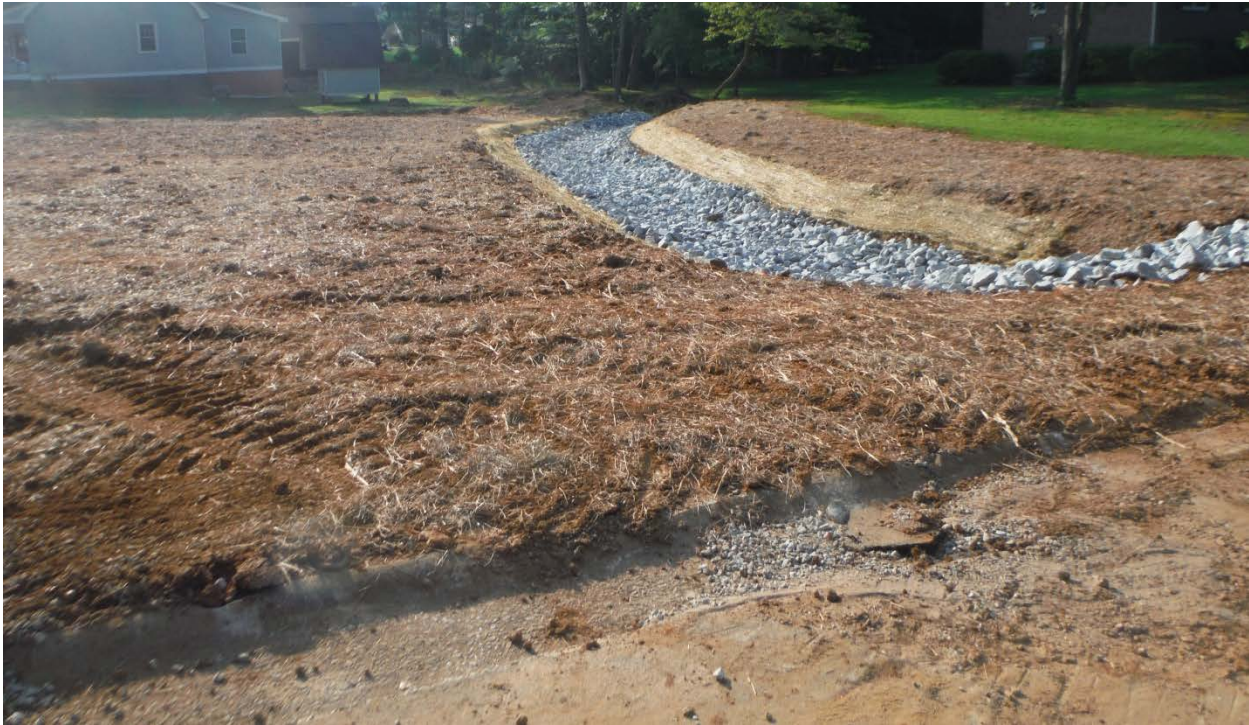
**Photo 1: Grading work is underway. Rocks were placed for new stream bed. Materials were placed to help with erosion and sediment control. (06/20/2014)**

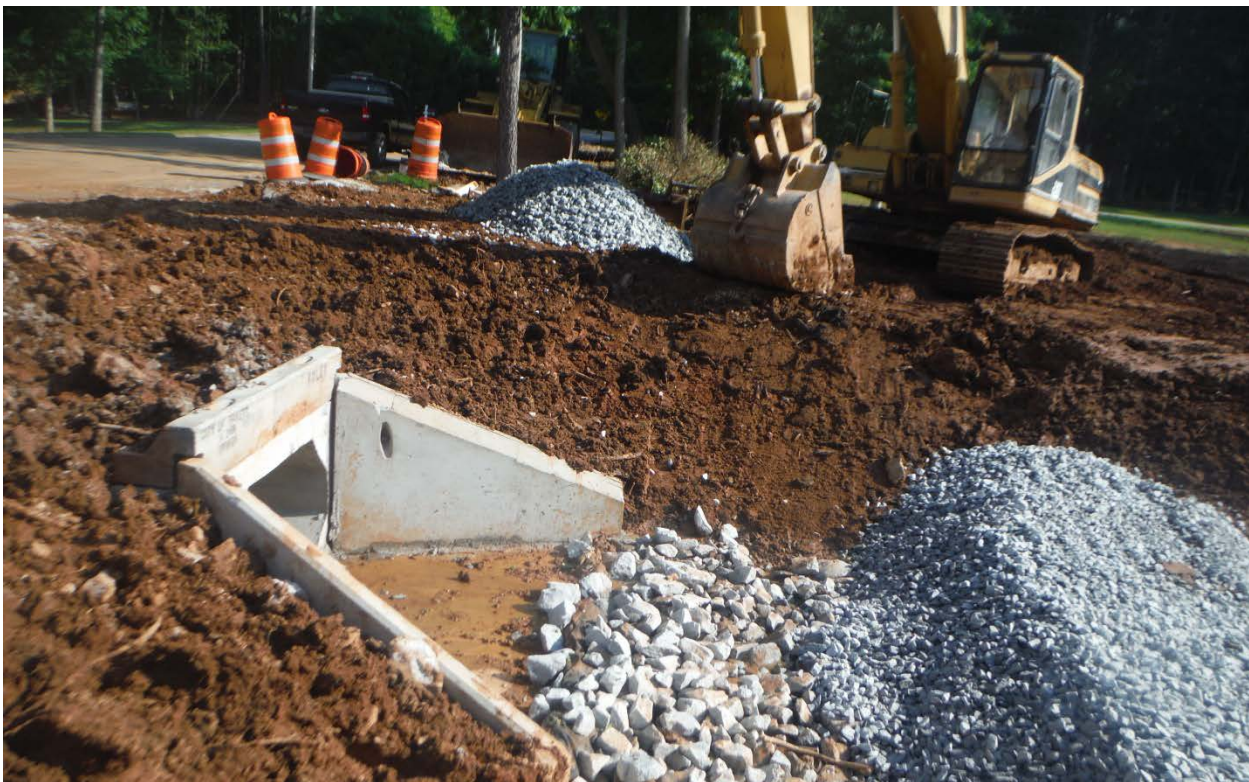
**Photo 2: Grading work underway. (06/13/2014)**

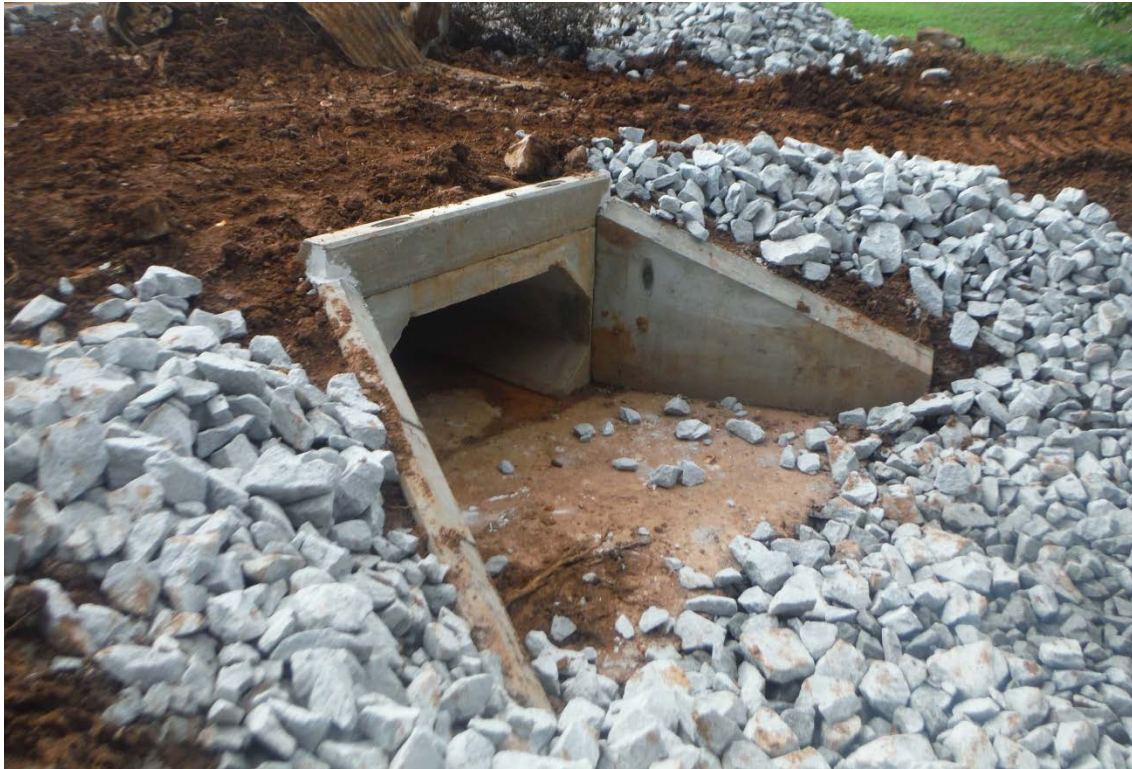
**Photo 1: Installation of new headwall. (06/12/2014)**

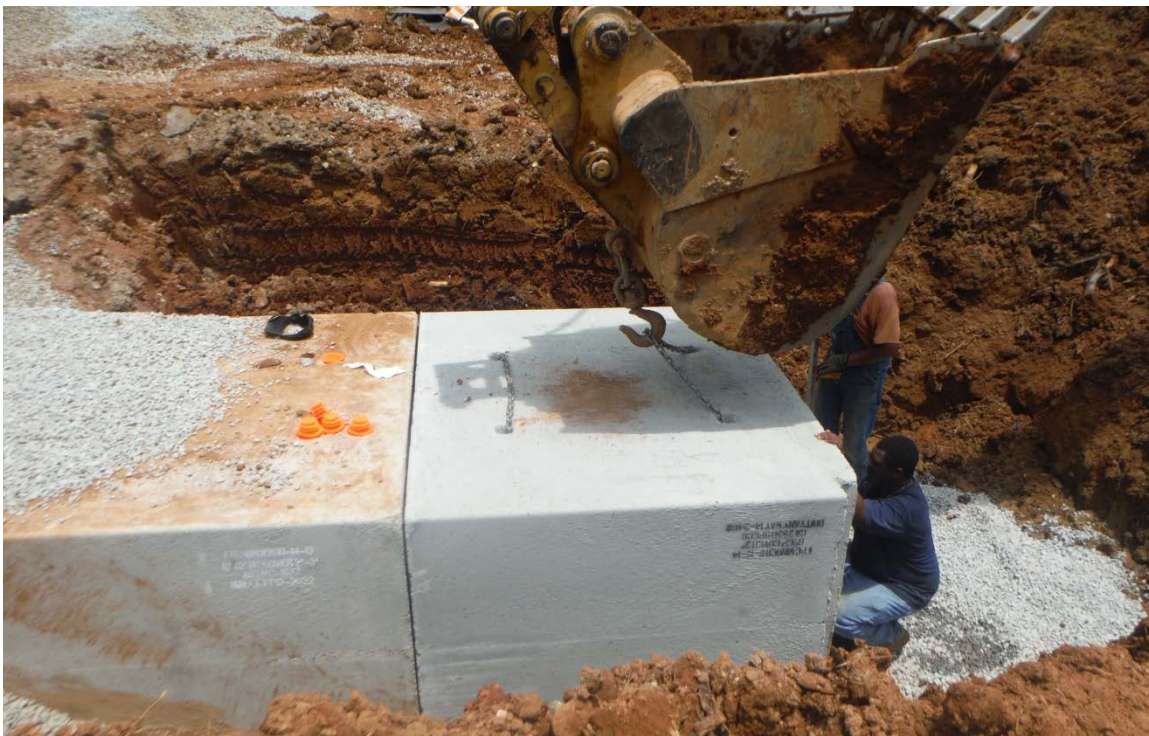
**Photo 2: Installation of new box culvert sections. (06/04/2014)**

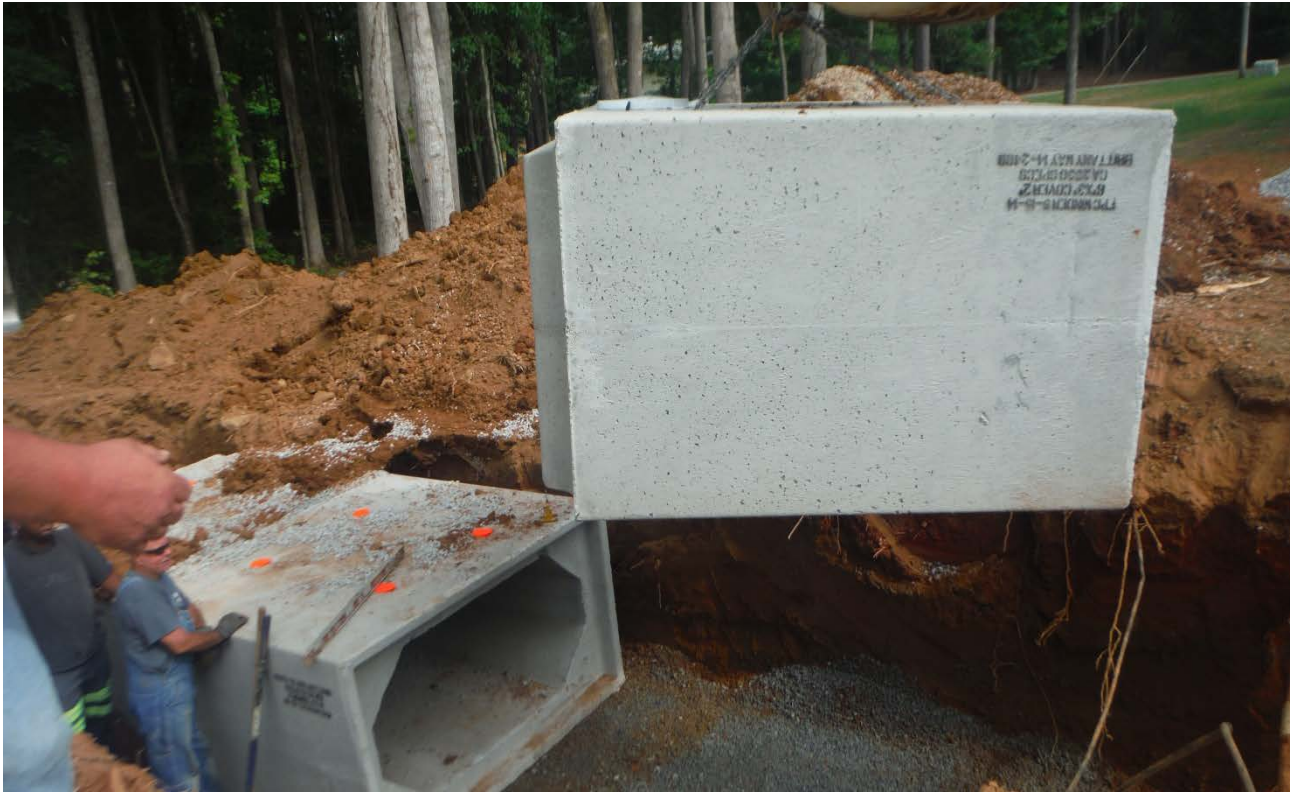
**Photo 1: Installation of new box culvert sections.**

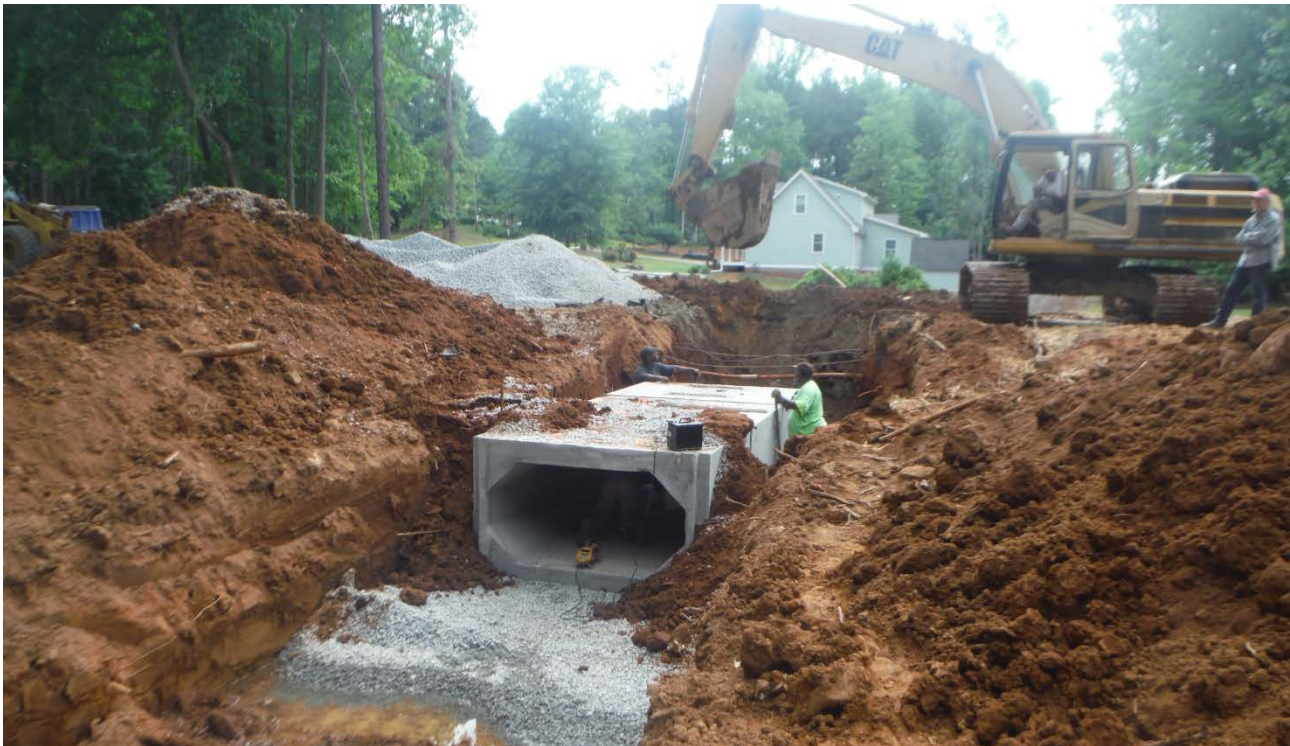
**Photo 2: Installation of new box culvert sections.**

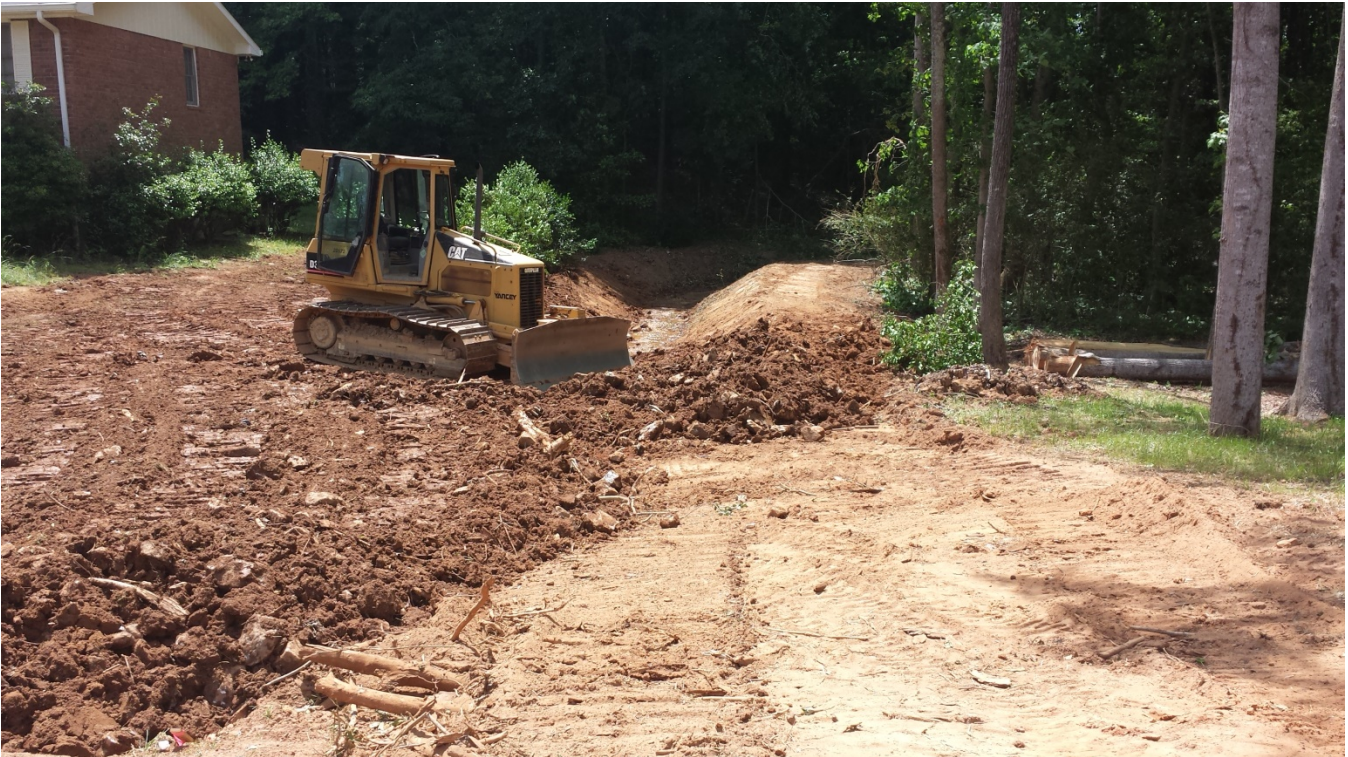
**Photo 1: Clearing and grading continues for stream redirection. (05/29/2014)**

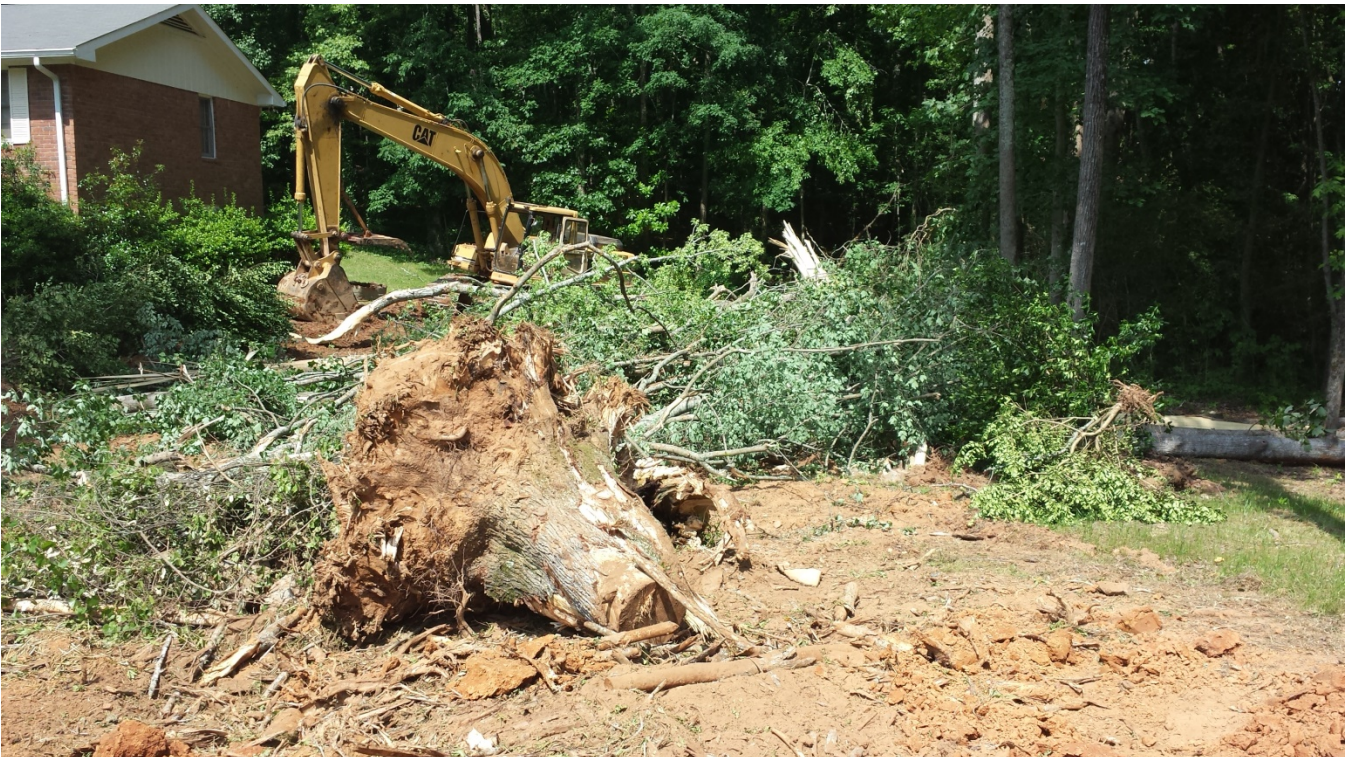
**Photo 2: Clearing underway to provide proper area to redirect the stream for new culvert placement. (05/28/2014)**

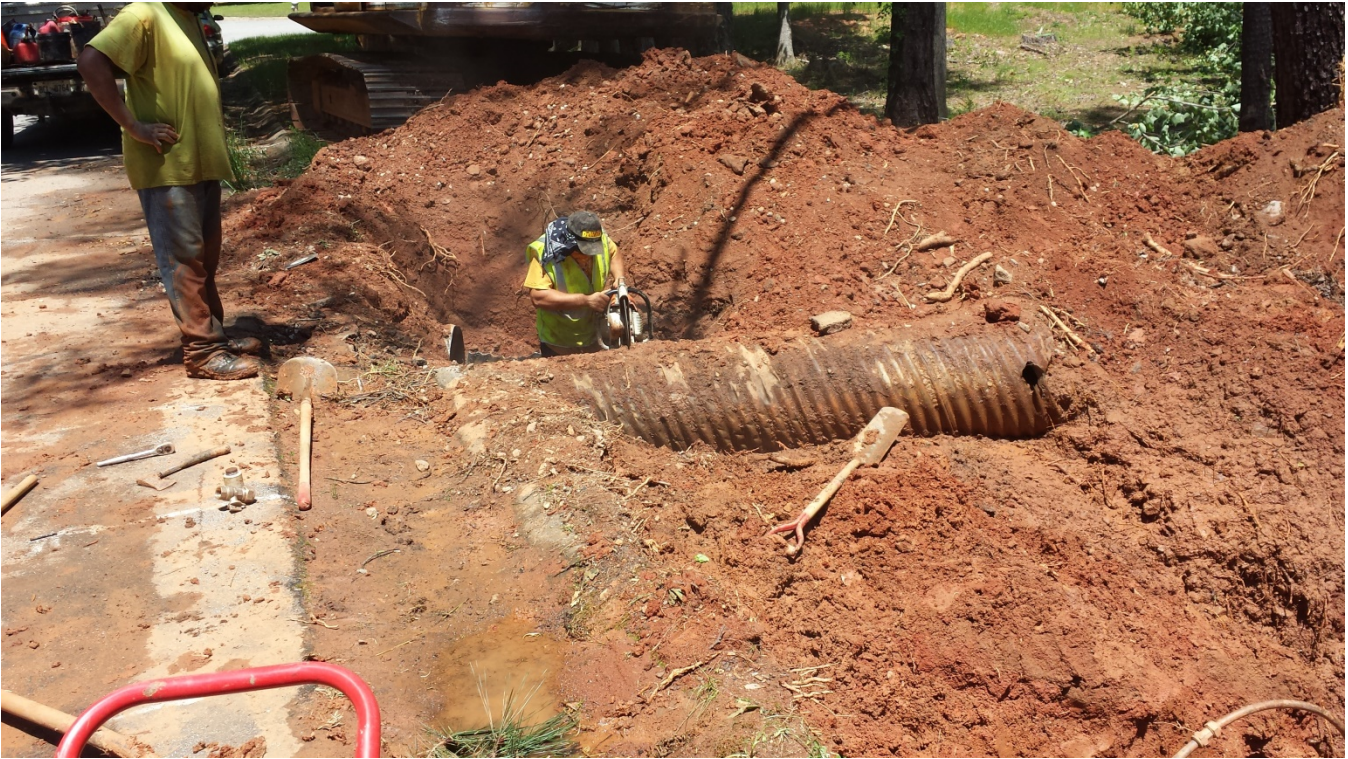
**Photo 1: Construction underway to remove old pipe.**

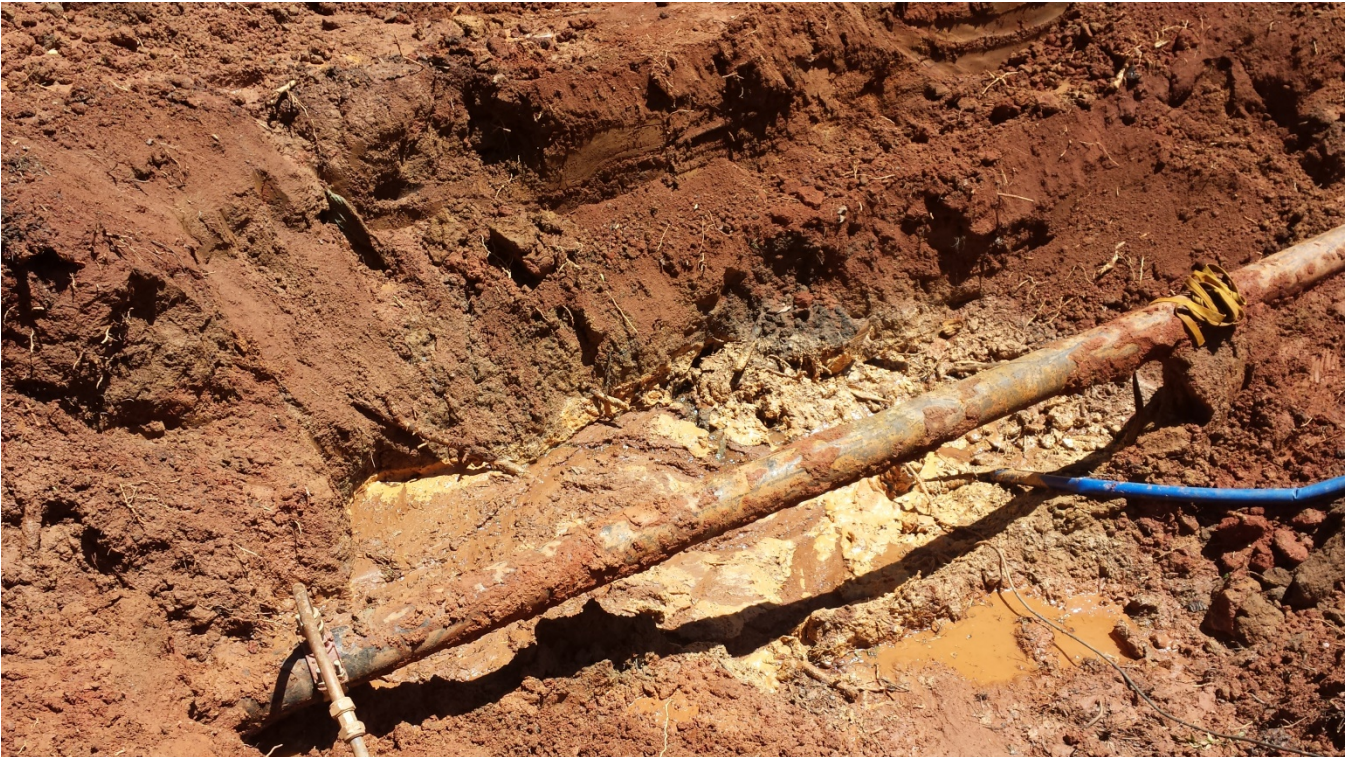
**Photo 2: A water line at the project location exposed and ready for relocation, to allow for installation of new box culvert.**

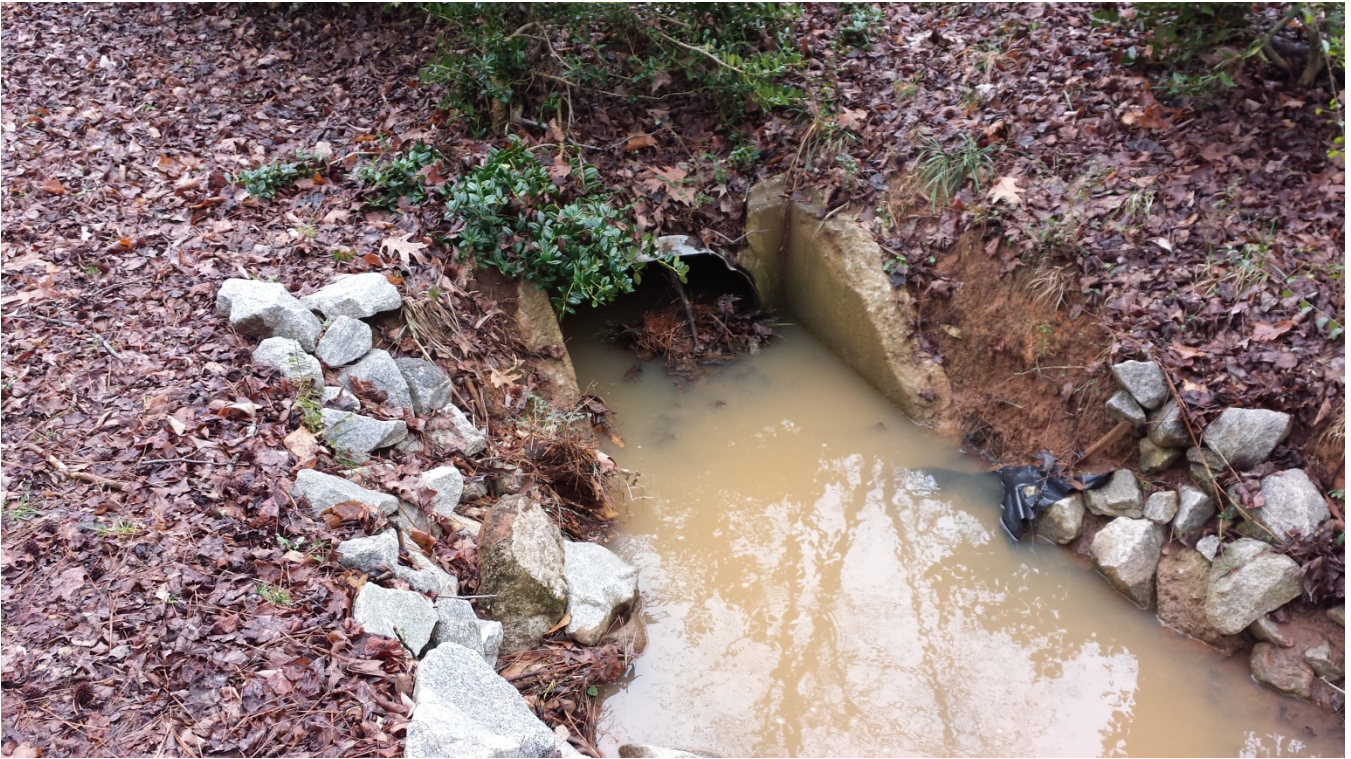
**Photo 1: Pre-existing conditions. (03/07/2014)**

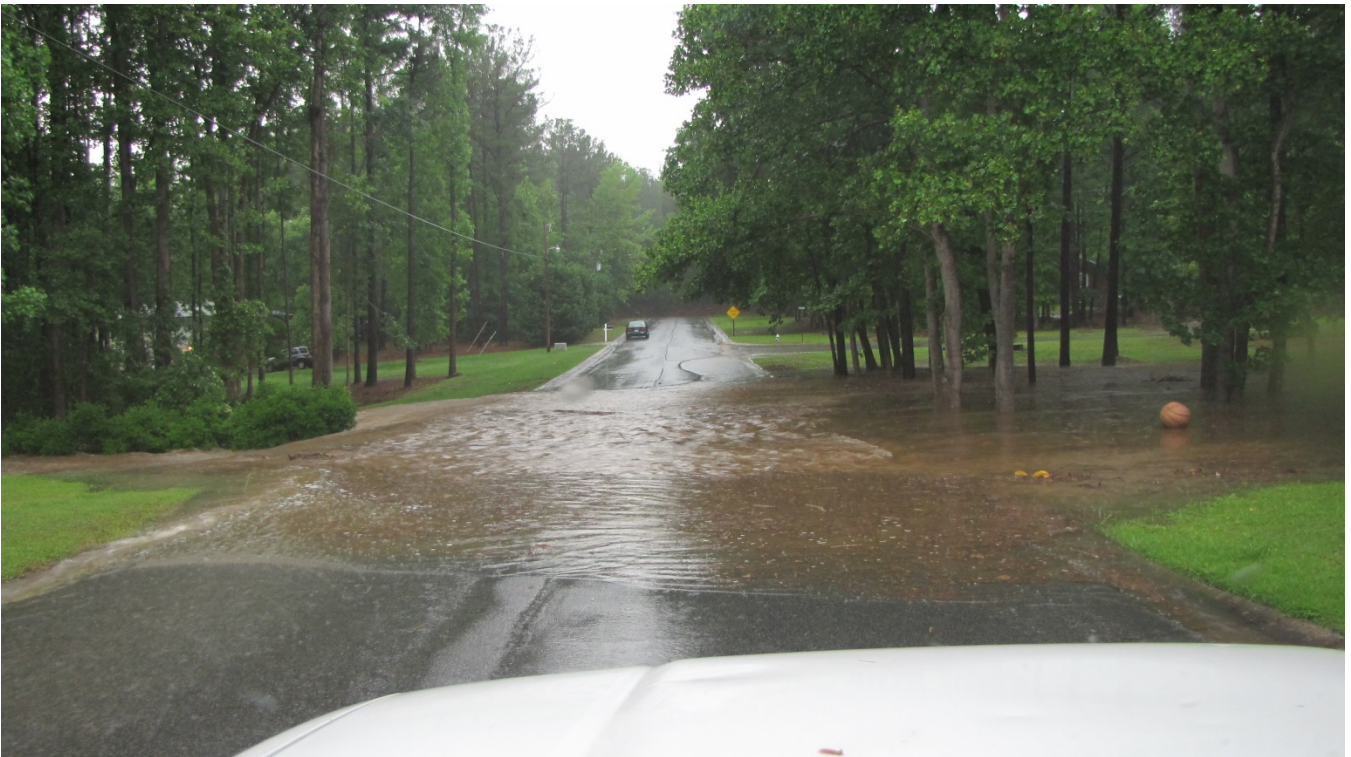
**Photo 2: Severe flooding on Brittany Way. (06/06/2013)**
