**Subject: ITB 2515-B: Roof Repairs - Fayette County Community Health Building
Addendum 1**

AERIAL INFRARED MOISTURE SURVEY
FAYETVILLE COMMUNITY CENTER
245 BOOKER AVENUE
FAYETTEVILLE, GEORGIA 30215

Reference: Fayetteville Community Center IR Scan
Project Number: 1001.209

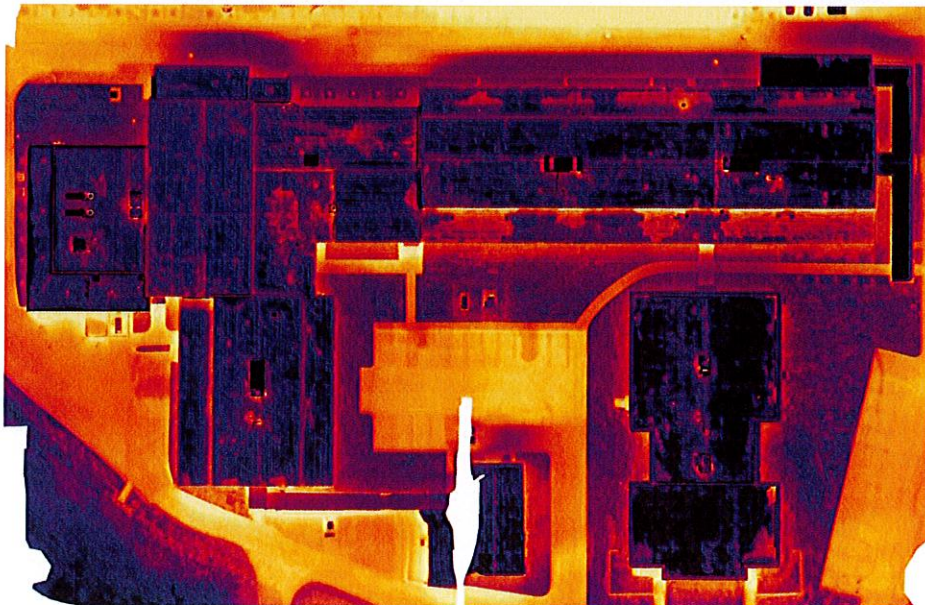
Radiometric Thermal Image, Fayetteville Community Center

Individual thermograms were thermally tuned and examined, suspicious anomalies identified qualitatively. Thermograms having suspicious anomalies were compared with the corresponding color photographs, and false positive signatures such as cast-iron drains, patches and coatings, sediment and stains, fan exhausts, etc. were ruled out. Anomalies which we suspect to be wet insulation were flagged and outlined in the below DroneDeploy roof plan. Areas were calculated and tabulated.

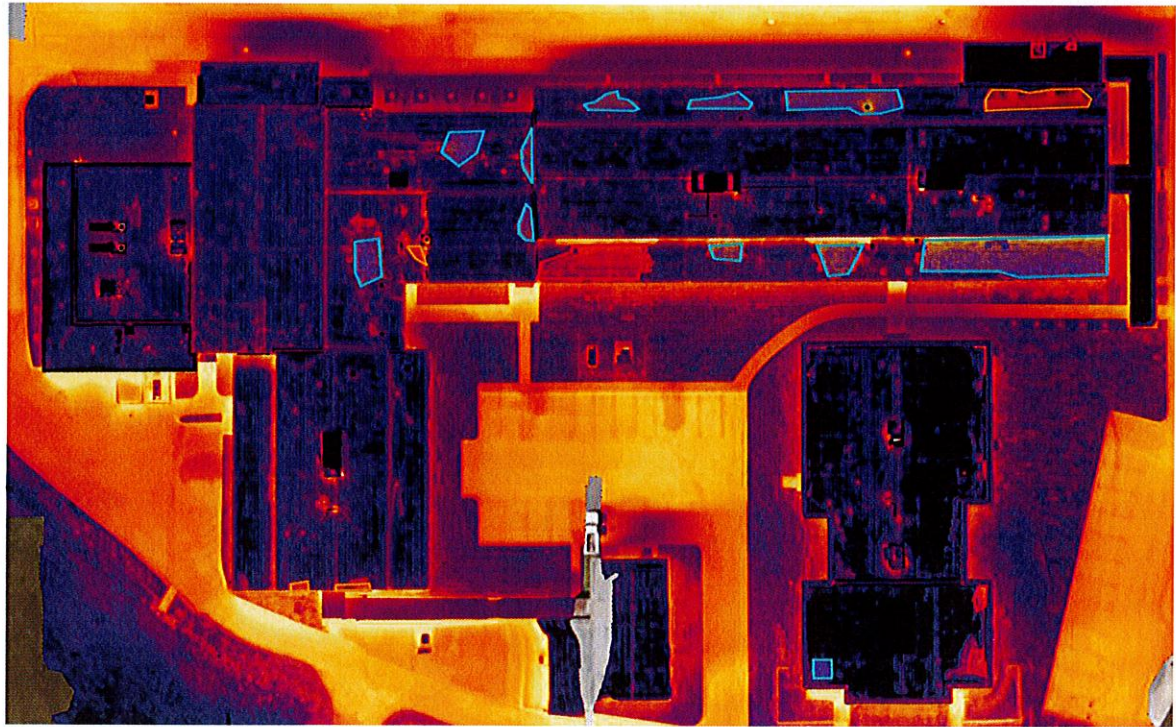
Radiometric Thermal Infrared Image with Anomalies, Fayetteville Community Center

Suspected wet insulation at roof areas was verified through destructive testing, however not all anomalies were available for testing due to ice and moisture present on the roof at the time of the testing.

INFRARED ANOMALIES CHART					
Anomaly	Test #	Roof Area	Confirmation	Square Footage	Wet/ Dry
#01	1	A	77.0	352 SF	Dry
#02	2	A	86.2	426 SF	Wet
#03	3	A	91.1	133 SF	Wet
#04	4	A	89.3	113 SF	Wet
#05	5	C	99.9	1,248 SF	Wet
#06	6	C	99.9	186 SF	Wet
#07	7	C	99.9	83 SF	Wet
#08	8	C	X	571 SF	Unknown
#09	9	D	99.9	75 SF	Wet
#10	10	E	90.7	74 SF	Wet
#11	11	E	89.7	186 SF	Wet
#12	12	E	82.5	33 SF	Dry
#13	13	E	99.2	195 SF	Wet
#14	14	F	72.6	40 SF	Dry
#15	15	F	72.6	28 SF	Dry
#16	16	O	X	42 SF	Unknown
#17	17	O	X	63 SF	Unknown
#18	18	O	91.5	64 SF	Wet
#19	19	P	X	31 SF	Unknown
#20	20	P	X	9 SF	Unknown

Confirmed Wet ■ Confirmed Dry ■
Not Tested ■

Please see attached moisture scan of the building. Allow for replacing 3,500sqft of wet insulation with an approved 4" insulation product. **See Attachment 1.**
