**Subject: Invitation to Bid 27043-B: Lake McIntosh Dam Structural Repairs**

**SCOPE AND SPECIFICATION**  
**ITB 27043-B: Lake McIntosh Dam Structural Repairs**

Fayette County Water System is seeking bids from qualified vendors for structural concrete repairs to the Lake McIntosh Dam spillway structure. The work is based on the Lake McIntosh and Lake Kedron Dam Spillway Walls Structural Assessment prepared by Arcadis U.S., Inc., dated October 27, 2023, and the associated Lake McIntosh Dam Spillway Structure Photograph Log. The work generally includes repair of non-structural and structural cracks, repair of leakage locations, patching of concrete surface deterioration and form-tie locations, and restoration of affected areas.

Structural Evaluation Report – Attachment A Photograph Log  
Lake McIntosh and Lake Kedron Dam Spillway Wall Structural Assessment  
Fayette County Water System (FCWS)

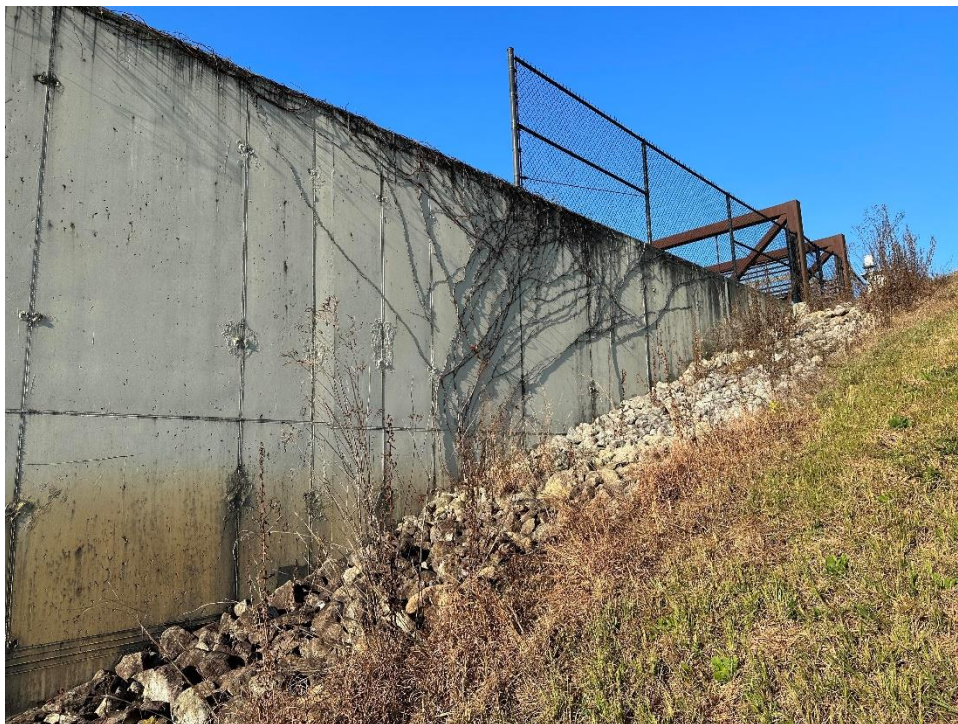
**Photograph: 1**

Vines were observed on both the exterior and interior sides of the north wall close to the pedestrian bridge and drain outlet pipe opening location. See Photographs 1 to 3 for reference. These vines have grown significantly on the exterior side. Vines generally grow on concrete surfaces and work their way

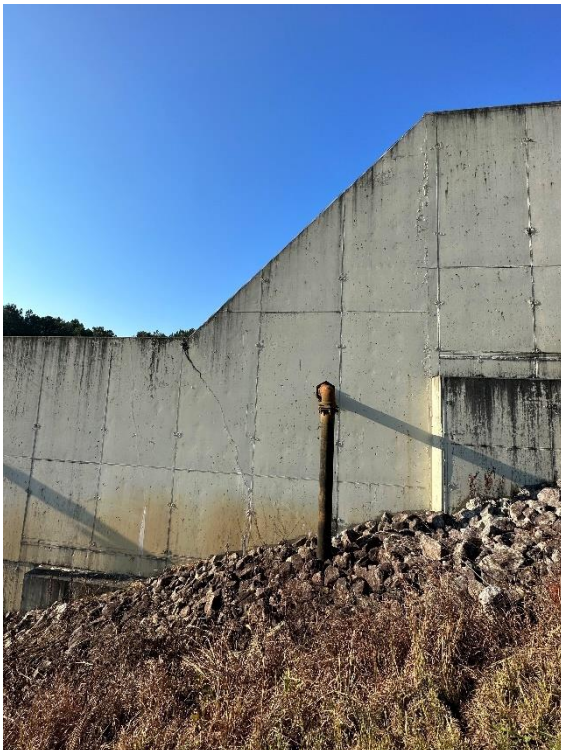
**Photograph: 4**

Crack on the north wall  
exterior face

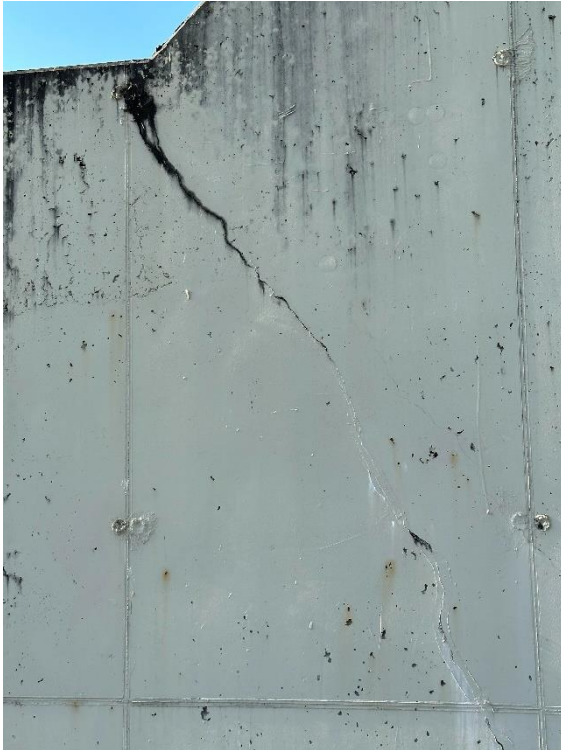
**Photograph: 5**

Crack on the north wall  
exterior face

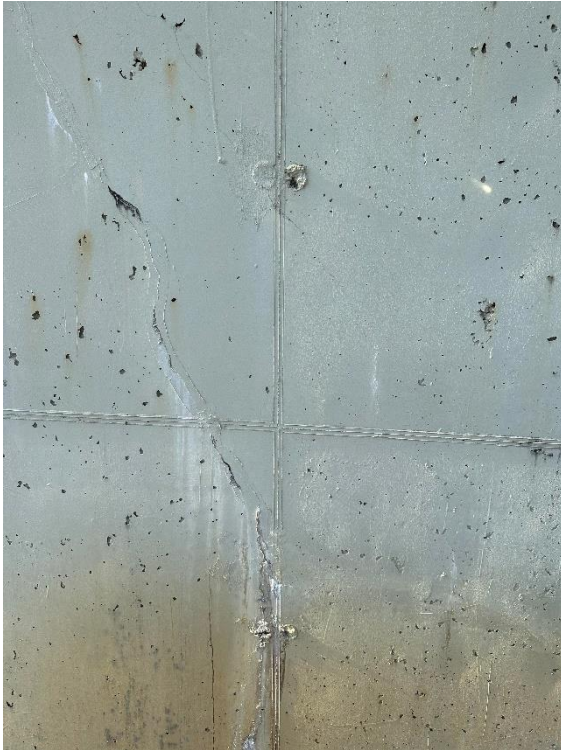
**Photograph: 7**

Crack on the north wall  
exterior face

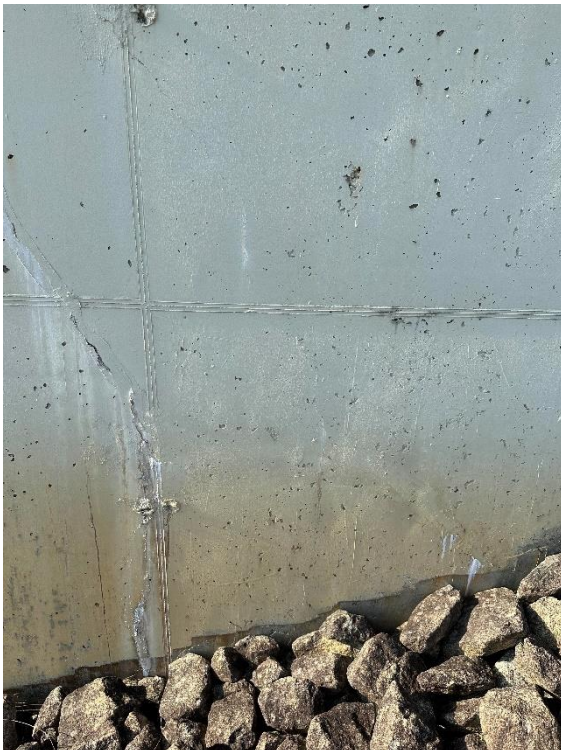
**Photograph: 8**

Crack on the north wall  
exterior face

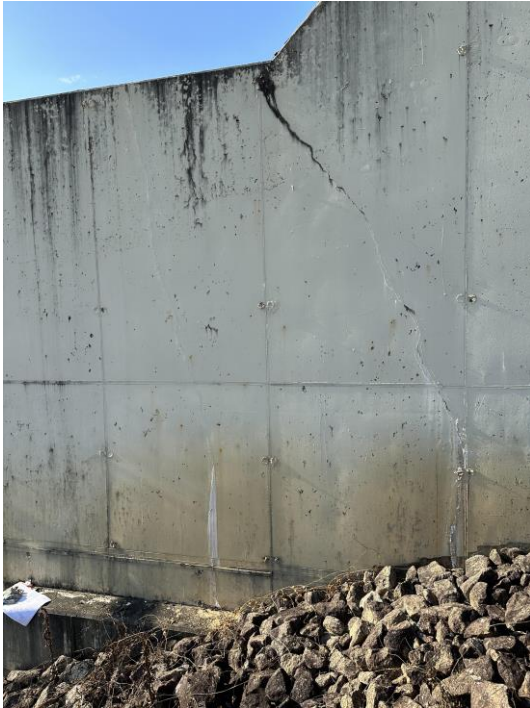
**Photograph: 9**

Crack on the north wall  
exterior face

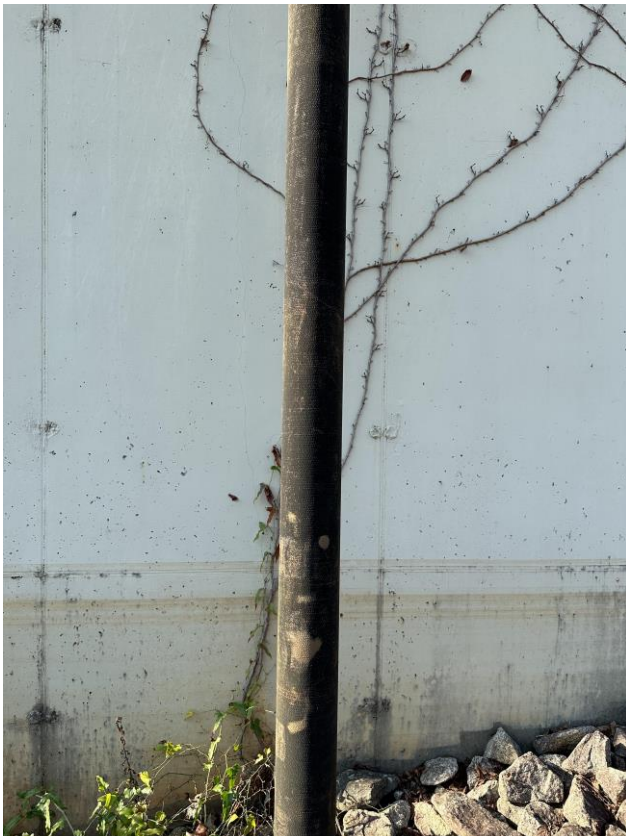
**Photograph: 10**

Crack on the north wall  
exterior face

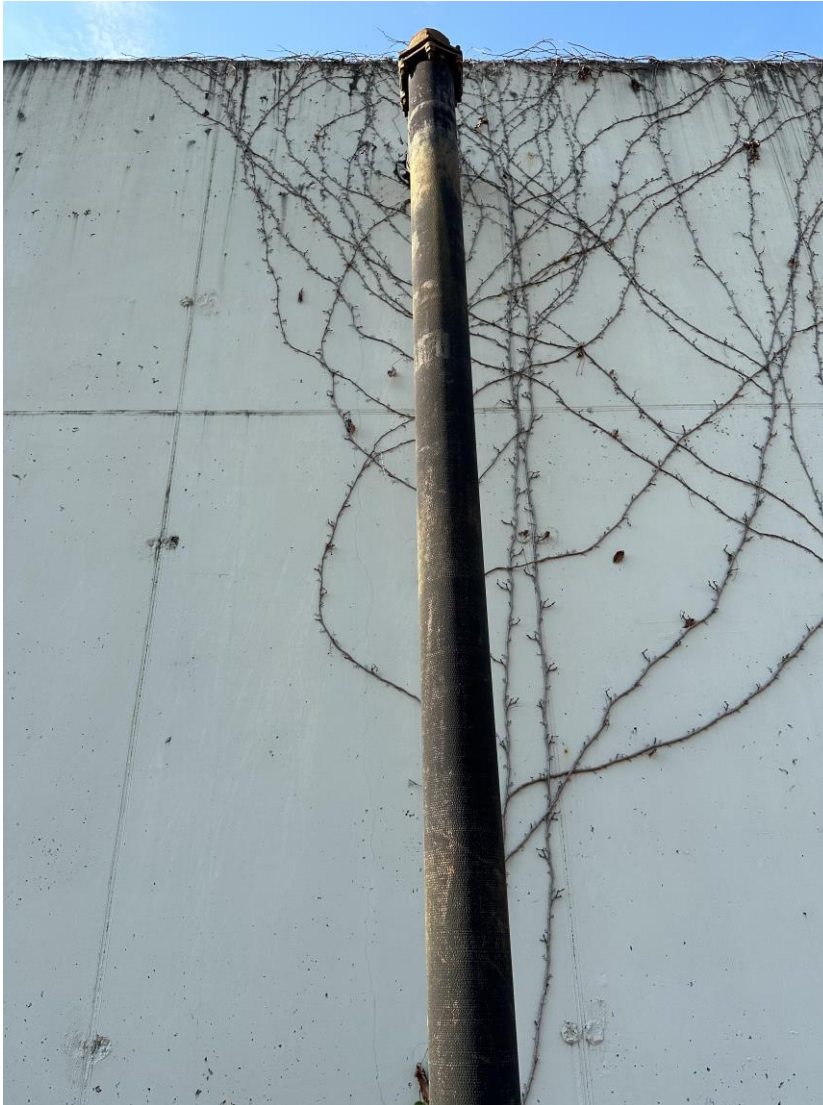
**Photograph: 11**

Crack on the north wall  
exterior face

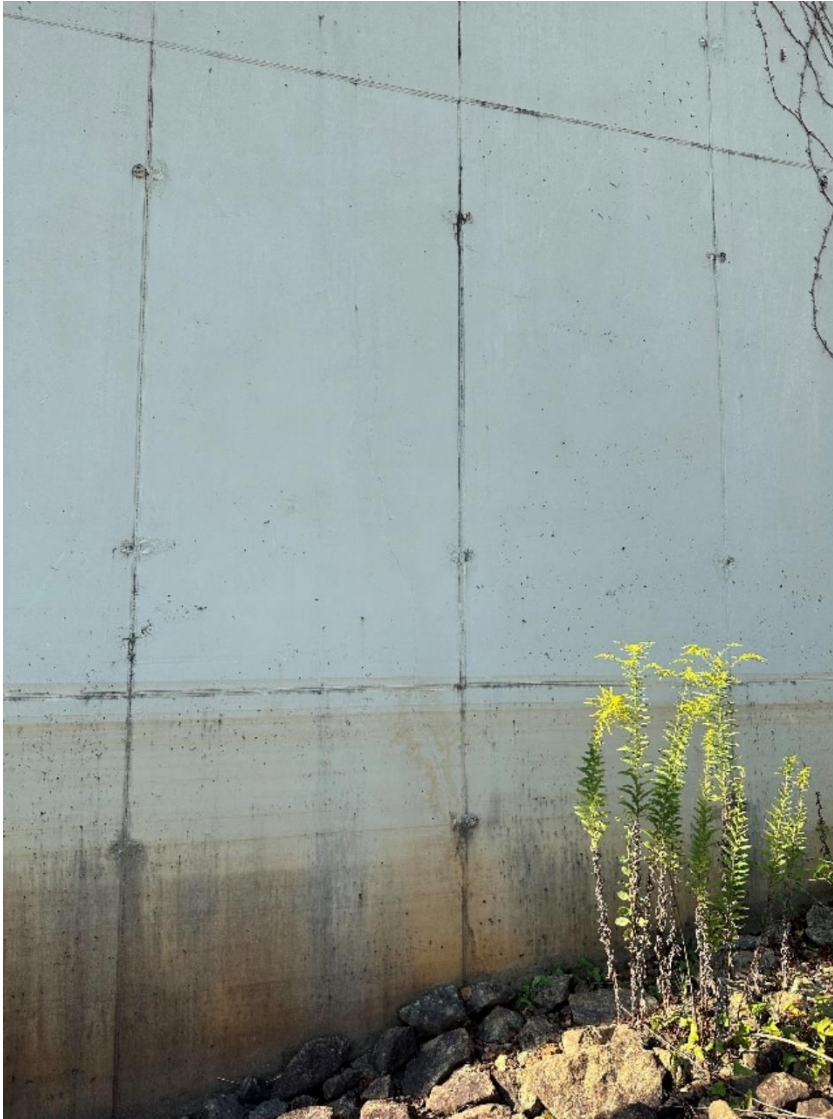
**Photograph: 12**

Crack on the north wall  
exterior face

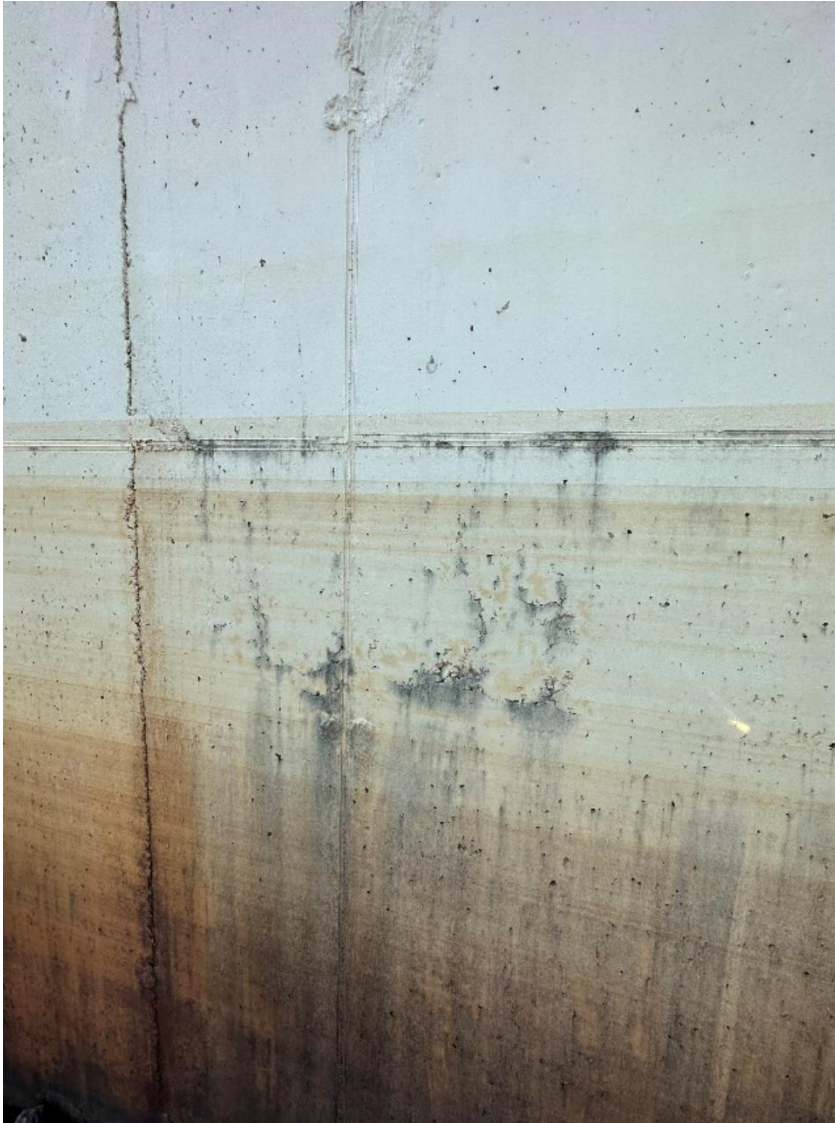
**Photograph: 13**

Crack on the north wall  
exterior face

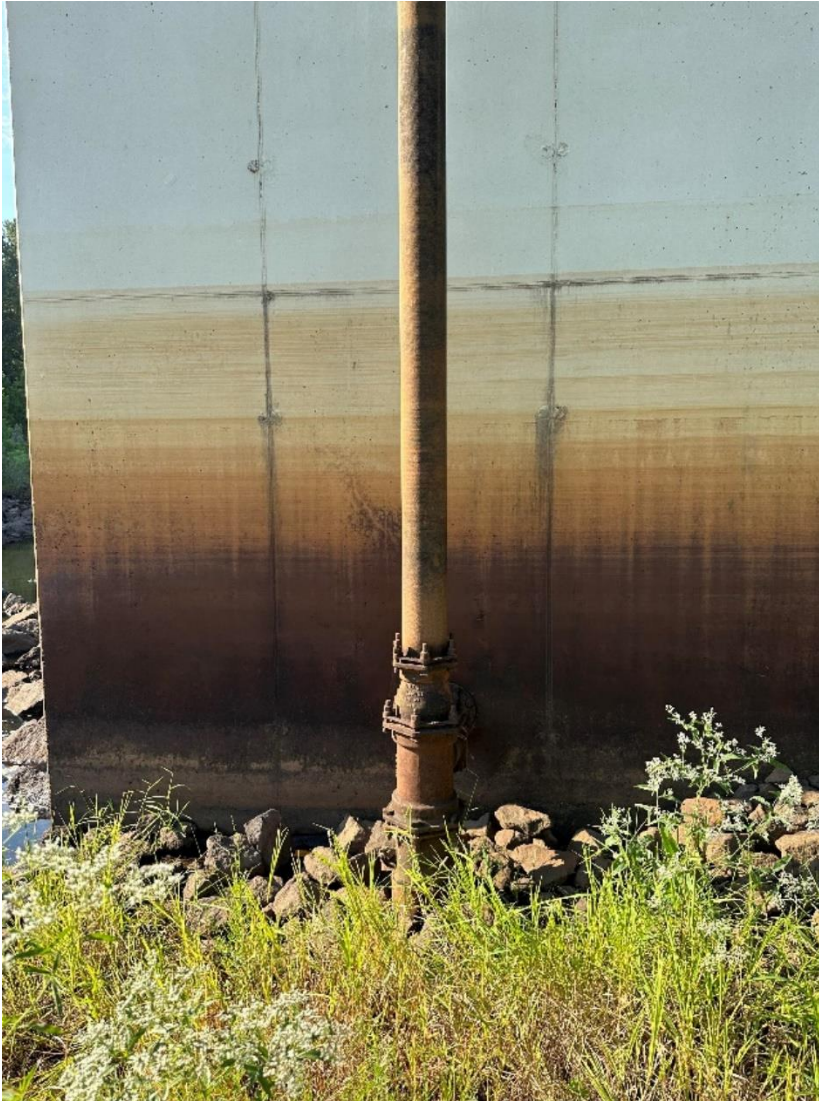
**Photograph: 14**

Minor vertical and diagonal cracks were commonly observed around several pipe and drain outlet openings. These cracks are cosmetic in nature and do not pose any significant structural damage or concerns. See Photographs 14, 15, and 60. However, as mentioned earlier, for crack widths greater than 0.01 inches, refer to the non-structural crack repair method discussed in section 4.1.

Crack on the north wall  
exterior face

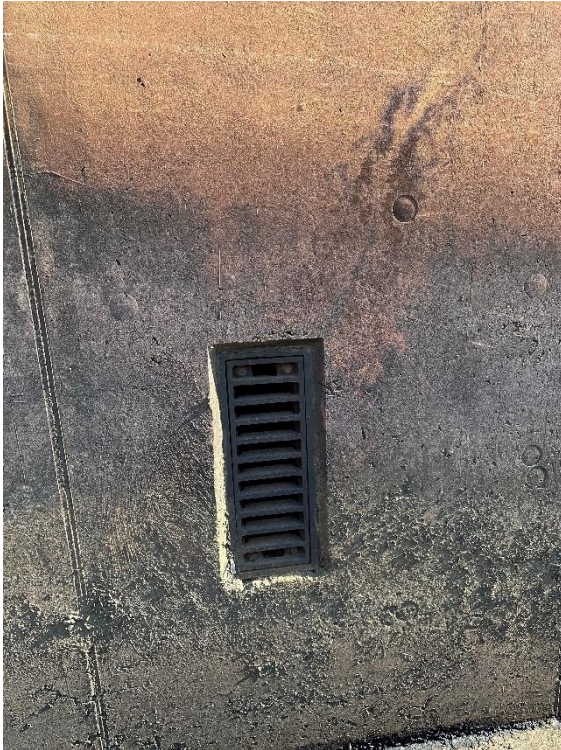
**Photograph: 15**

Crack on the north wall  
interior face

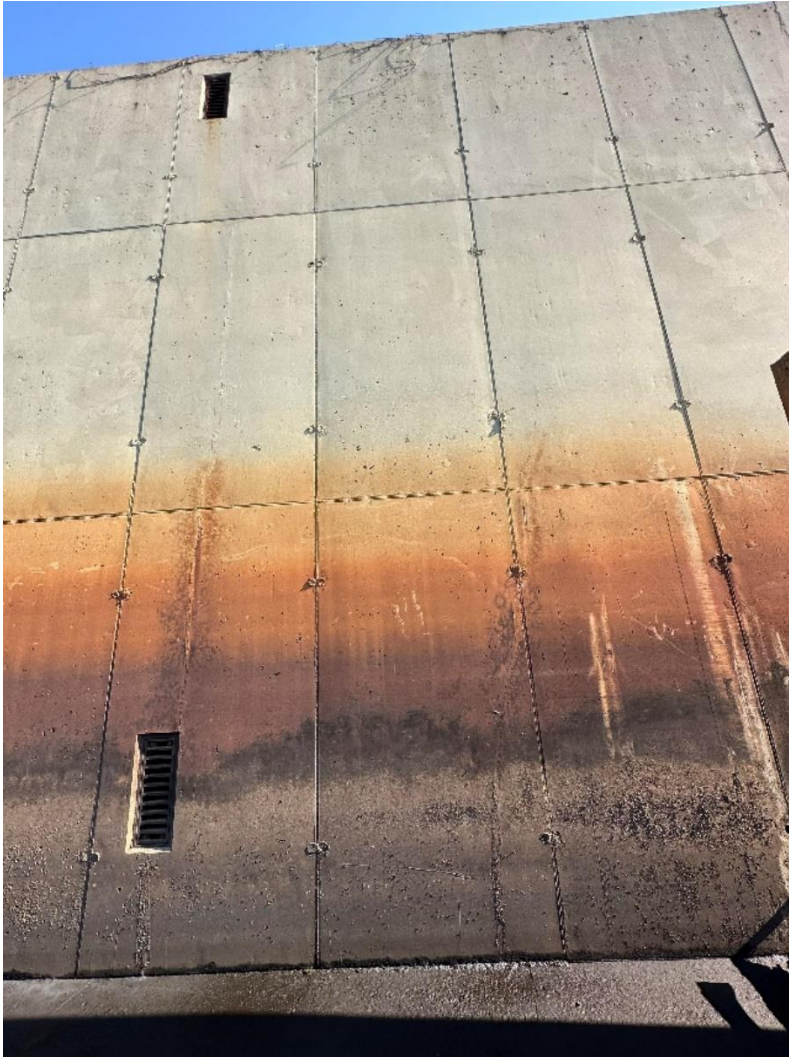
**Photograph: 16**

During the assessment, multiple vertical and diagonal cracks were observed on the North and South spillway walls. These cracks exhibited variations in their width, length, and depth. Some cracks were observed on both sides of the walls, extending through the entire thickness of the concrete. However, certain cracks appeared on one face of the wall and did not appear on the opposite face. It was observed that some cracks had been patched from the interior side and at some locations these cracks showed signs of efflorescence including those that appear to have self-healed over time. Refer to Photographs 16 to 18.

Cracks appeared to be healed on the north wall interior face

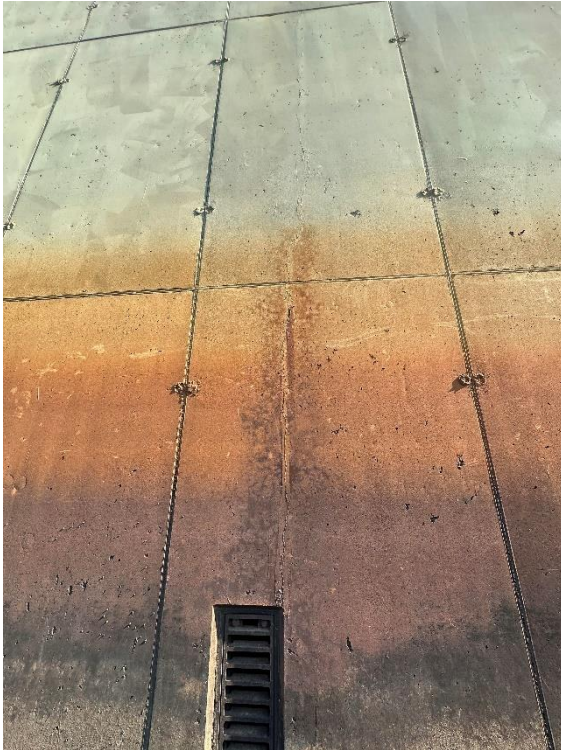
**Photograph: 17**

Crack appeared to be healed on the north wall interior face

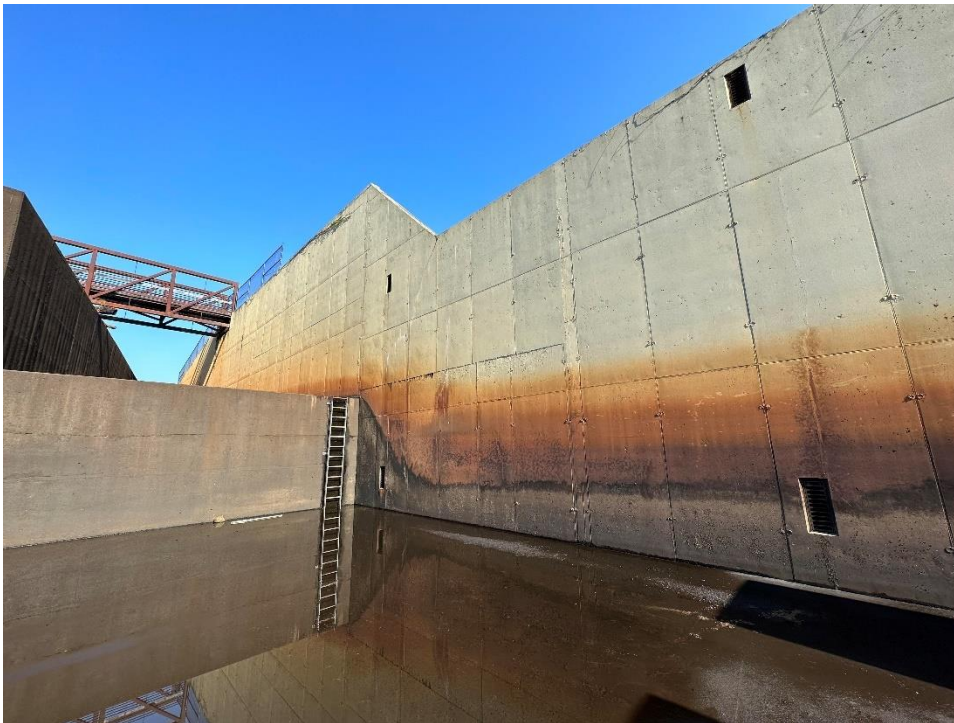
**Photograph: 18**

Crack on the north wall interior face

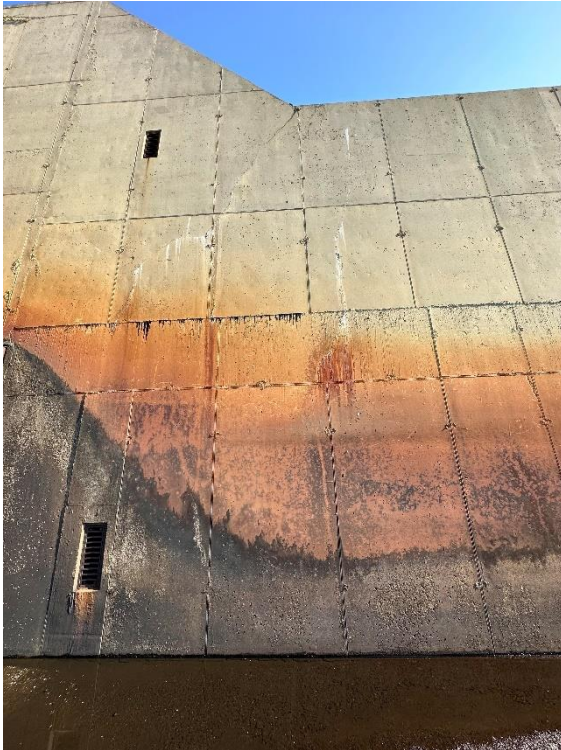
**Photograph: 19**

Crack on the north wall  
interior face

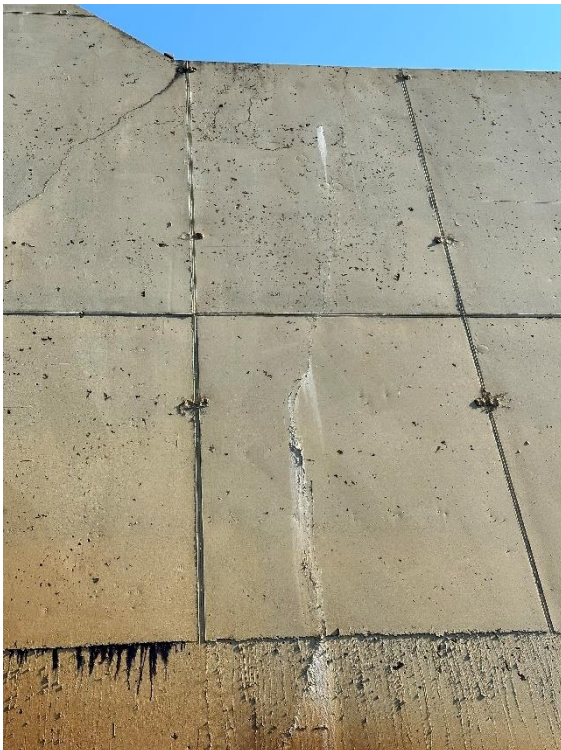
**Photograph: 20**

Crack on the north wall  
interior face

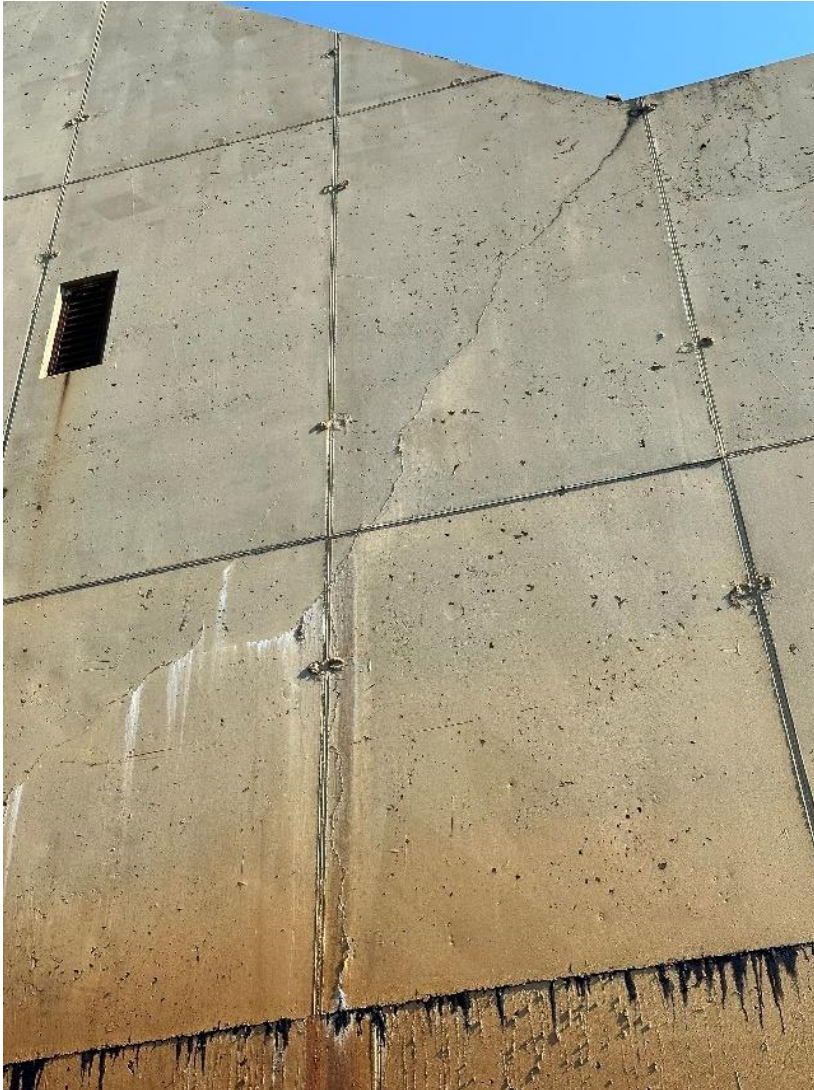
**Photograph: 21**

Crack on the north wall  
interior face

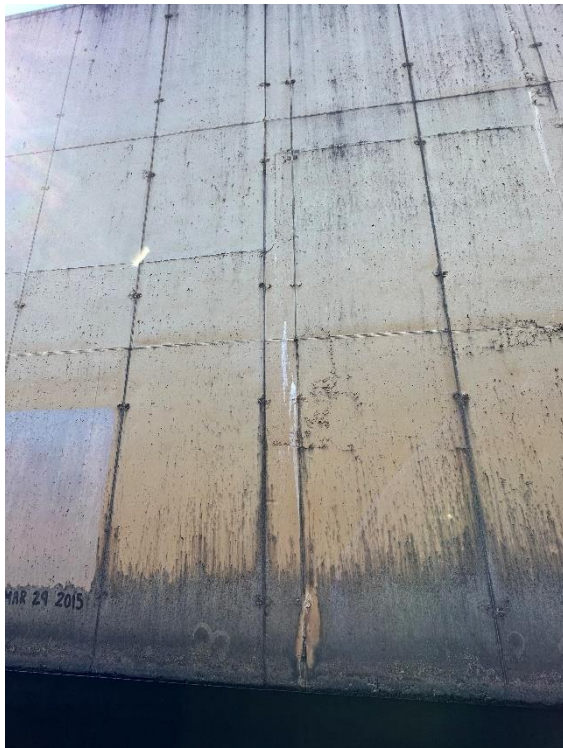
**Photograph: 38**

Crack on the south wall interior face with signs of efflorescence

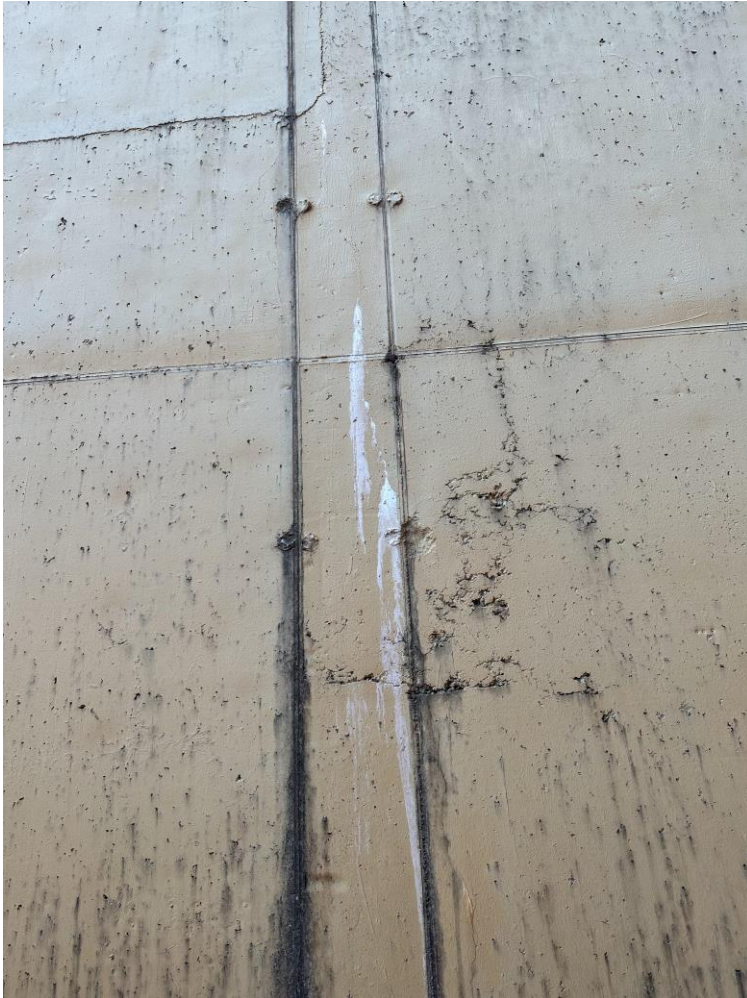
**Photograph: 39**

Crack on the south wall  
interior face with signs  
of efflorescence

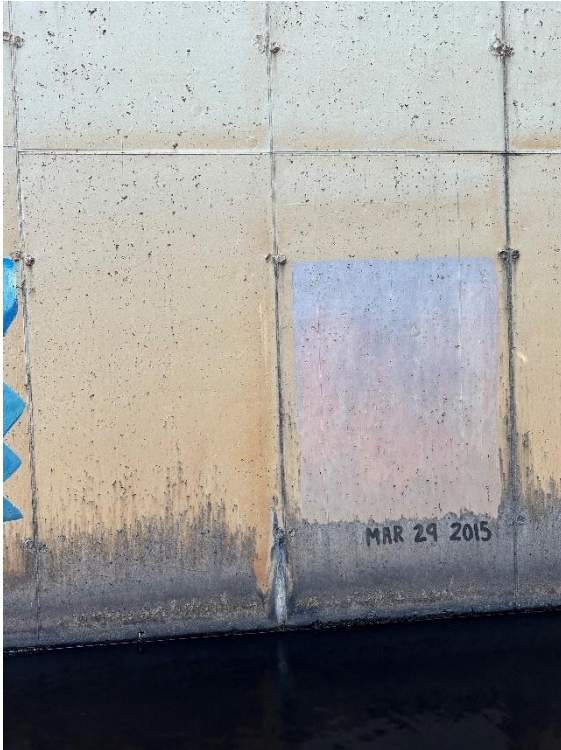
**Photograph: 40**

Crack on the south wall  
interior face with signs  
of efflorescence

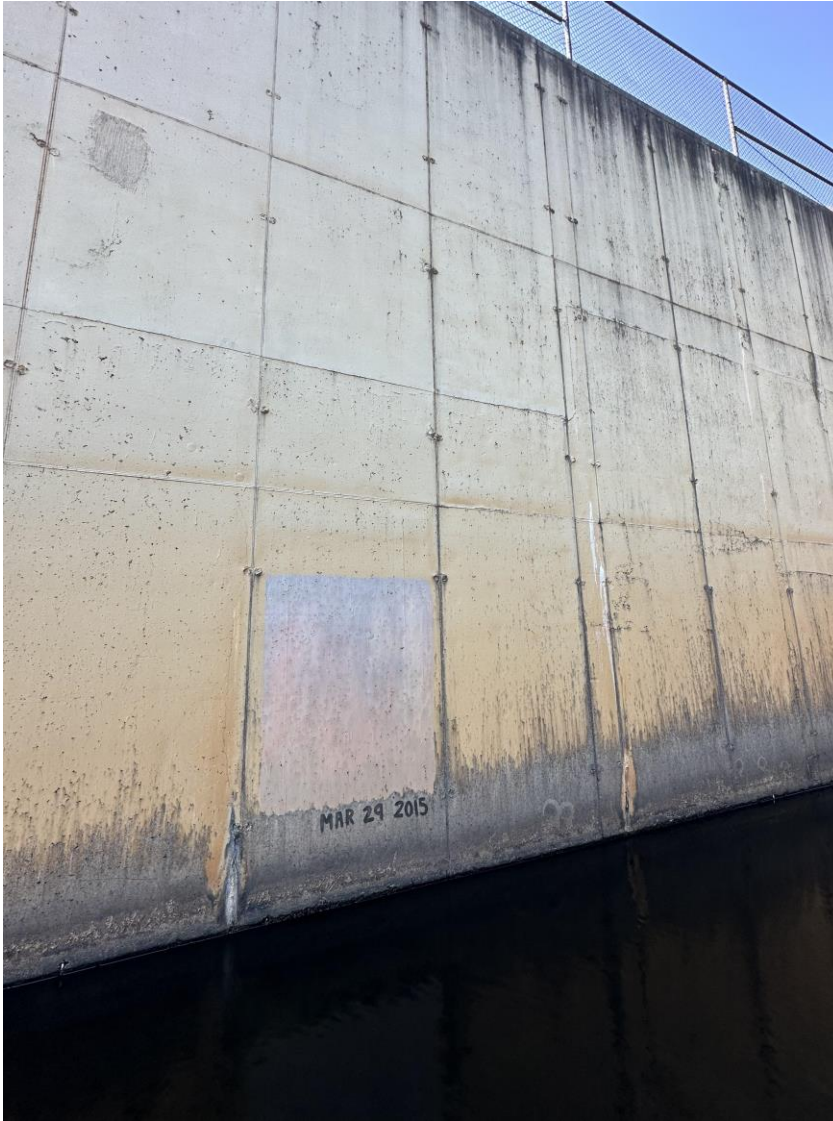
**Photograph: 41**

Crack on the south wall  
interior face with signs  
of efflorescence

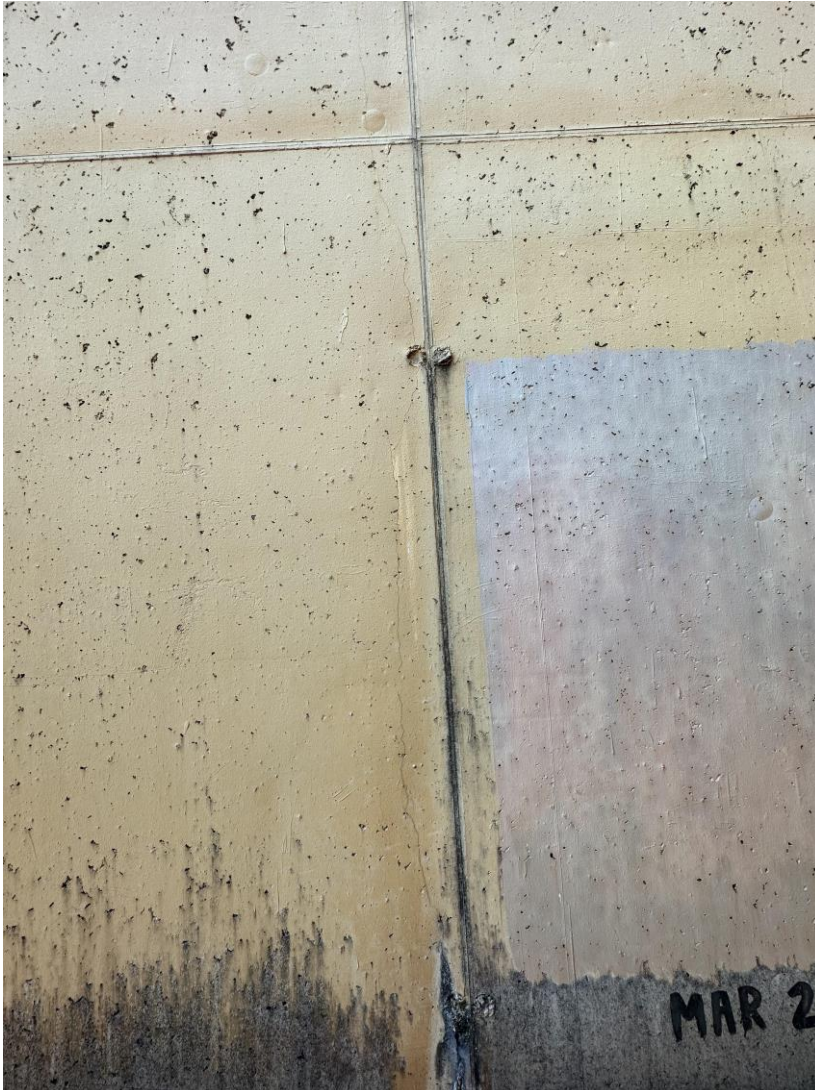
**Photograph: 42**

Crack on the south wall  
interior face with signs  
of efflorescence

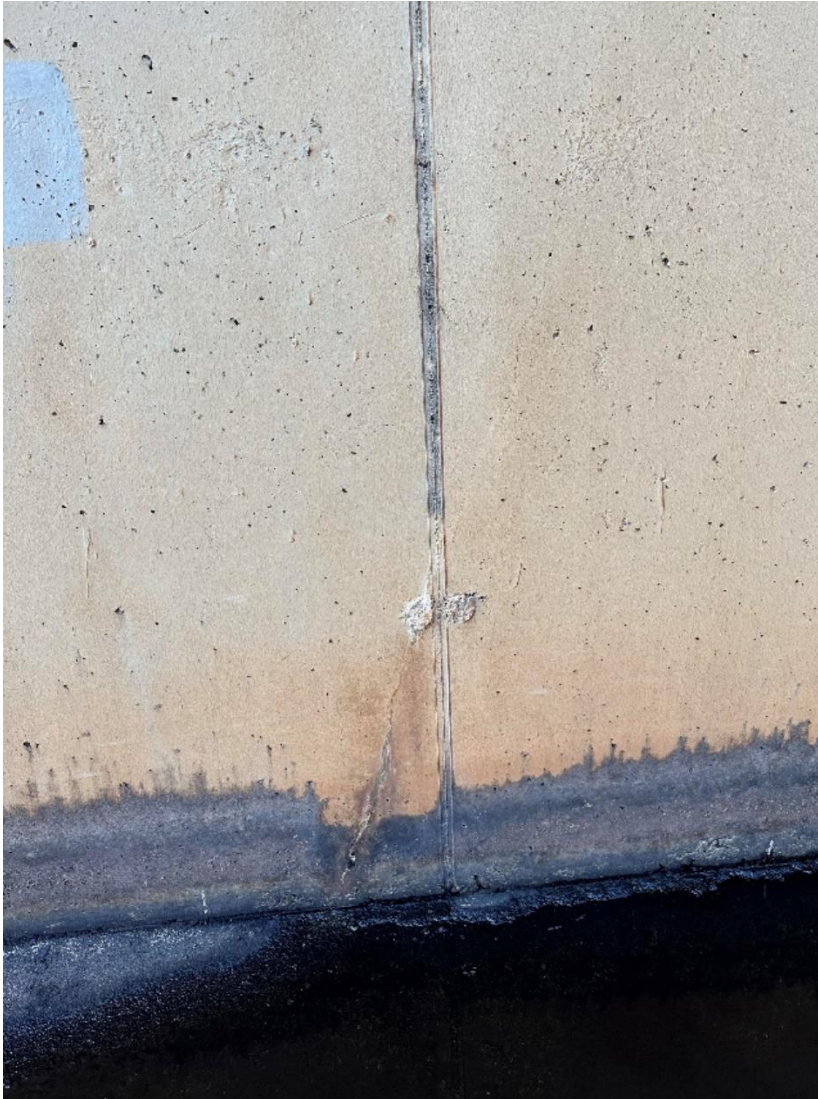
**Photograph: 43**

Crack on the south wall  
interior face with signs  
of efflorescence

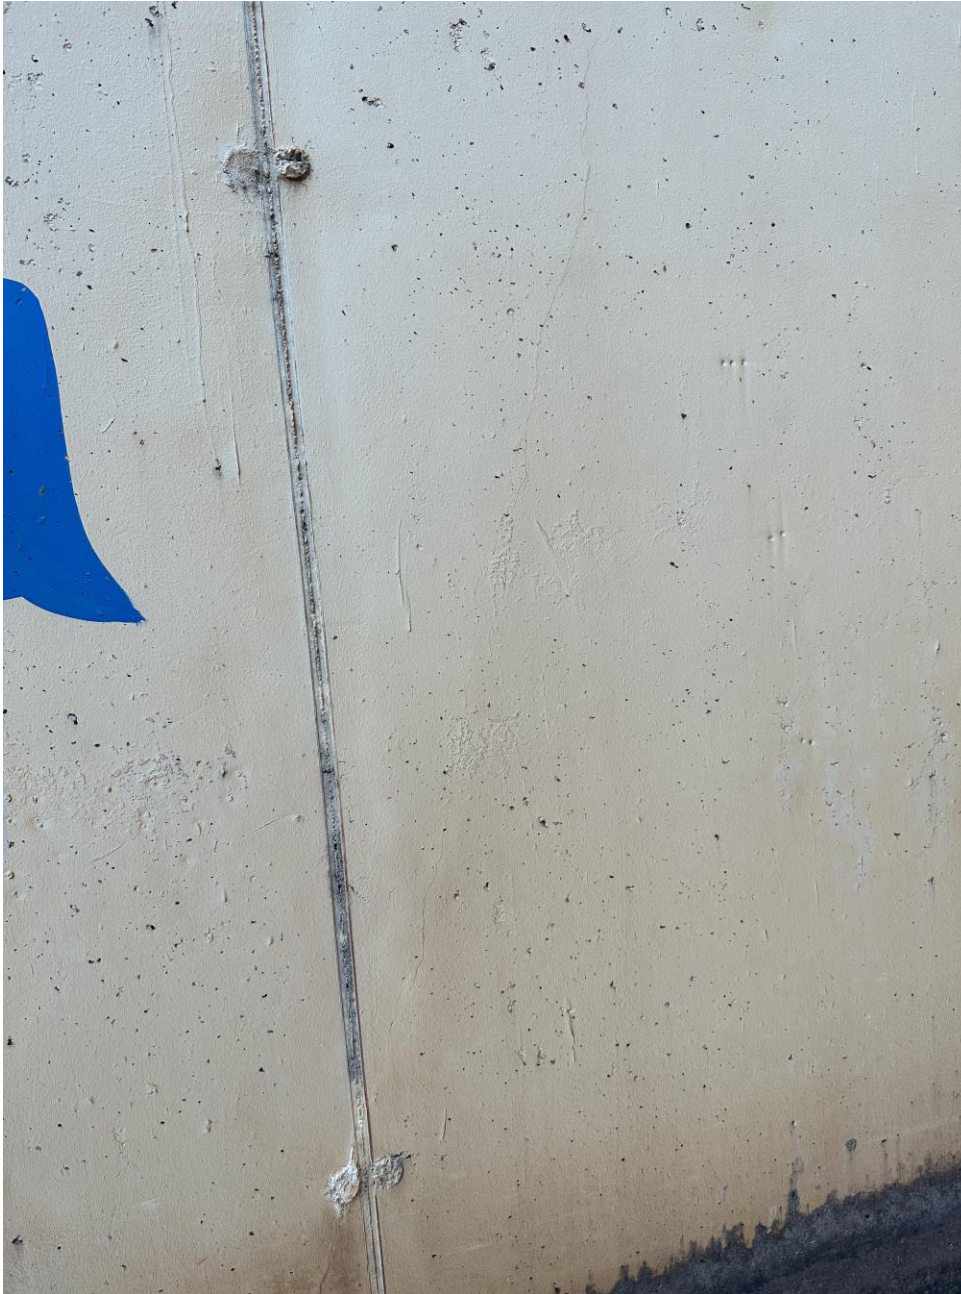
**Photograph: 44**

Crack on the south wall  
interior face with signs  
of efflorescence

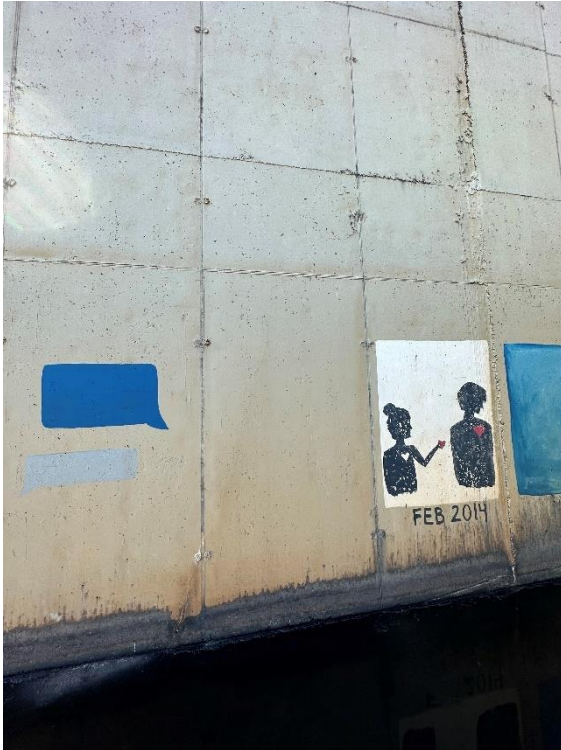
**Photograph: 45**

Crack on the south wall interior face with signs of efflorescence

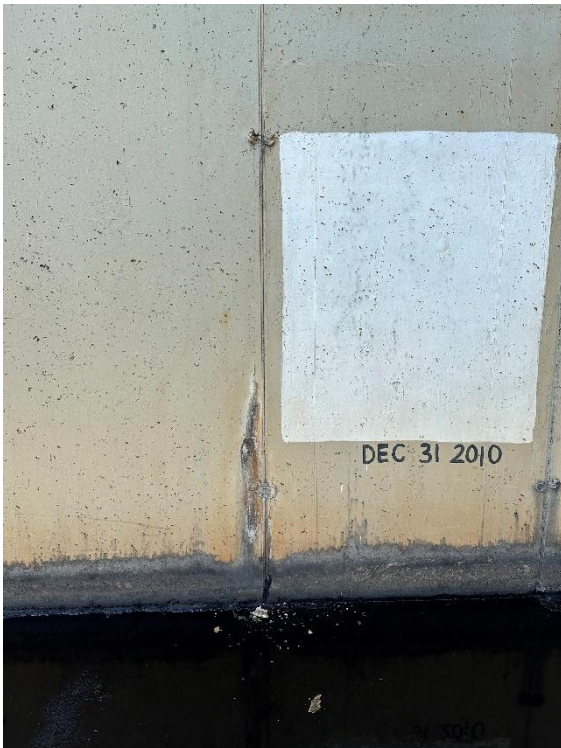
**Photograph: 46**

Crack on the south wall interior face with signs of efflorescence

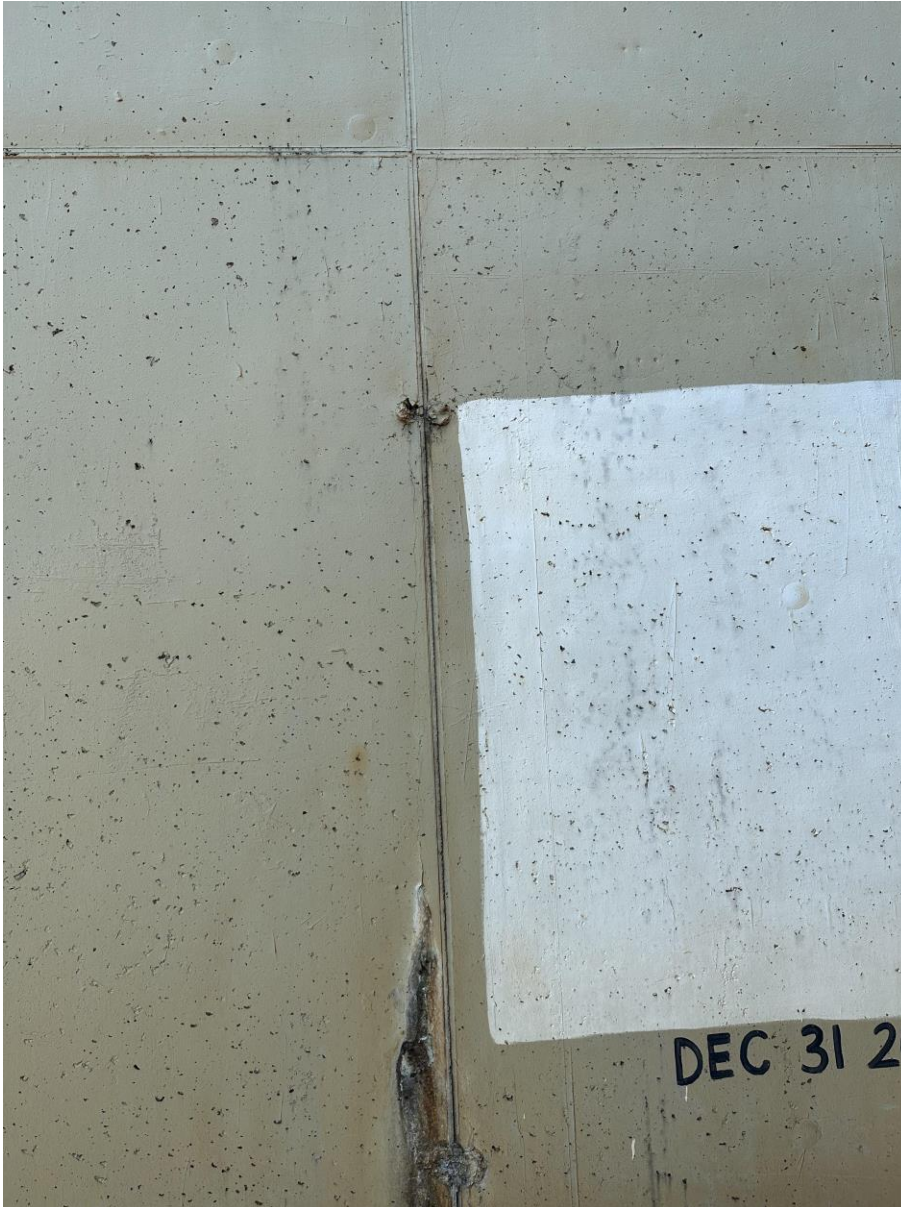
**Photograph: 47**

Crack on the south wall  
interior face with signs  
of efflorescence

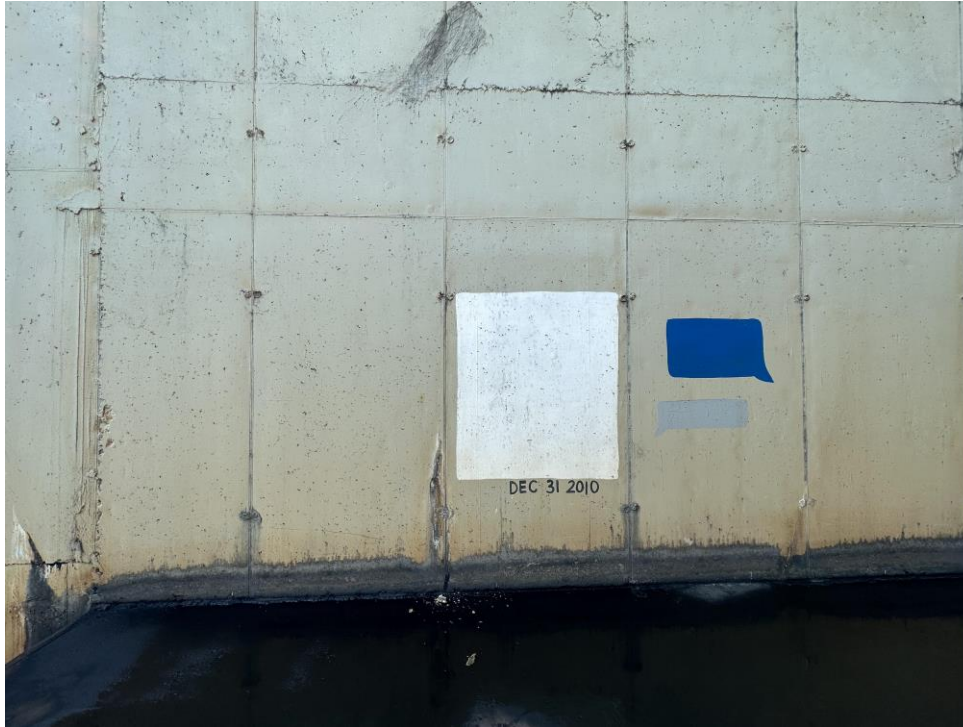
**Photograph: 48**

Crack on the south wall interior face with signs of efflorescence

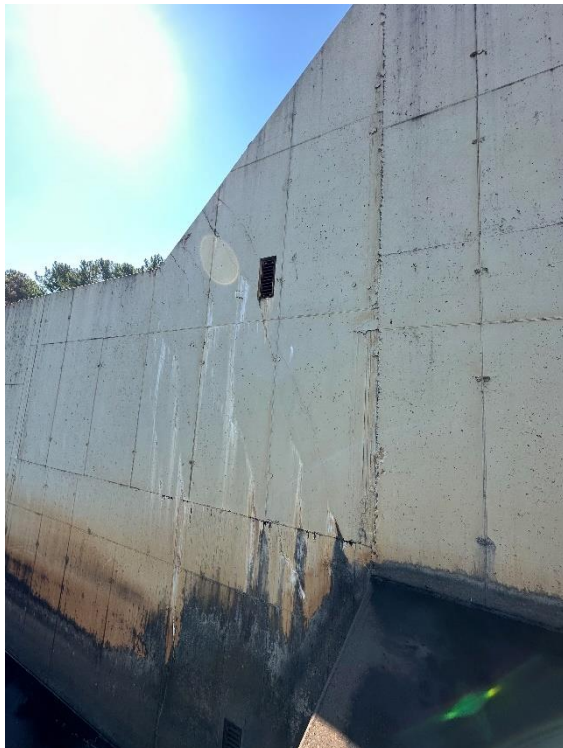
**Photograph: 49**

Cracks on the south wall interior face with signs of efflorescence

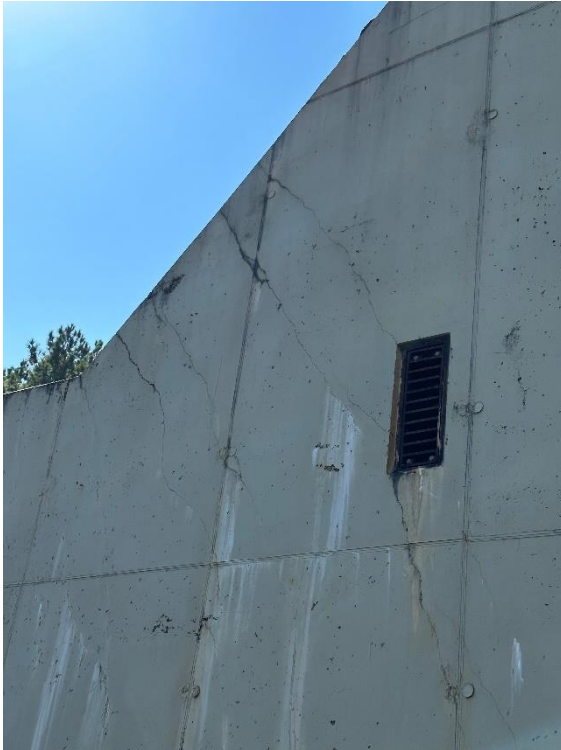
**Photograph: 50**

Cracks on the south wall interior face with signs of efflorescence

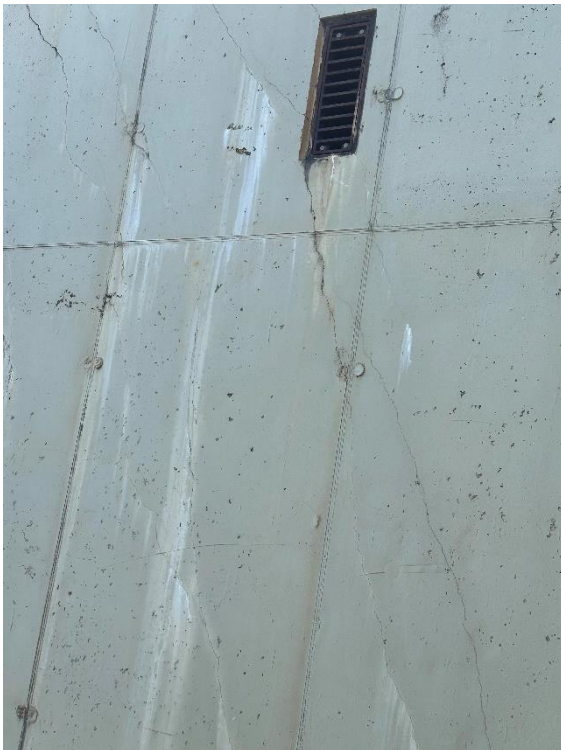
**Photograph: 51**

Cracks on the south wall interior face with signs of efflorescence

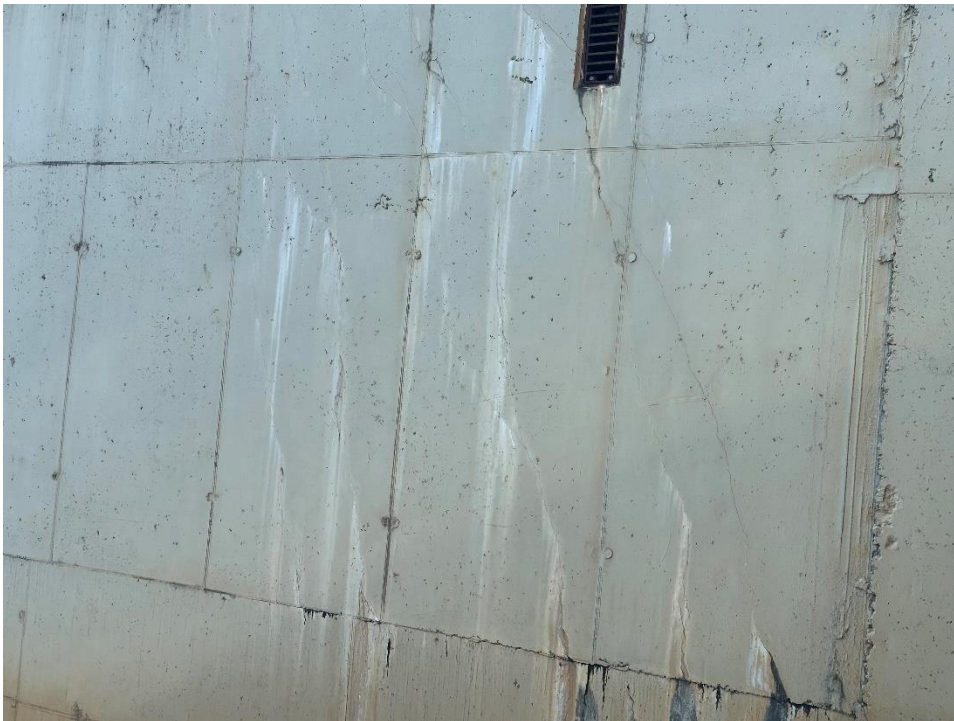
**Photograph: 53**

Cracks on the south wall interior face with signs of efflorescence

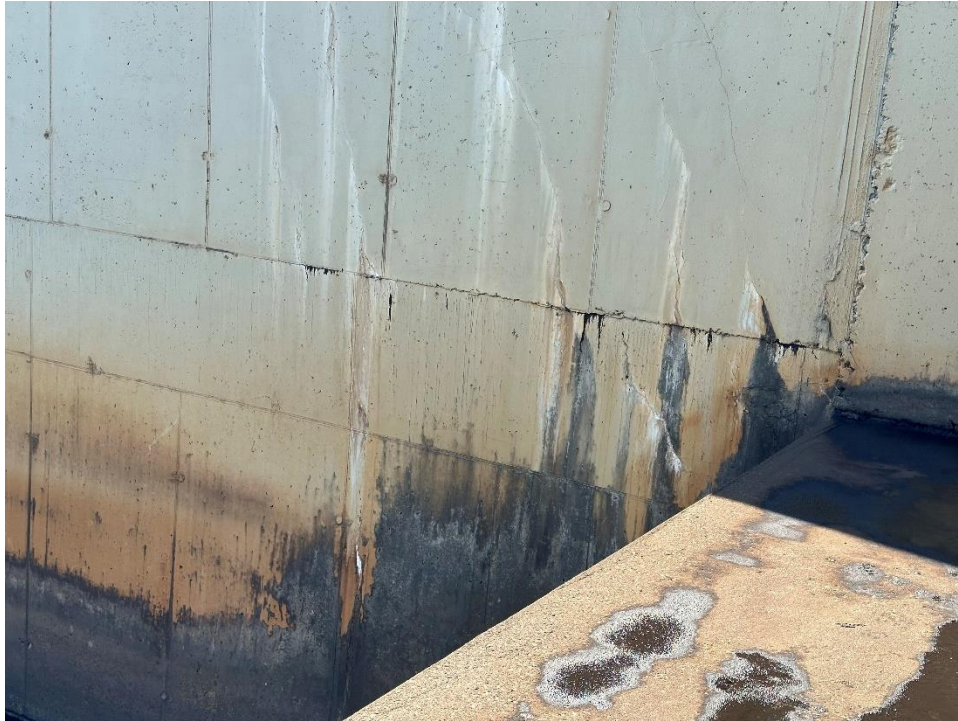
**Photograph: 54**

Cracks on the south wall interior face with signs of efflorescence
