**Subject: Invitation to Bid 27043-B: Lake McIntosh Dam Structural Repairs**

**SCOPE AND SPECIFICATION**  
**ITB 27043-B: Lake McIntosh Dam Structural Repairs**

Fayette County Water System is seeking bids from qualified vendors for structural concrete repairs to the Lake McIntosh Dam spillway structure. The work is based on the Lake McIntosh and Lake Kedron Dam Spillway Walls Structural Assessment prepared by Arcadis U.S., Inc., dated October 27, 2023, and the associated Lake McIntosh Dam Spillway Structure Photograph Log. The work generally includes repair of non-structural and structural cracks, repair of leakage locations, patching of concrete surface deterioration and form-tie locations, and restoration of affected areas.

Structural Evaluation Report – Attachment A Photograph Log  
Lake McIntosh and Lake Kedron Dam Spillway Wall Structural Assessment  
Fayette County Water System (FCWS)

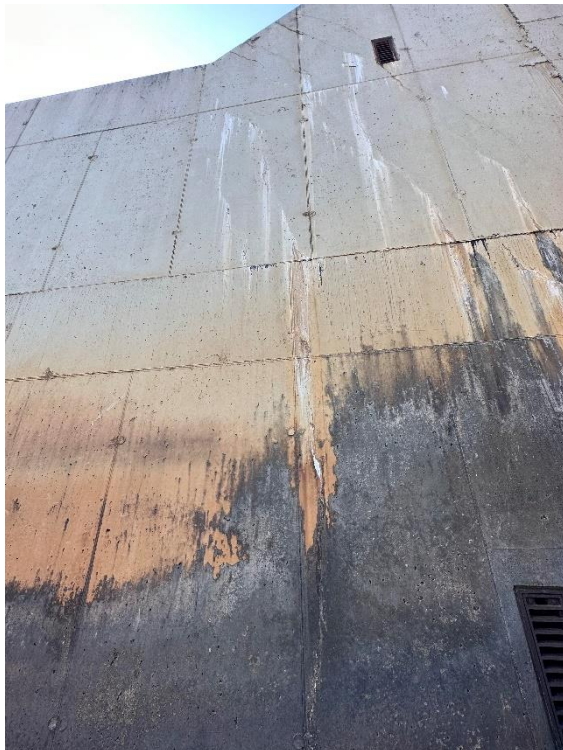
**Photograph: 55**

Cracks on the south wall interior face with signs of efflorescence

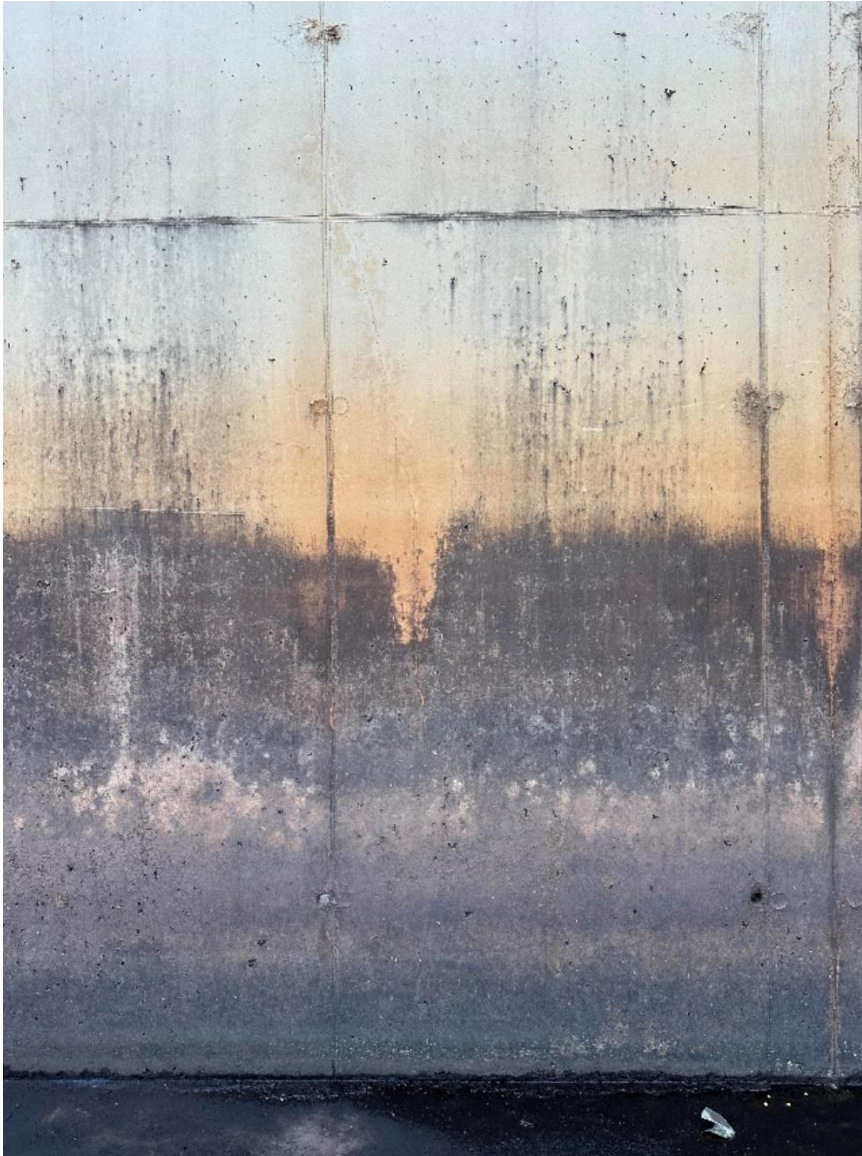
**Photograph: 56**

Crack on the south wall  
interior face

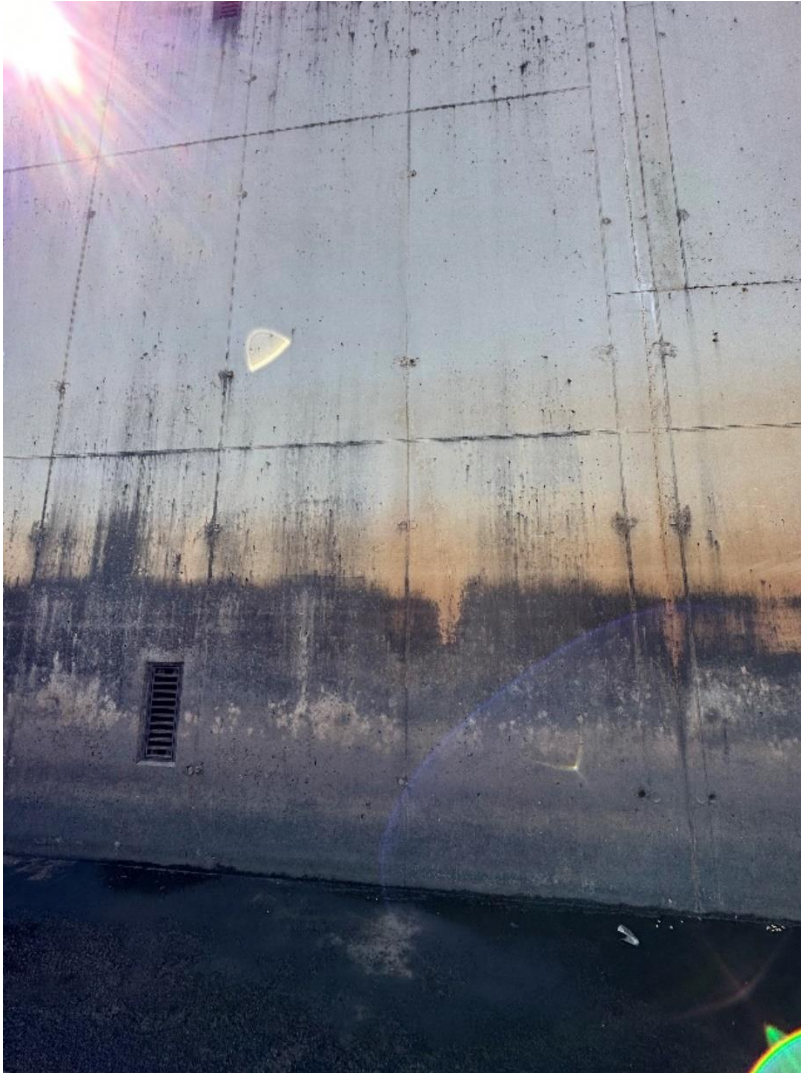
**Photograph: 57**

Crack on the south wall  
interior face

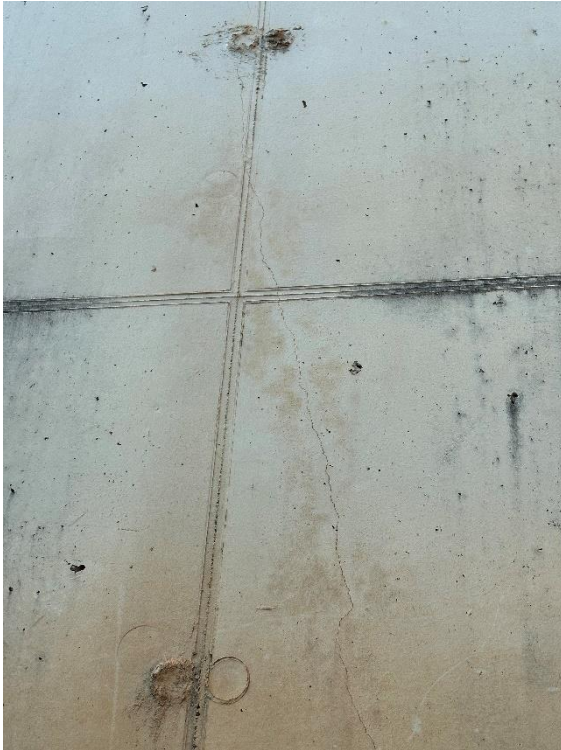
**Photograph: 58**

Crack on the south wall  
interior face

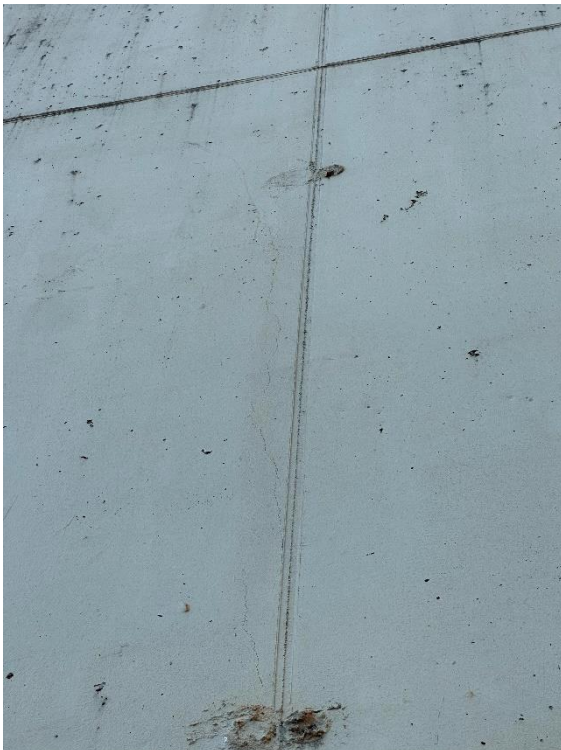
**Photograph: 59**

Crack on the south wall  
interior face

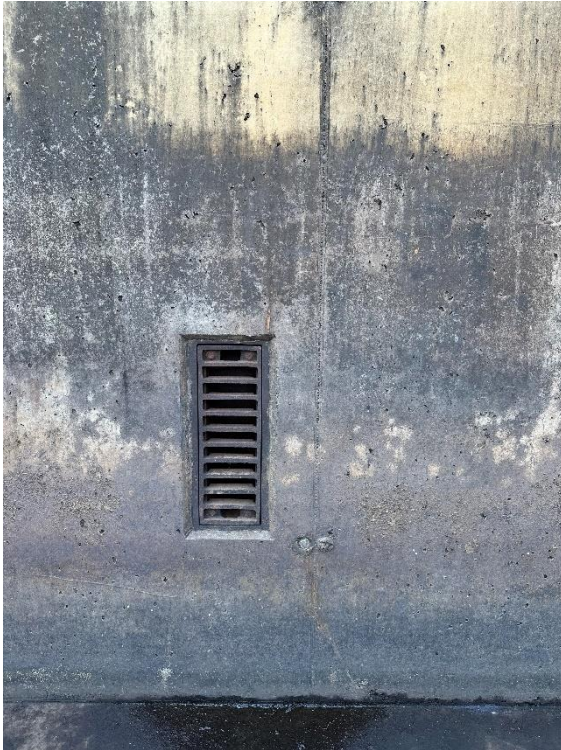
**Photograph: 60**

Crack on the south wall  
interior face

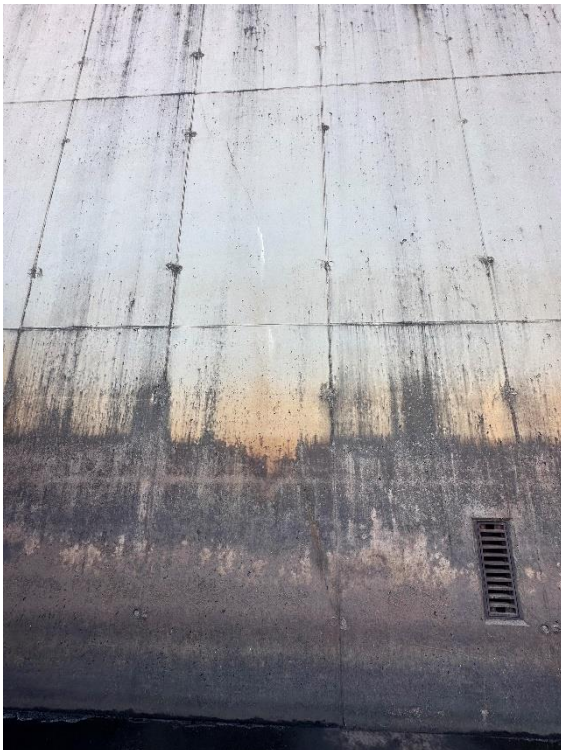
**Photograph: 61**

Crack on the south wall  
interior face with signs  
of efflorescence

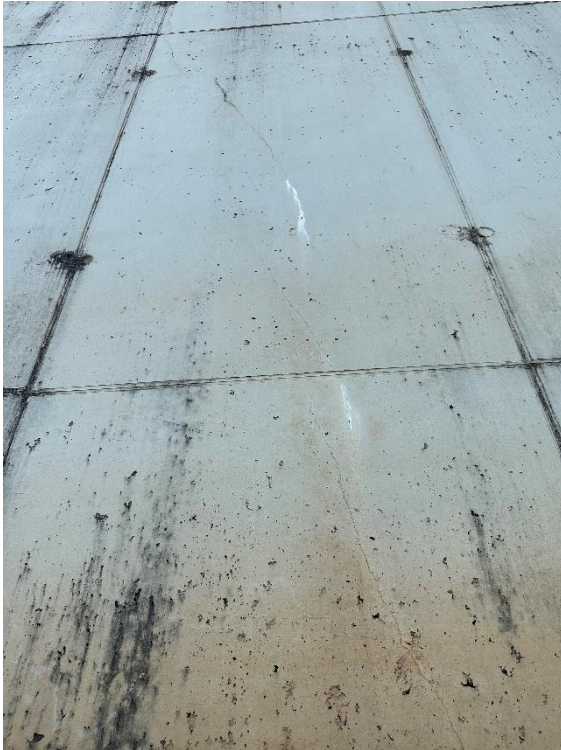
**Photograph: 62**

Crack on the south wall interior face with signs of efflorescence

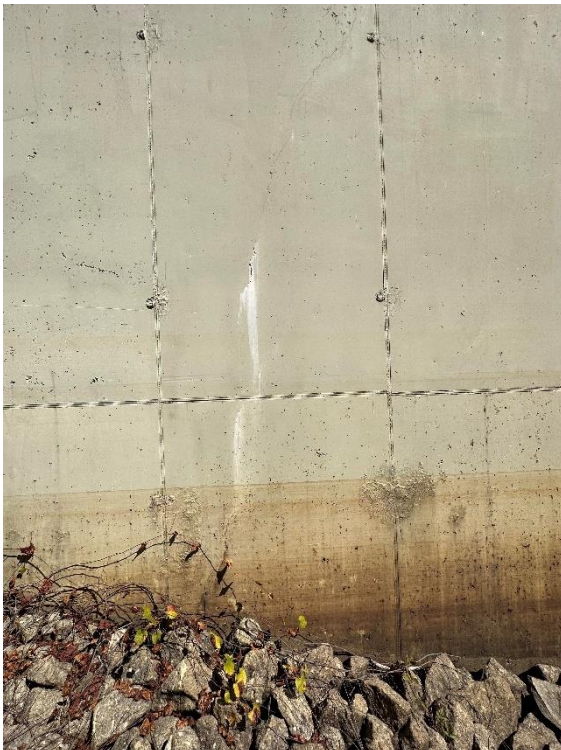
**Photograph: 63**

Crack on the south wall exterior face with signs of efflorescence

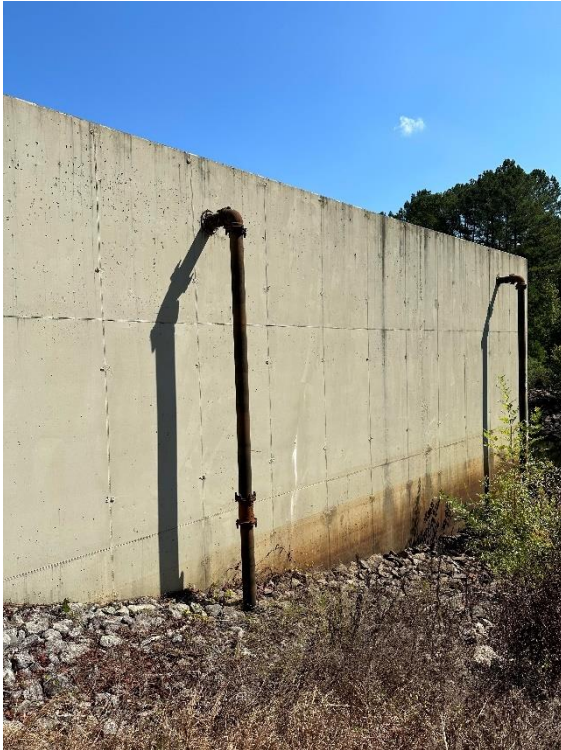
**Photograph: 64**

Crack on the south wall exterior face with signs of efflorescence

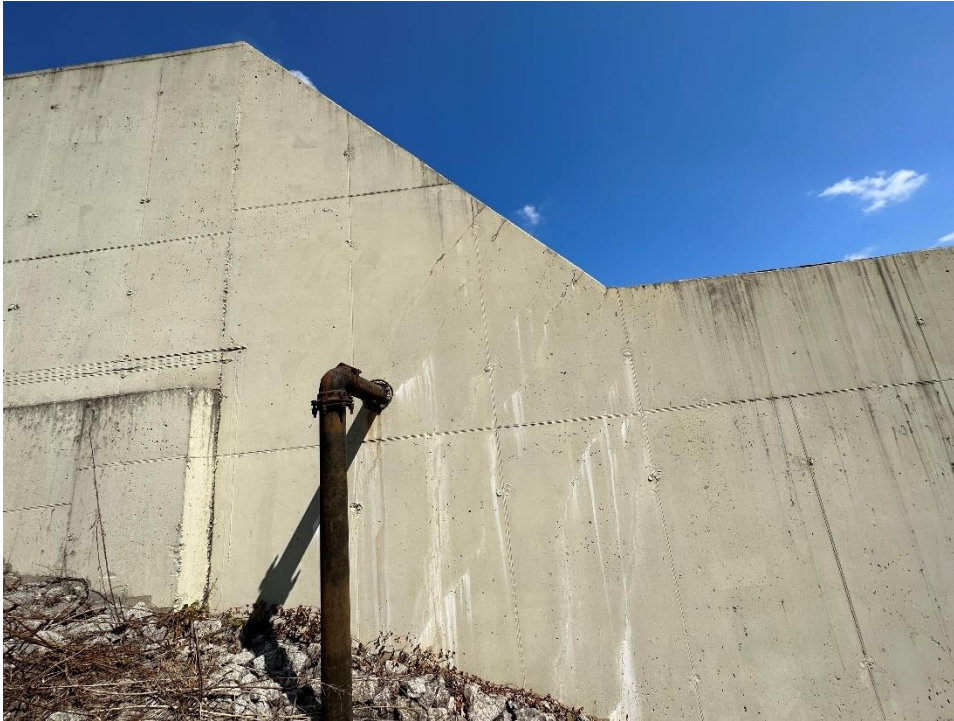
**Photograph: 66**

Diagonal cracks were observed on both the north and south walls in the area where the wall slopes down from EL. 793.00 to EL. 780.00. On the south wall, these diagonal cracks were closely spaced and appear to be due to shear and represent potential structural distress. Additionally, the presence of these diagonal cracks could be attributed to the lack of reentrant corner rebars or the insufficient rebars placed along the wall slope. For visual reference of the observed diagonal cracks, please refer to Photographs 49 to 55, 65, and 66. For these shear cracks, refer to the structural crack repair method discussed in section 4.1.

Cracks on the south wall exterior face with signs of efflorescence

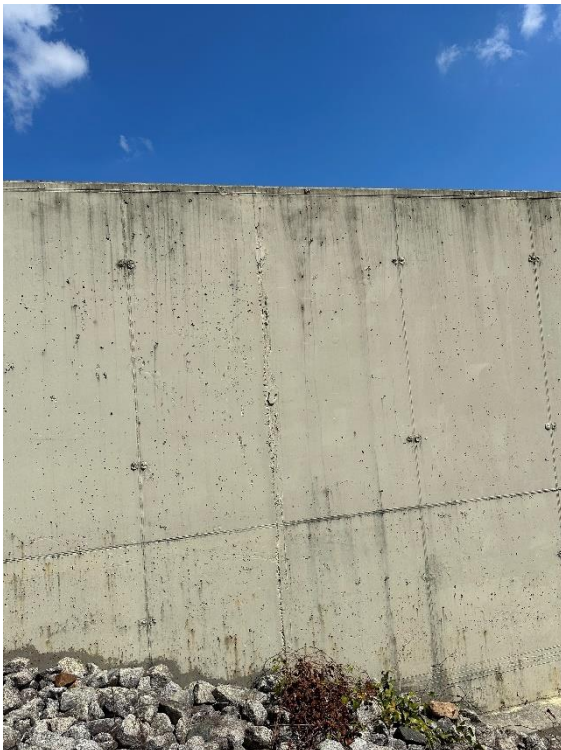
**Photograph: 67**

west wall. This issue was also observed at the west wall keyway construction joint located at the inlet area. Refer to Photographs 67 and 68.

### B. West Wall Joint Repair at Lake Kedron Dam (Refer to Attachment B – Photograph 67 and 68)
